## The Adams Home Farm

*An Illustrated Historical &  
Architectural Description  
of an Old Family Farmstead  
in Northwest Fork Hundred  
of Sussex County, Delaware,  
and an Account of the Family  
who has lived there.*

By Catherine Adams Masek

# AN ARCHITECTURAL DESCRIPTION AND ASSESSMENT OF THE ADAMS HOME FARM

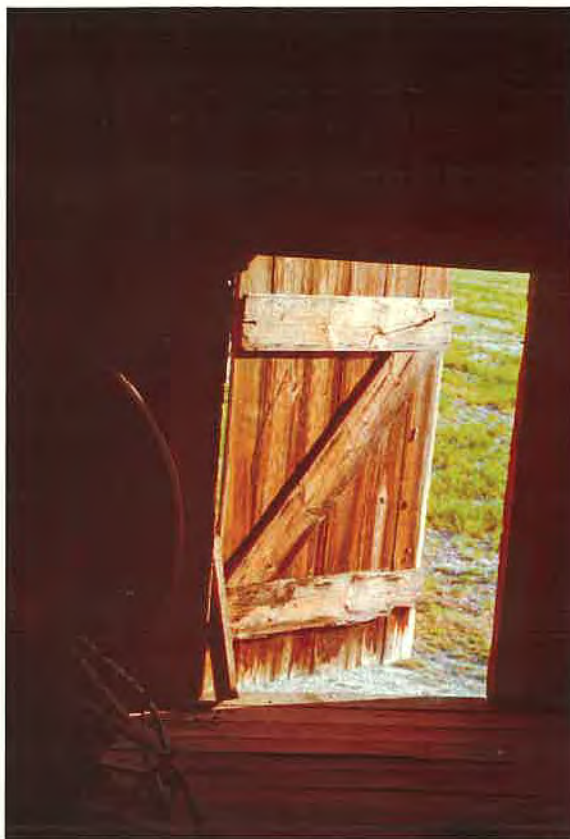
*Door on the second floor south wall of the 19th century granary.*

A timber framed, gable front, one and a half story, house-like granary, 24.5' x 17' in size, 19' in overall height, stands 7' southeast of the corncrib. The original exterior walls are covered by artificial horizontal siding, 8" in width, on all four sides, and replacement roof is of standing seam metal. The foundation is composed of six concrete block piers. Moved c.1974-1980 from the adjacent parcel of land, once owned by the Knowles/Dawson/Wilson families, the axe hewn sills and corner posts now are supported by concrete block and brick. In the process of reconstruction, two upbraces at interior corners are missing, and four lap joints un-used. But the principal posts and rails show combination lap and mortise and tenon joints. Similar to the central square

section of the Willowdale Barn, Accomack County, Va., built c. 1800, the Adams granary is built of axe hewn and pit sawn timbers, with no down braces, and the interior is divided into two nine-foot bays on the north side. The divider, originally full height, is composed of random width horizontally laid roughly cut boards. The exterior vertical board walling, in random widths of 11", 6", 8.5", 11.5", would have provided a tight seal for the first floor threshing. Flooring is composed of random width 11", 12", 8" and 8.5" width boards, held with early cut nails. A second floor, originally, was accessed only on the exterior via a second floor 4' door on the south façade above the exterior door. Now it is accessible via an open stringer stair without rail, inserted into the southwest corner of the building. Horizontal wainscoting, 28" in height, is located on the lowest portion of the second floor walls, probably used to contain or enclose loose grain or bagged grain. In moving the granary from the Knowles farm to the Adams home farm, the building was not rotated to be oriented to the primary farm lane. This is apparent when viewing the original exterior entry door to the first floor, which is on the south façade, away from the primary farm lane. A second entry has been cut into the west façade beside the stair, which provides better
