National Register of Historic Places
Registration Form

historic name Meeteer House

other names/site number N-206

street & number 801 Kirkwood Highway N/A not for publication

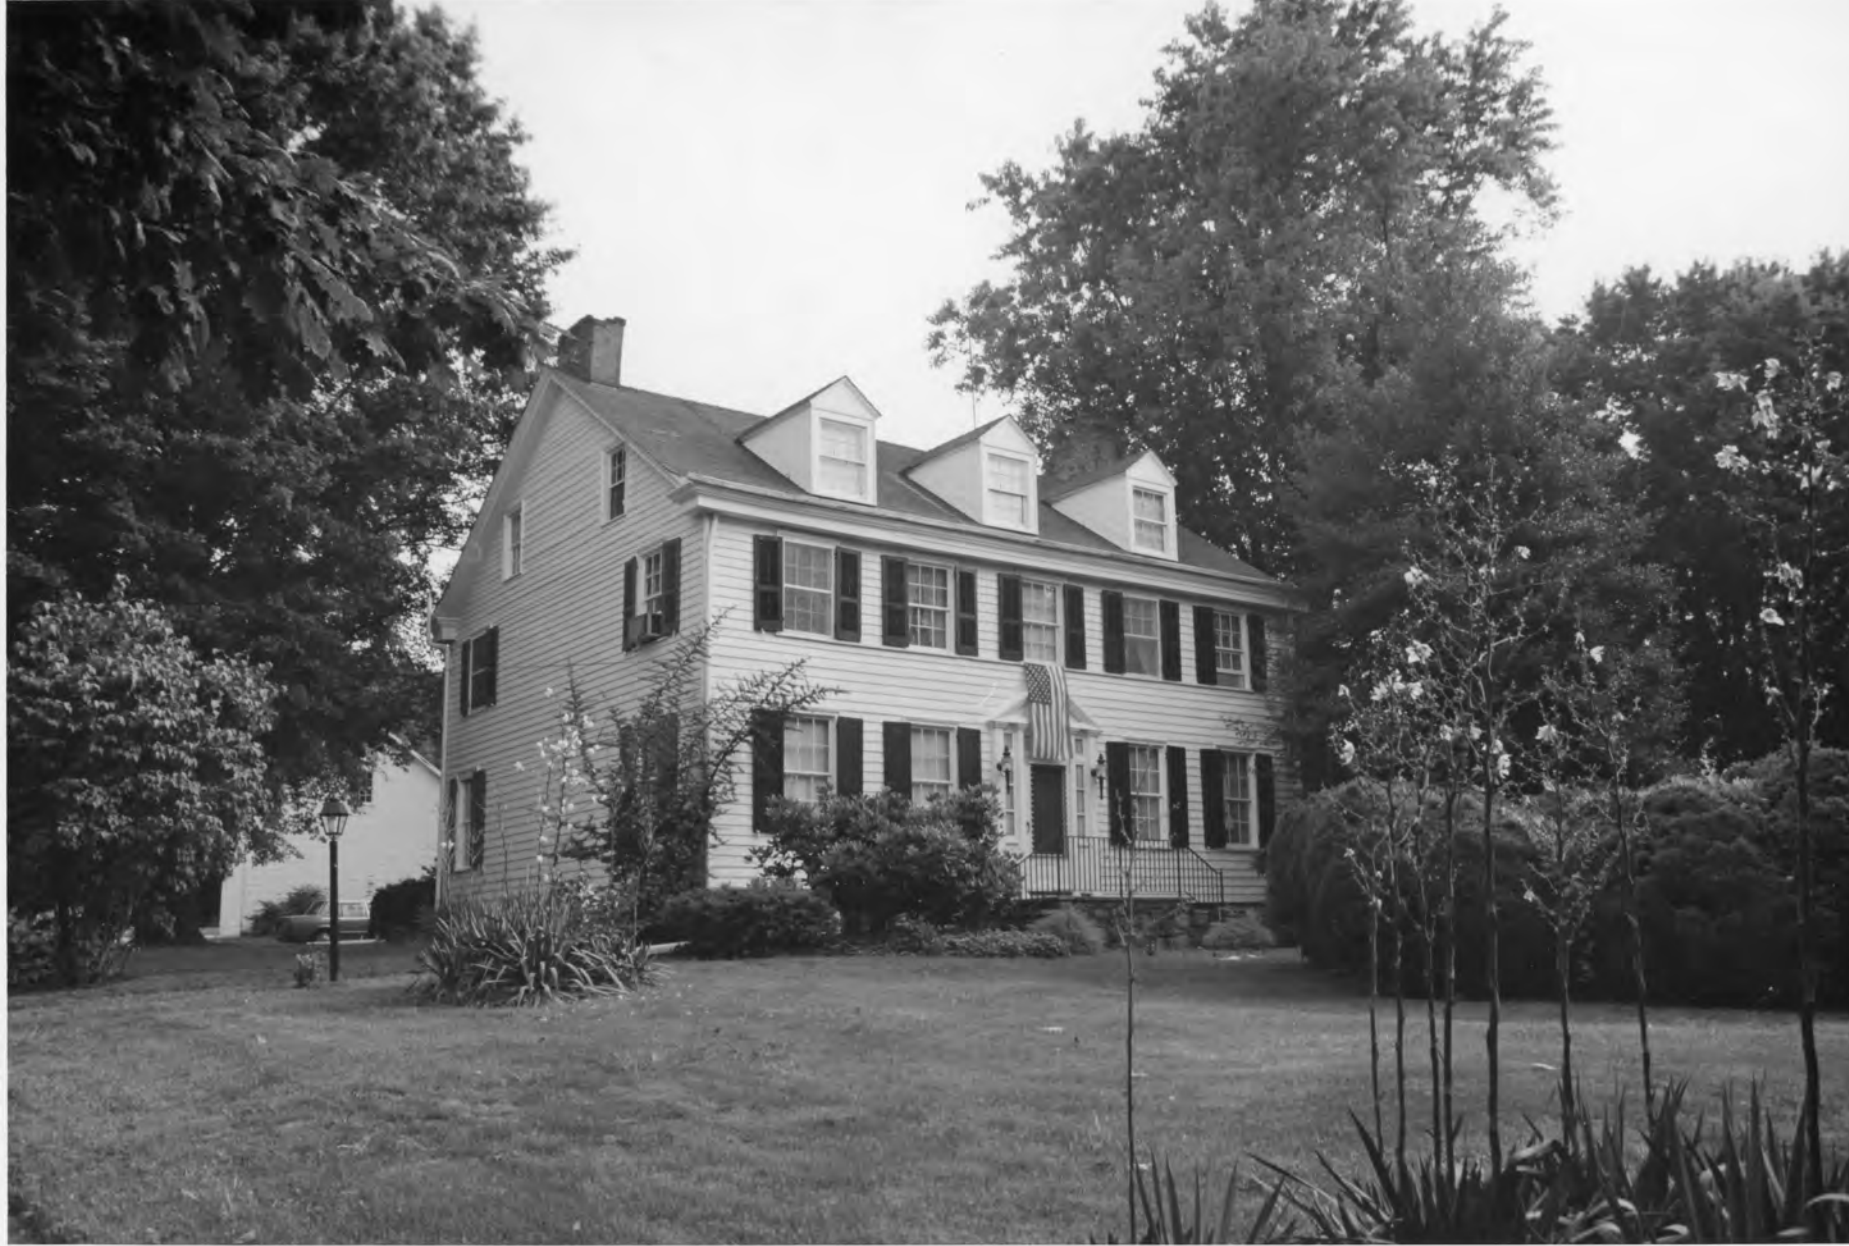
1 OF 7

PRIMARY FACADE: CAMERA FACING NORTH

The principal facade faces south. It is 39' 6" along this elevation. The foundation is exposed approximately 2' 7" above the ground. There are two windows at the foundation level, one on either side of the centrally located stoop for the front door. The windows are made up of six panes in a fixed sash. Seven squared, wood slats run horizontally across the frame. The stoop appears to be a later replacement for the original porch. It has two sets of three steps on opposite sides of a landing made out of coursed rubble, with an iron railing.

The first story of the principal face has four windows, with two flanking each side of the centrally placed door. The windows are six-over-six, double hung sash. Each window has a pair of original, wooden paneled and pegged shutters and iron shutter dogs. The front door has two long vertical panels. A three-pane transom and four-pane side light surround the door opening. Below the side lights is a paneled area that mimics the paneling found in the first story shutters. The door surround is in temple form, with coupled pilasters supporting a pediment.

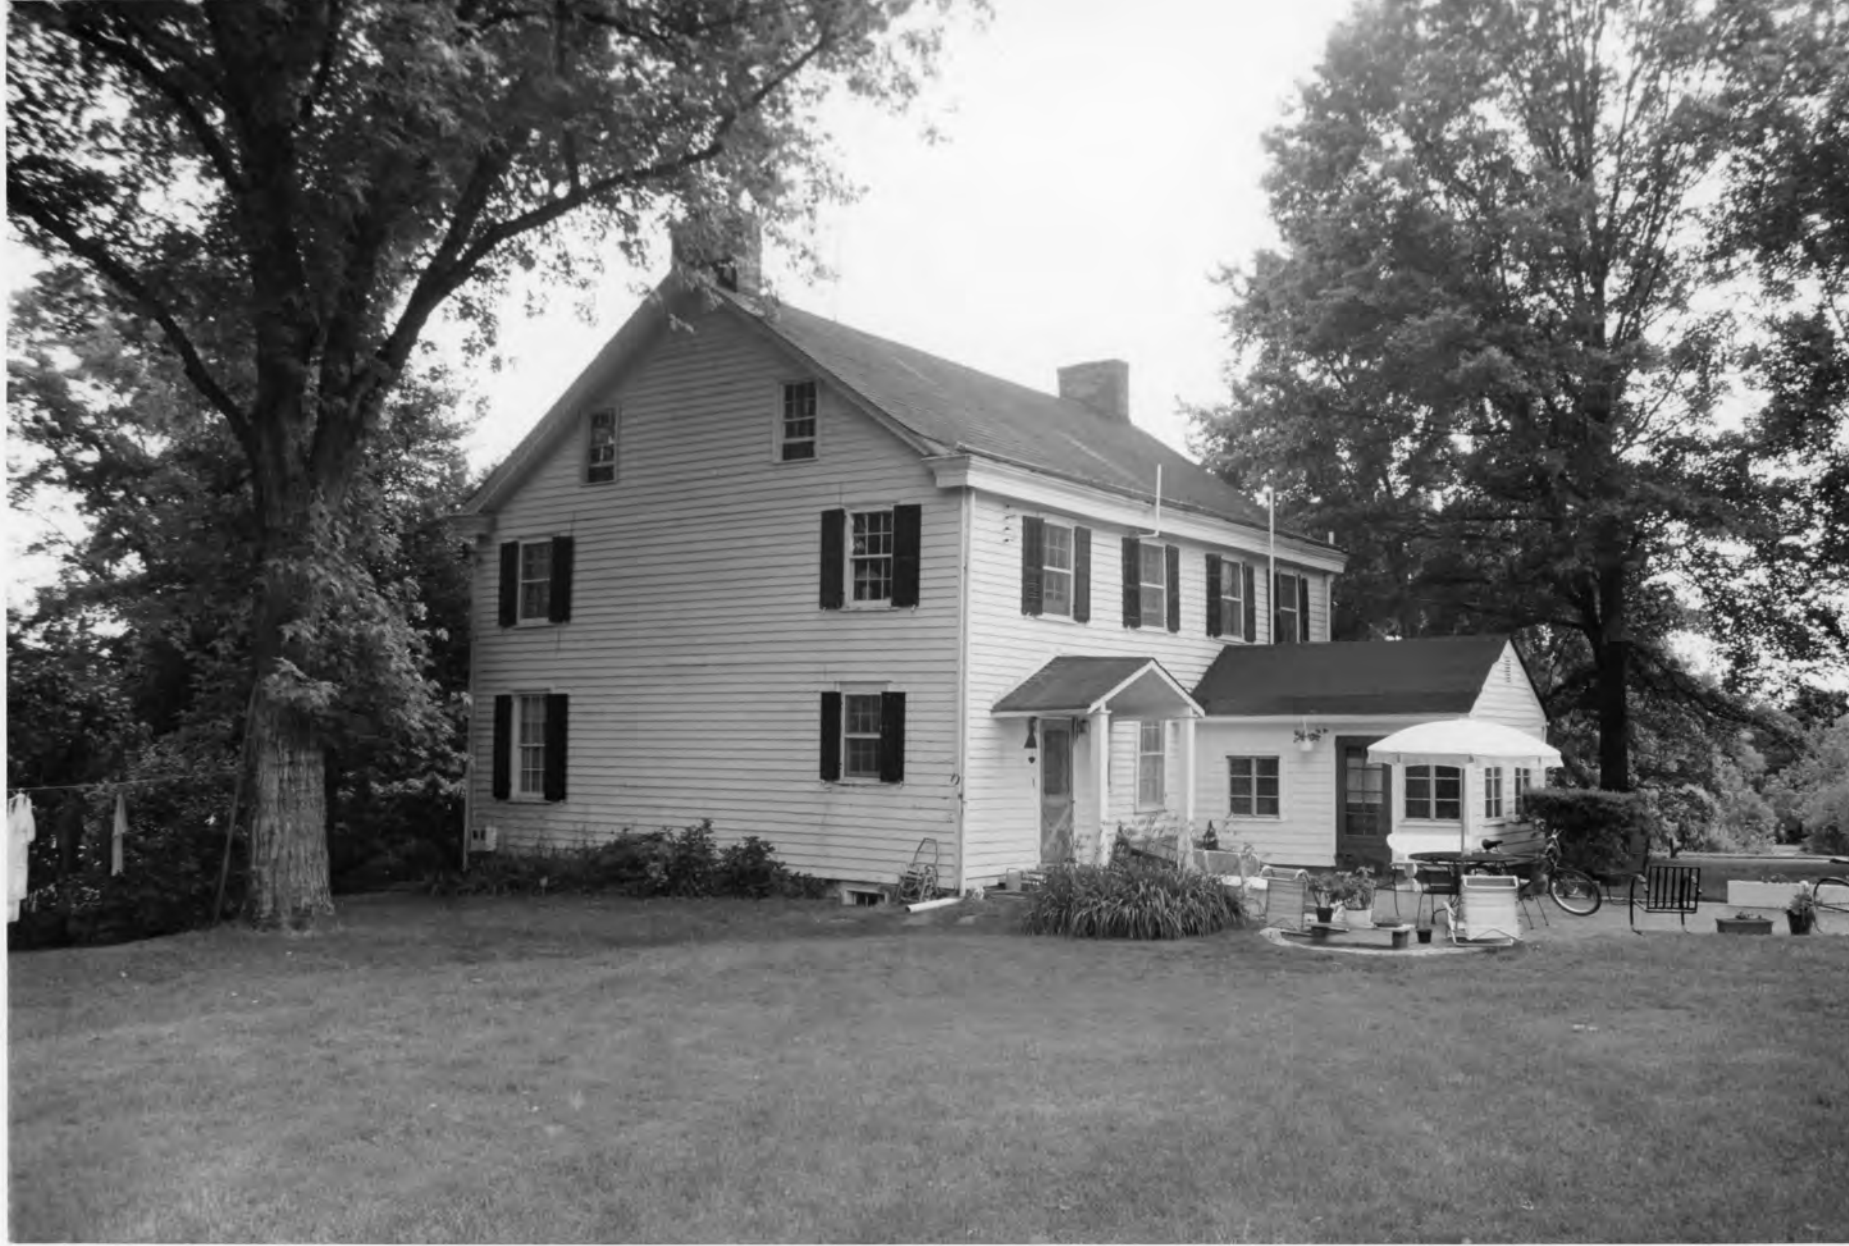
2 OF 7

PERSPECTIVE VIEW OF REAR: CAMERA FACING SOUTH

The north (rear) elevation is not symmetrical, and has no dormers. There is recent one story addition to the west side of this elevation. The foundation only shows about 6 inches above the ground level, allowing no room for cellar windows. There is a bulkhead entrance to the cellar made out of the same roughly coursed rubble as the foundation. The double, exterior cellar doors have been replaced in the 20th century, and the steps leading to the interior door have been covered in cement.

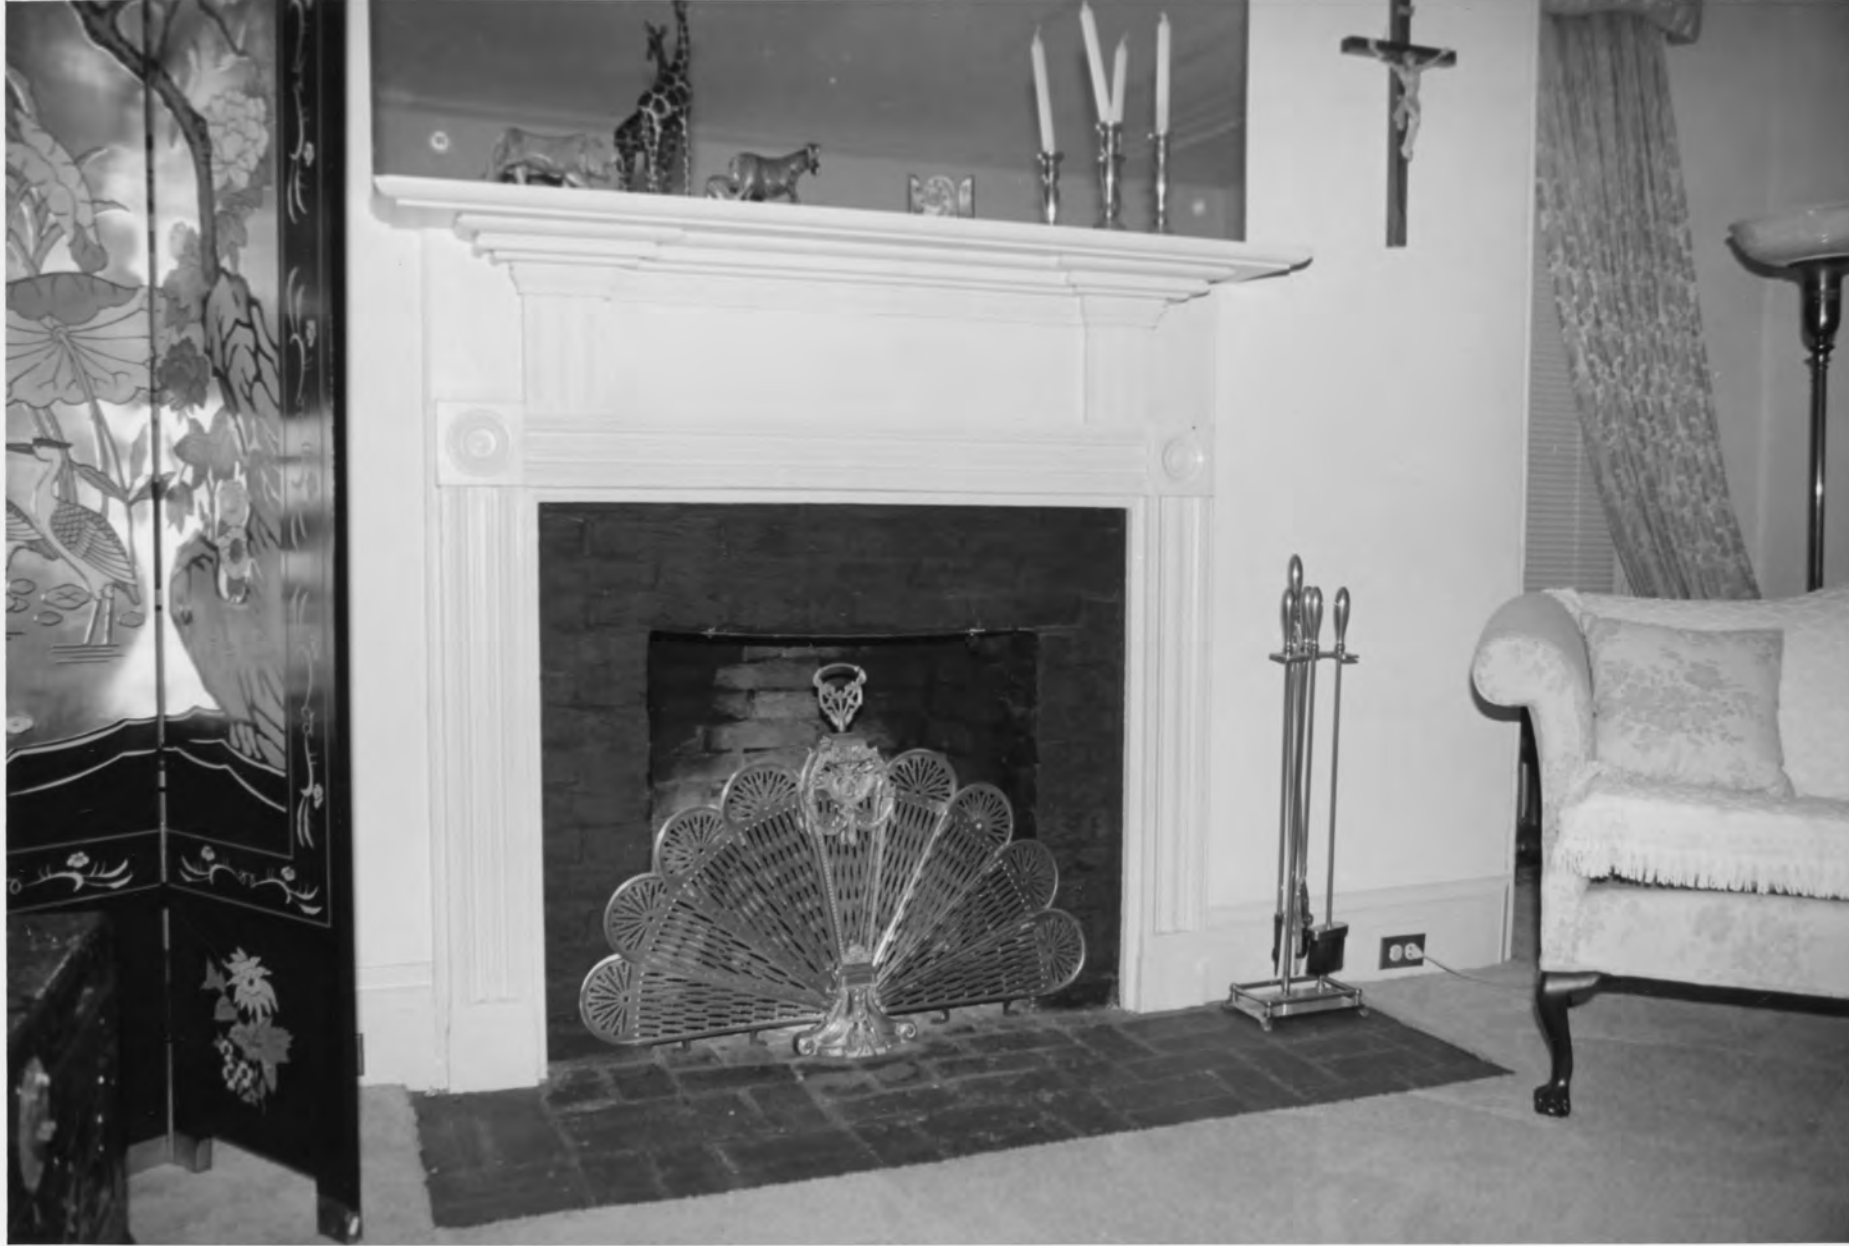
5 OF 7

FIREPLACE IN 1ST FLOOR, SOUTHWEST
PARLOR. CAMERA FACING SOUTHWEST,

Working clockwise, the room entered from the left side of the central passage is the living room. This room has been enlarged. It was originally two rooms, but the dividing wall has been removed, therefore, this room runs the entire depth of the house. There are five, six-over-six double-hung-sash windows in this space. There were two fireplaces on the west wall, but the one towards the front has been walled over. The baseboards are simple, and the door and window surrounds are molded with bulls eye corner blocks. The doors are paneled with two long panels extending the height on the door. The mantelpiece mimics the door and window surrounds, and also has a mantel shelf supported by two small doric style blocks in the frieze. To the north is a doorway leading to a 20th century addition. There is also a doorway leading to the rear passage. Over this doorway is a three pane transom.
