National Register of Historic Places Registration Form

historic name New Castle County Workhouse – Women’s Ward

other names/site number N-13728

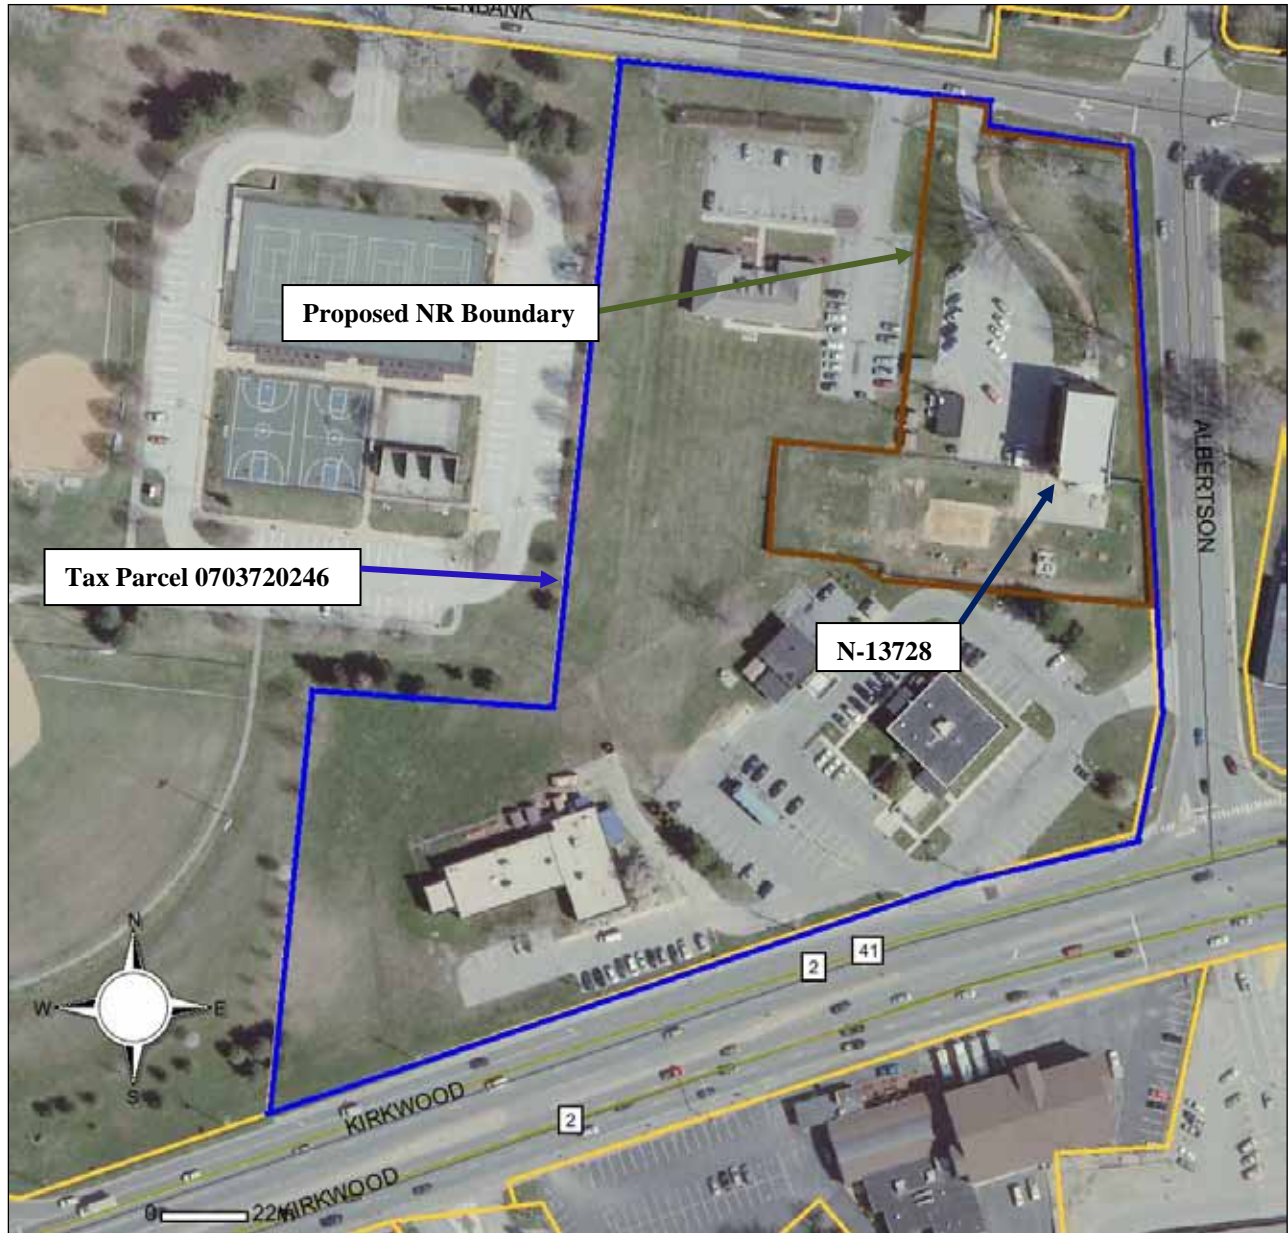
Aerial view of the property showing the National Register Boundary in relation to the tax parcel.

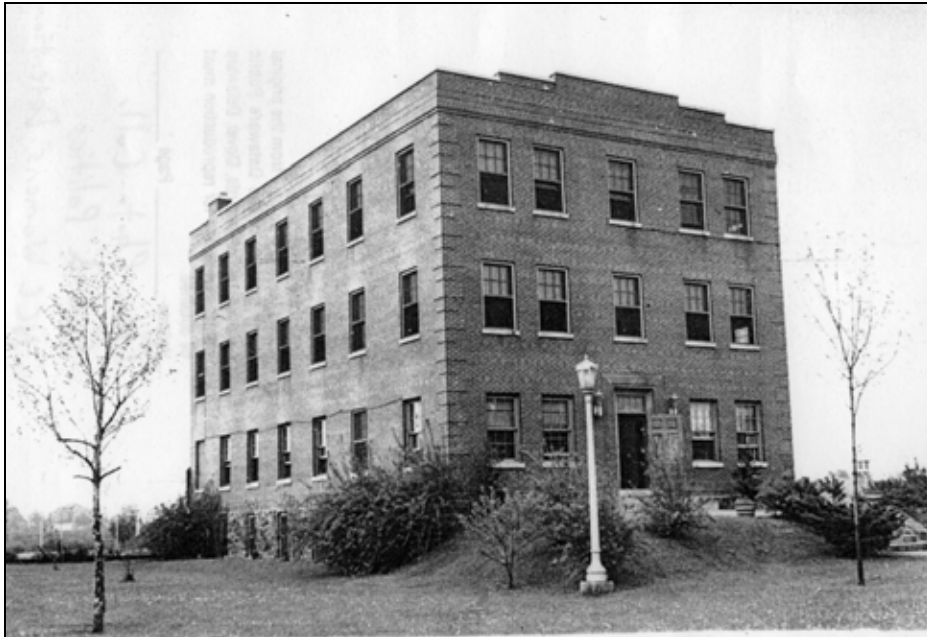
An undated view of the “Women’s Detention Home,” looking southwest. The photograph was found with the New Castle County Workhouse 1930 annual report and may be associated with the opening of the building. (Delaware State Archives)

An undated view of the east and north elevations of the “Women’s Detention Home,” looking southwest. The photograph was found with the New Castle County Workhouse 1930 annual report and may be associated with the opening of the buildin

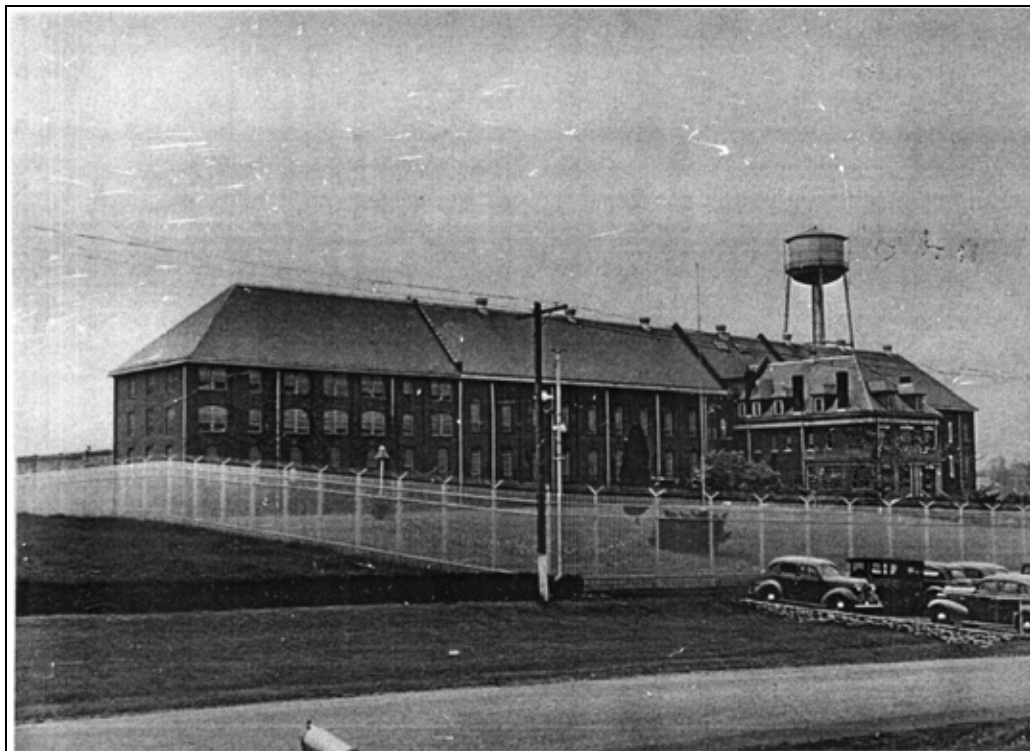
View of the New Castle County Workhouse after the installation of the perimeter fence c. 1936, looking southwest. The fence in this picture is very similar to the fence currently in place around the women's ward. Note the stone wall in the lower right foreground. This feature is extant.

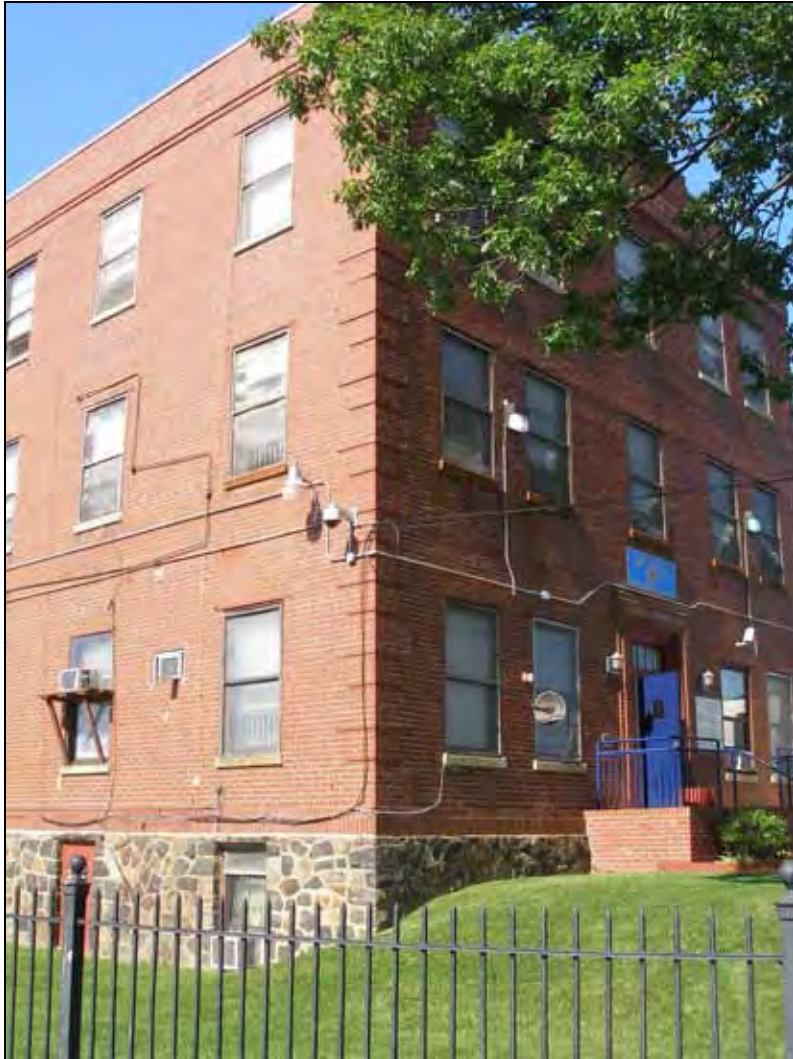
View of the northeast corner of the New Castle County Workhouse – Women's Ward (N-13,728) looking southwest.

The five-bay, three-story John L. Webb Correctional Facility is constructed of brick laid in common bond with decorative quoins at either end of the façade. The resource displays the manner of institutional Art Deco, implementing the style through a series of subtle features and characteristics. Deco details include the parapet wall at the top of the façade, decorative brick quoins, and the architectural emphasis of the main entry.

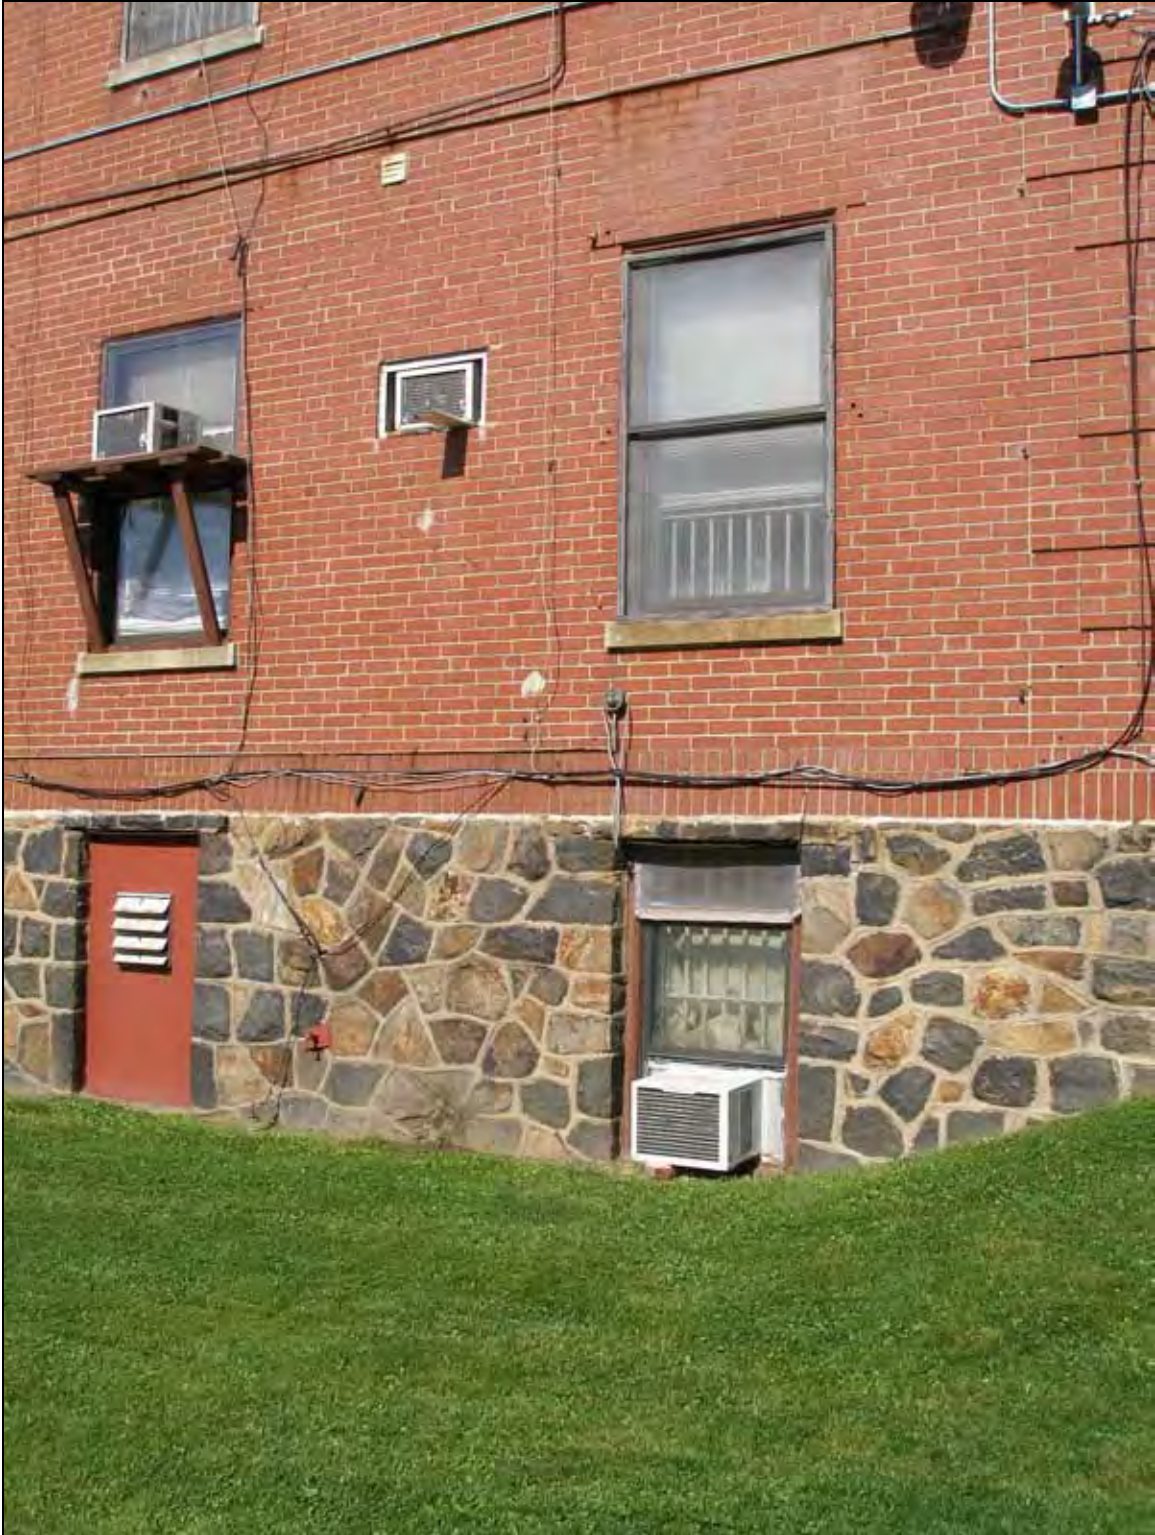
Detail of the foundation, brick cladding, and fenestration at the northern end of the east elevation.

The seven-bay, three-story east elevation exhibits a half-story of the uncoursed stone foundation. As featured throughout the building, a course of vertical bricks lines the base and frieze of the elevation. Fenestration is regular and symmetrical, consisting of one-over-one, wood sash windows fitted with vertical metal bars at the interior. Identical to the other elevations, the windows are trimmed with narrow wood surrounds and projecting concrete sills. Several windows on the elevation are fitted with window unit air conditioners. A kitchen ventilation fan is situated at the southernmost window at the first floor. The lone drain pipe of the resource is at the southern end of the elevation. An interior brick chimney is also located at the southern end of the elevation.

Detail of the foundation, brick cladding and fenestration at the northern end of the east elevation.

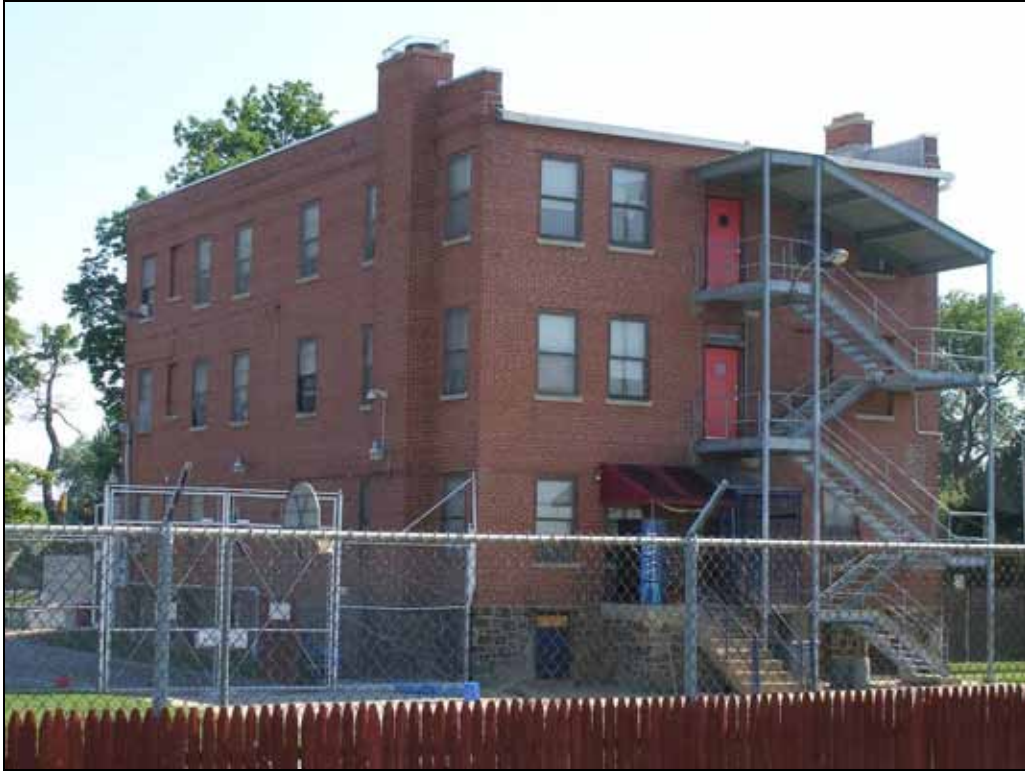
View of the south and west elevations, looking northeast.

The five-bay, three-story rear elevation is oriented toward the south. The elevation is comprised of common bond brick, with the uncoursed stone foundation exposed at the base. The bottom and top courses of the elevation are trimmed with vertical brick. The defining feature of the elevation is a permanent, metal fire escape at the eastern half of the elevation. The structure provides inmates access to an enclosed recreation area immediately adjacent to the correctional facility. There are entries at the center of the first, second, and third floors. Each is fitted with a flat panel, steel door with a one-light window. Transoms above the second and third story doors have been infilled with brick. The door at the first floor is fitted with vertical metal bars at three sides, creating a steel enclosure. A poured concrete stair provides access to this entry. Fenestration at the elevation is regular and asymmetrical. There are only four bays at the first floor. The easternmost window bay is absent. At the second story, the eastern two bays are infilled with brick. Only the third floor retains a symmetrical five-bay arrangement similar to the façade. All windows are one-over-one, single-hung wood sash fitted with vertical, metal bars at the interior. The windows are trimmed with a thin wood surround and projecting concrete sills. As on other elevations, a variety of electrical conduit, lighting, and security equipment are mounted to the elevation.

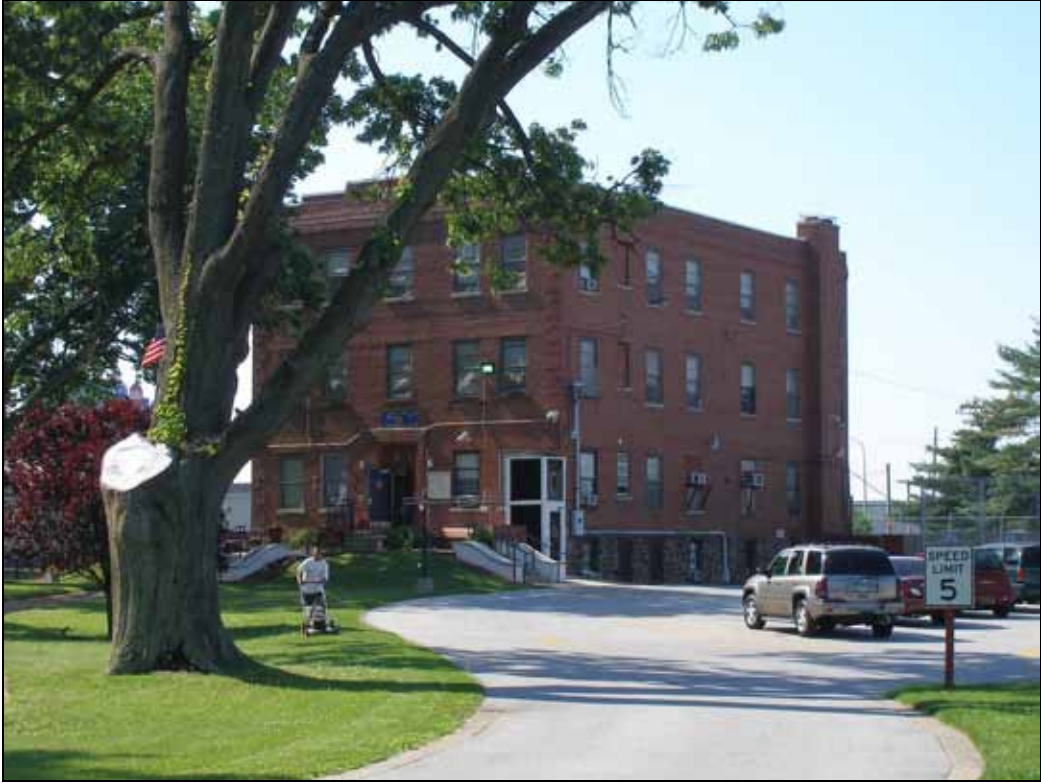
View of the facade and west elevations from the existing entry, looking southeast.

The seven-bay, three-story west elevation is situated atop an exposed, ground-level foundation. The first, second, and third floors of the elevation are clad with brick. A narrow frieze band of vertical bricks caps the elevation.

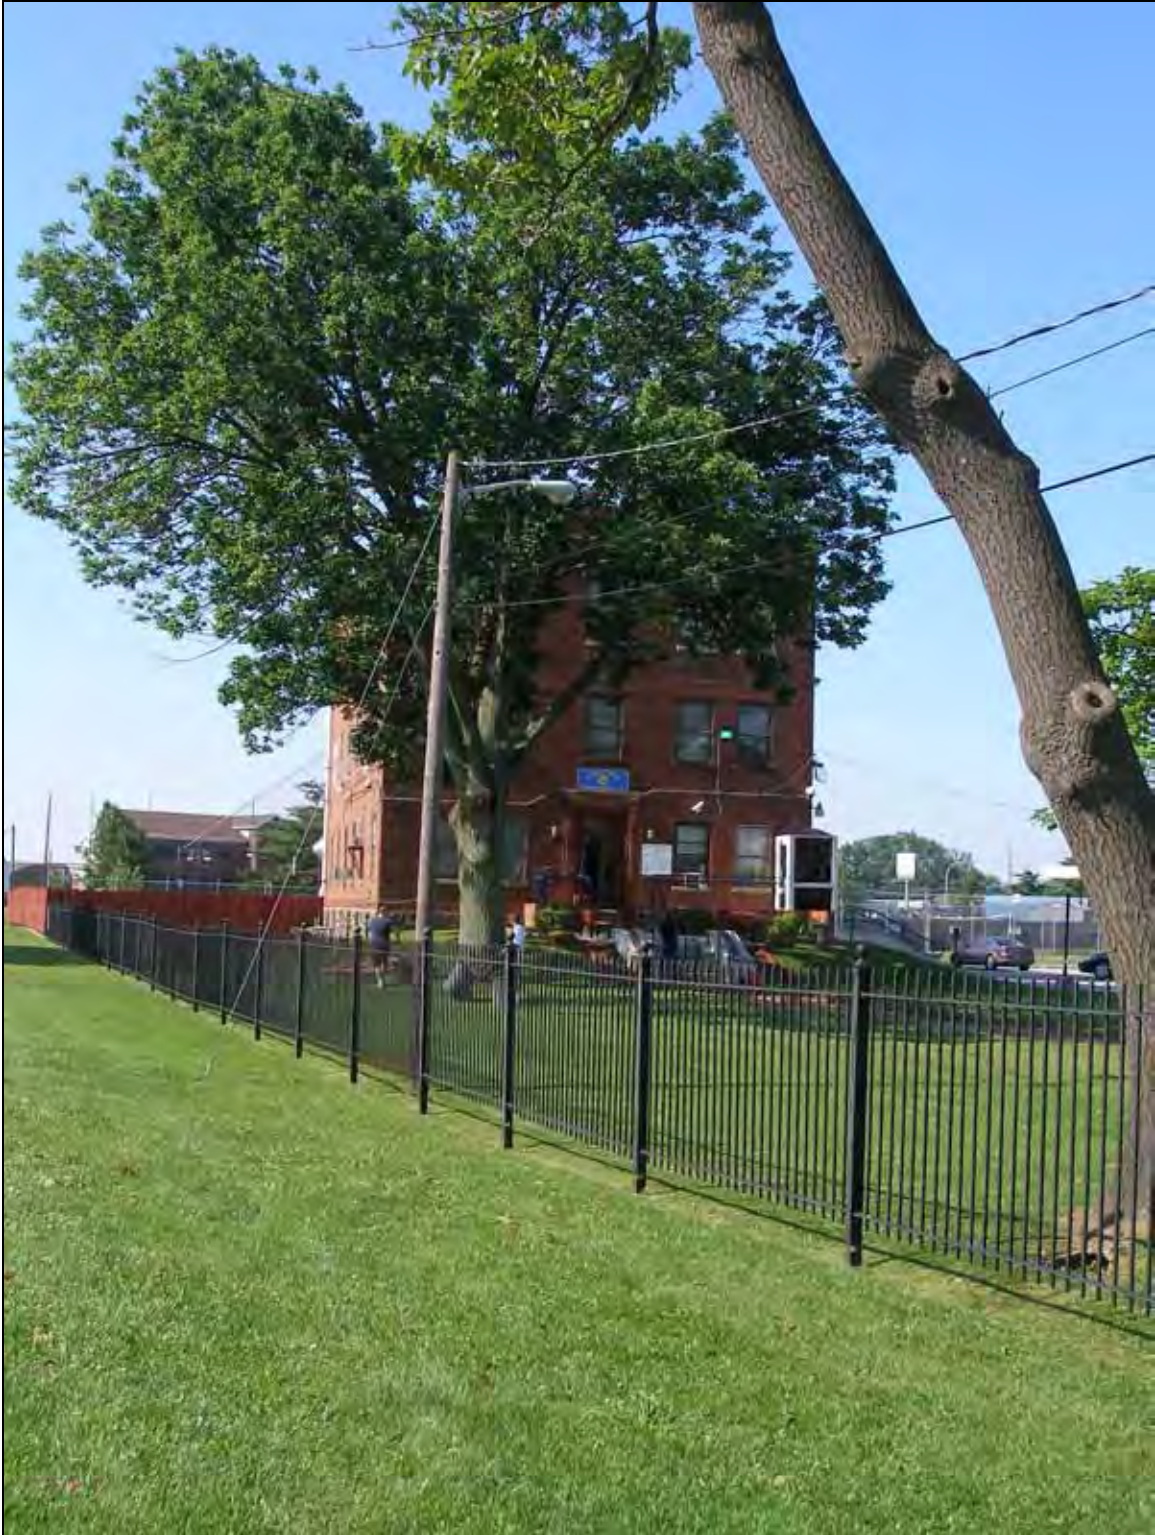
View of the fence installed around the perimeter of the New Castle Workhouse – Women's Ward. Although the fence has been relocated in the past, it appears to have been installed prior to 1954.

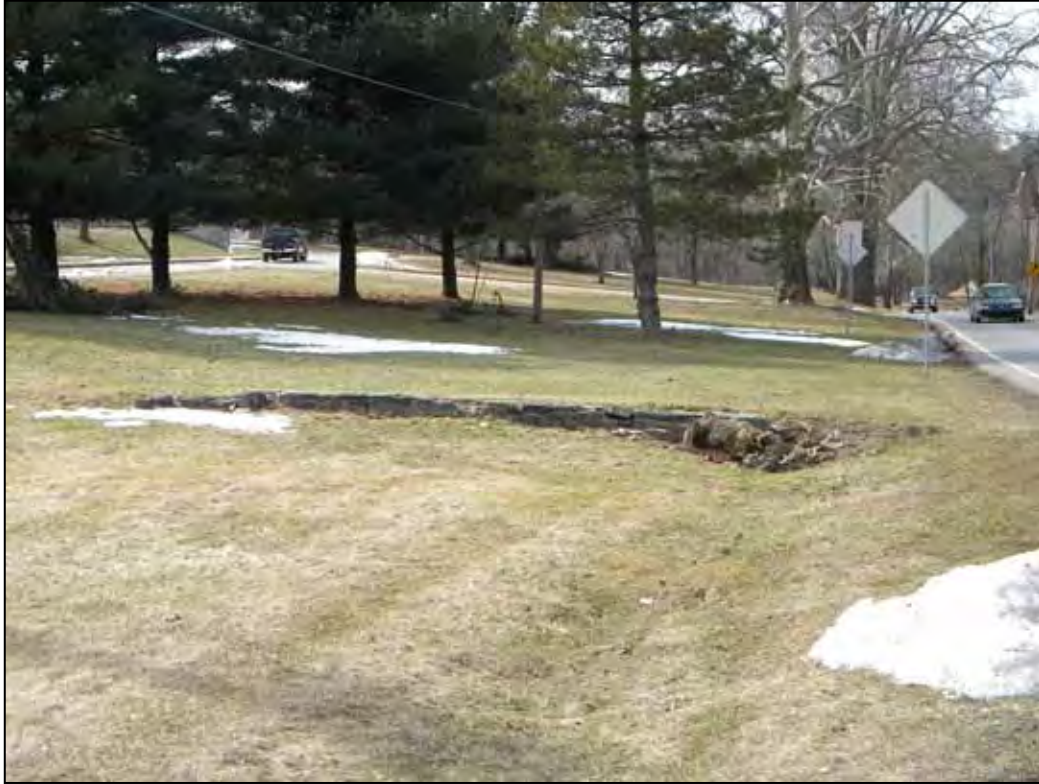
Remnant stone wall at the northwest corner of the tax parcel, a feature associated with a removed parking area for the demolished New Castle County Workhouse. Photo looking west.

A remnant feature of a parking lot associated with the demolished New Castle County Workhouse is located at the far northwestern corner of the property, approximately 37 feet from the western boundary of the tax parcel. The feature is a partially buried stone wall that extends north-to-south approximately 23-feet 4-inches long. A comparison of historic and current photographs and a survey of historic plan sheets have identified the feature as a stone retention wall associated with a 12" terra cotta pipe used for drainage. The wall appears to have been installed c. 1937, when an asphalt parking area was constructed along Greenbank Road as part of perimeter improvements to the Workhouse. Historic and current photographs of the retention wall are in Appendix A.

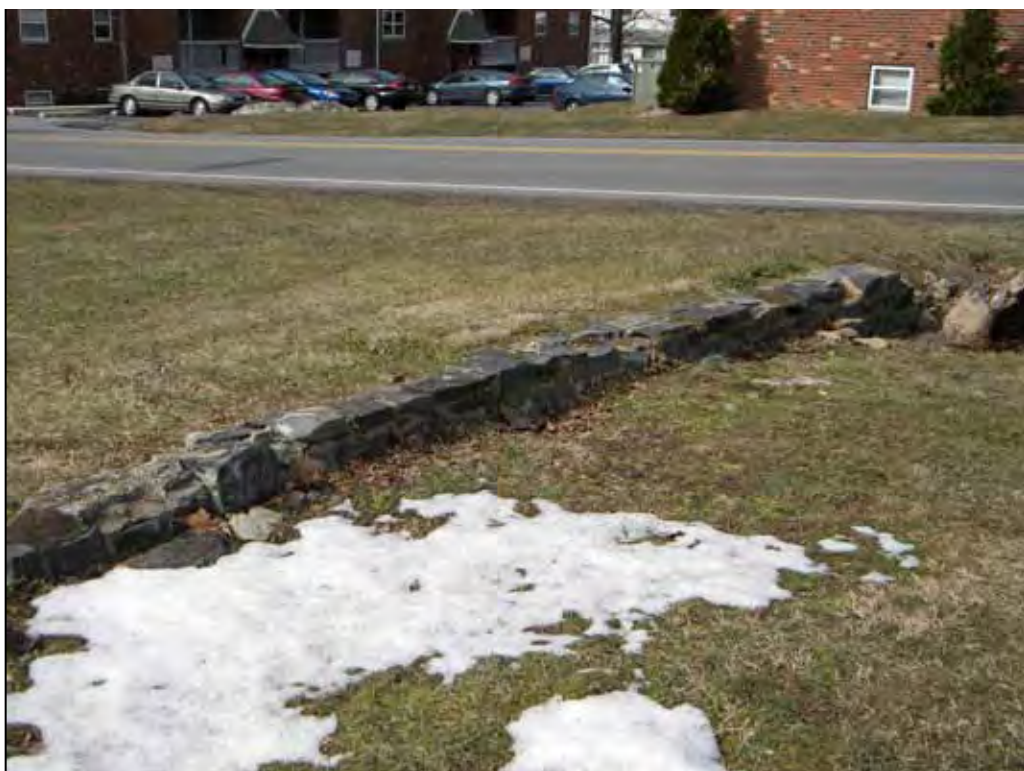
View of the stone wall looking southwest.

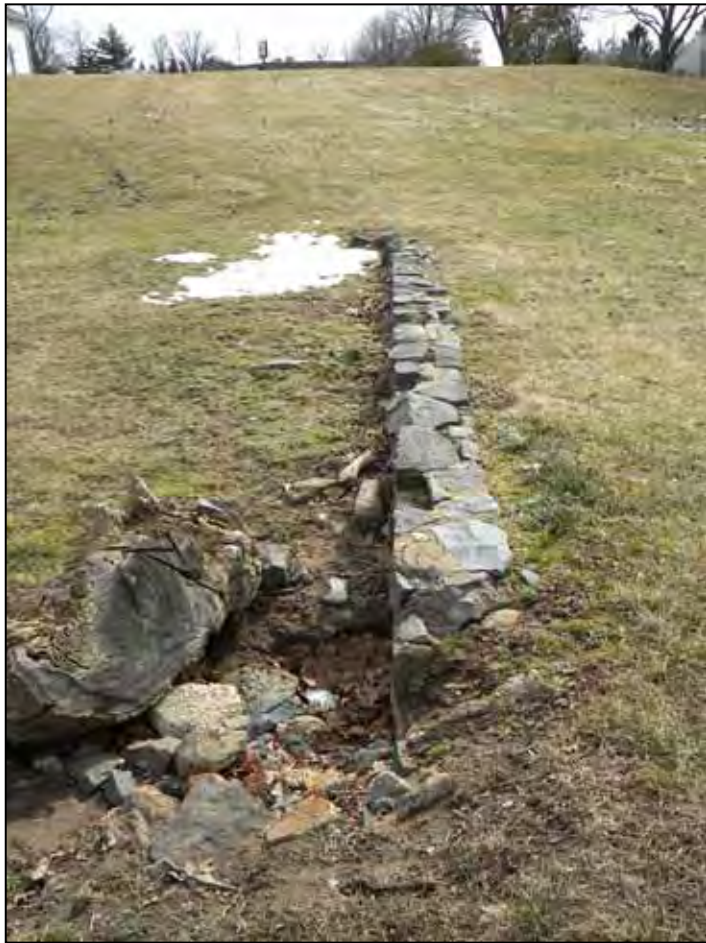
View of the remnant stone wall, looking south. Note the debris at the drainage basin.

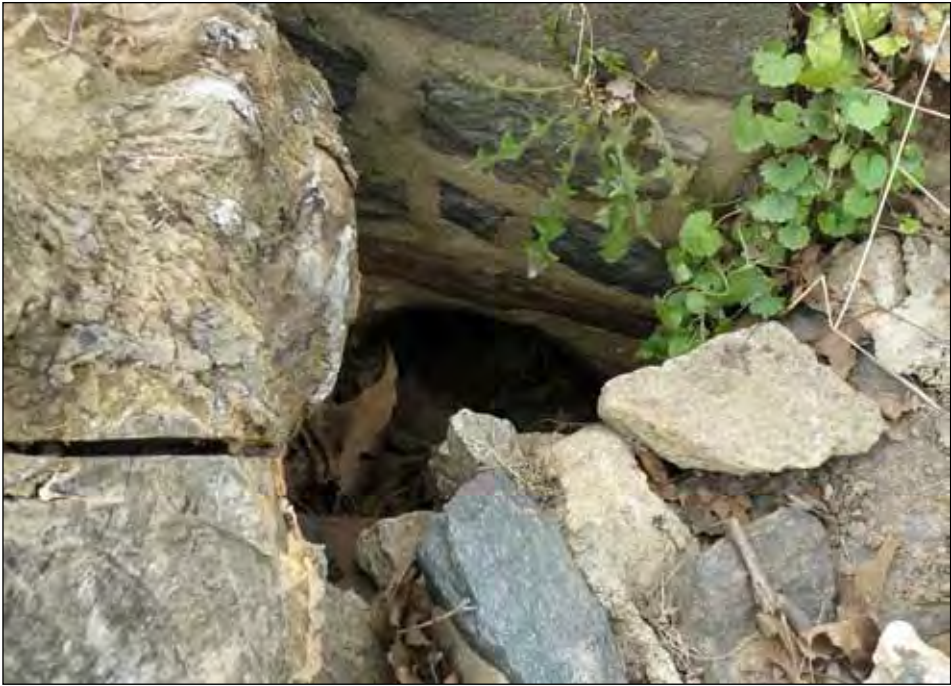
Detail of the failed 12-inch terra cotta pipe at the northern end of the stone wall. Once a part of the drainage system along Greenbank Road, this pipe outlet no longer functions.

The drainage pipe has failed and is no longer associated with the existing drainage along Greenbank Road. Upgrades to the drainage system associated with the undertaking will involve removing an eleven foot portion of the wall closest to Greenbank Road.

Detail of the failed 12-inch terra cotta pipe at the northern end of the stone wall. Once a part of the drainage system along Greenbank Road, the outlet no longer functions.
