National Register of Historic Places
Continuation Sheet

Poplar Hall
Property Name

historic name POPLAR HALL
other names/site number N-6199

street & number 3176 DENNY ROAD (COUNTY ROAD 396)
city, town NEWARK
state DELAWARE code 10 county NEW CASTLE code 002 zip code 19711

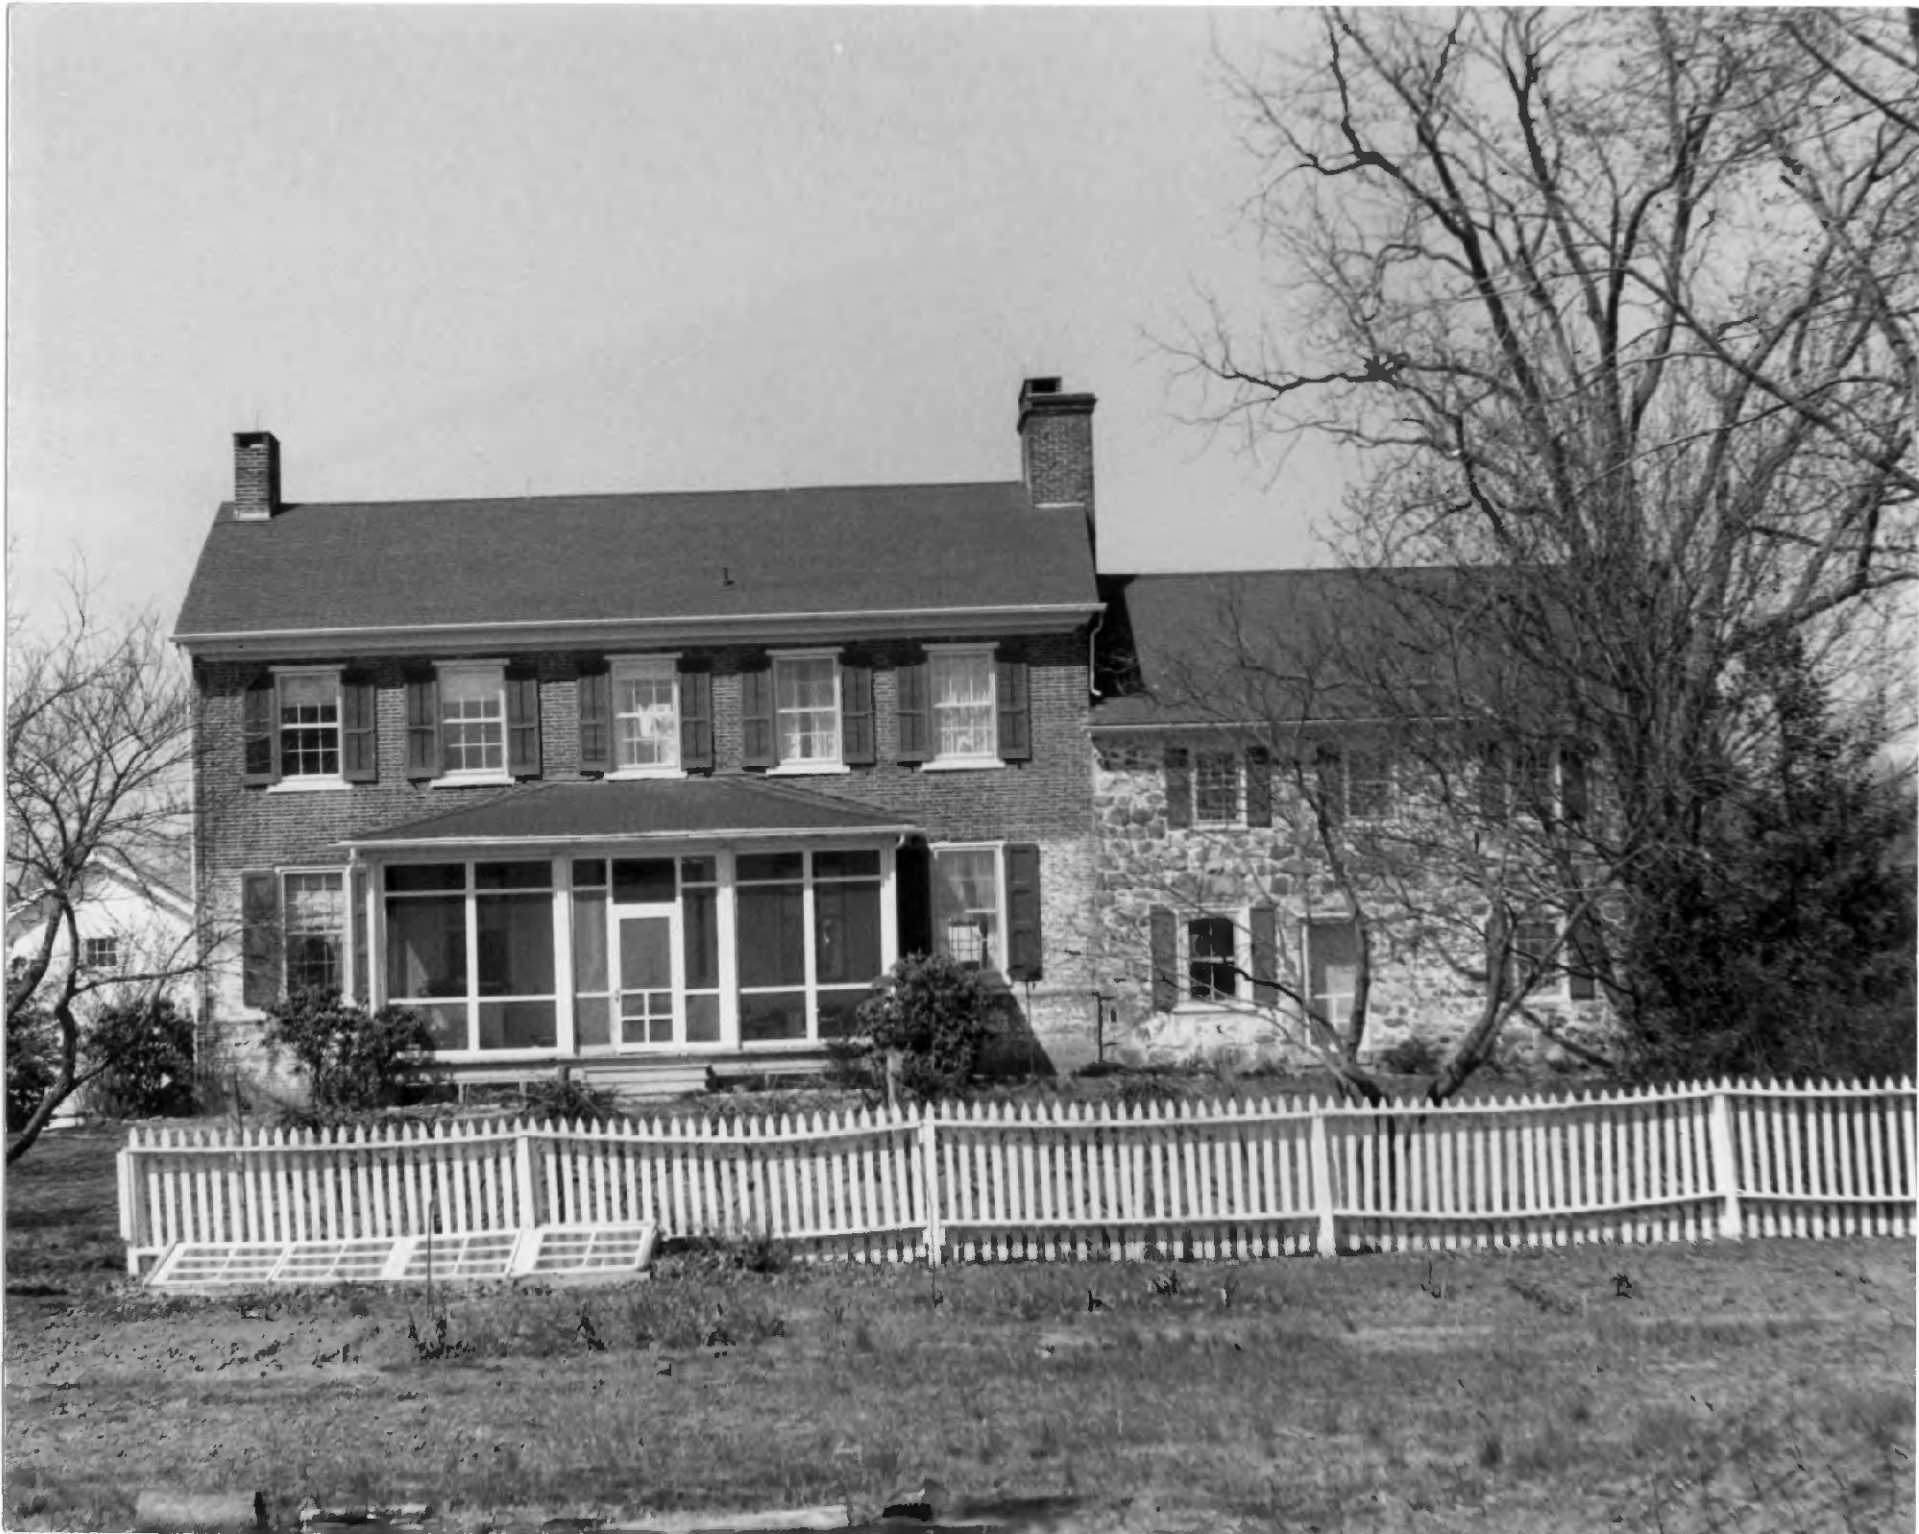
2/11

Description: Dwelling - View from Southeast

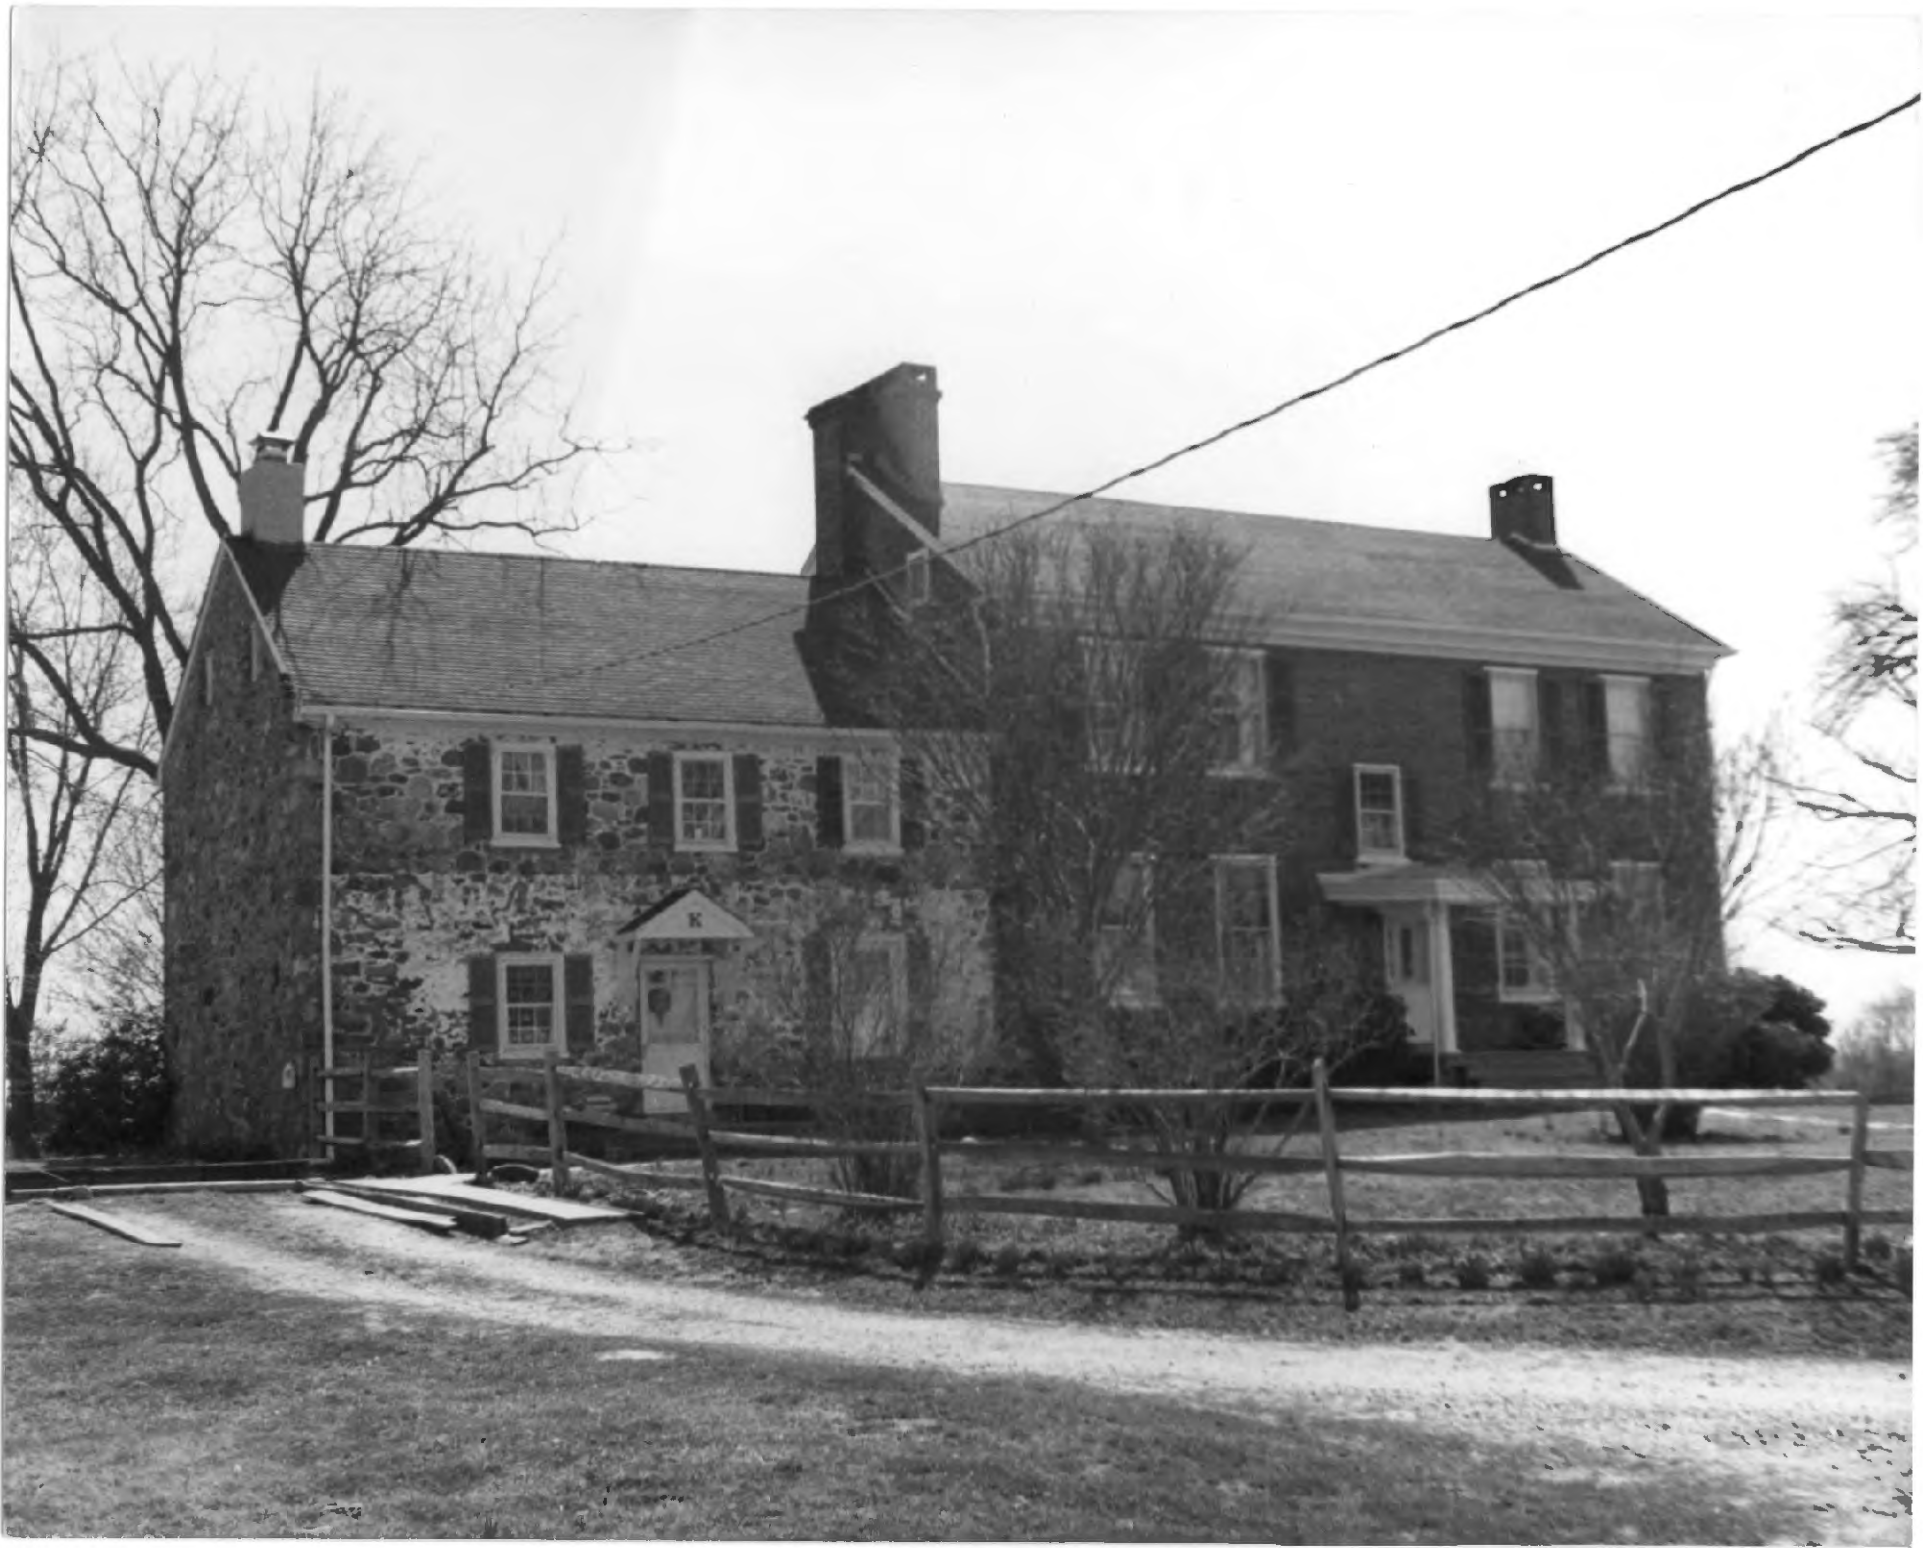
3711

Description: Dwelling, view from North

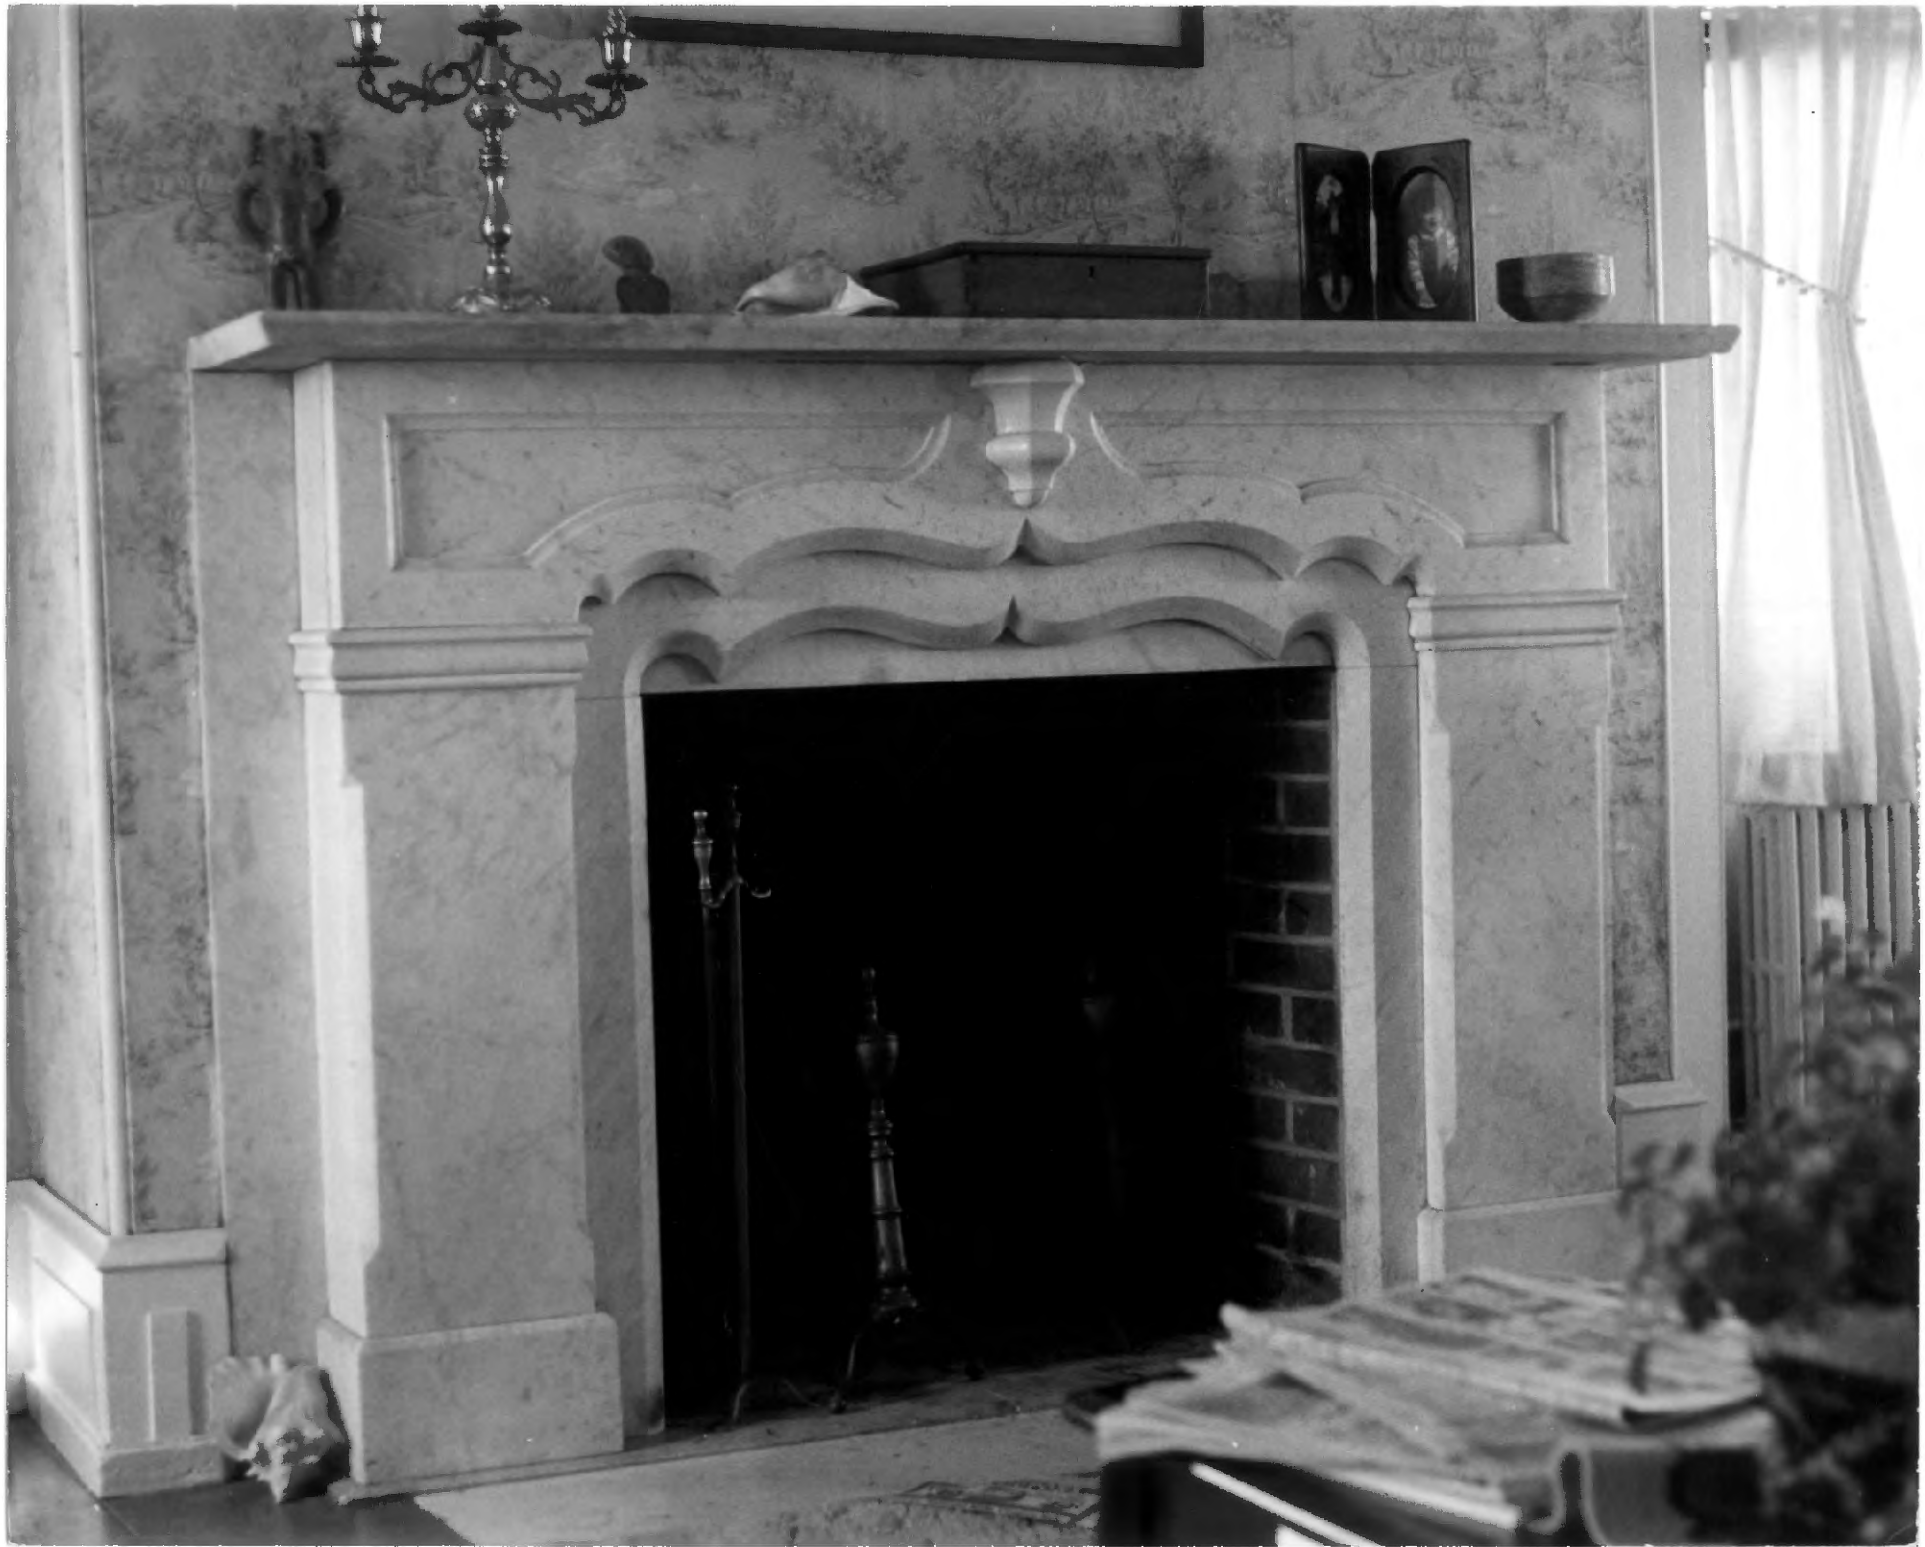
5 of 11

DESCRIPTION: Southwest Chamber (Parlor) marble mantel

The most ostentatious room in the house is the southwest chamber, the formal parlor. The baseboard has a raised panel, and the windows are trimmed with a beaded surround, pilasters, and capped with ogee moulding. The windows sit over moulded recessed panels. The centerpiece of the room is the marble mantel, a strikingly large and ornate mid-nineteenth century work. The mantel consists of two large, squat, chamfered pilasters supporting an entablature with paneled spandrels and a bevel-edged shelf. The hearth opening features two double ogees on the top edge. Just beneath the shelf, between the spandrels, is a projecting, polygonal ornament. The room is lit by two opposing windows on the long elevations as well as two equally large windows flanking the hearth on the gable end.

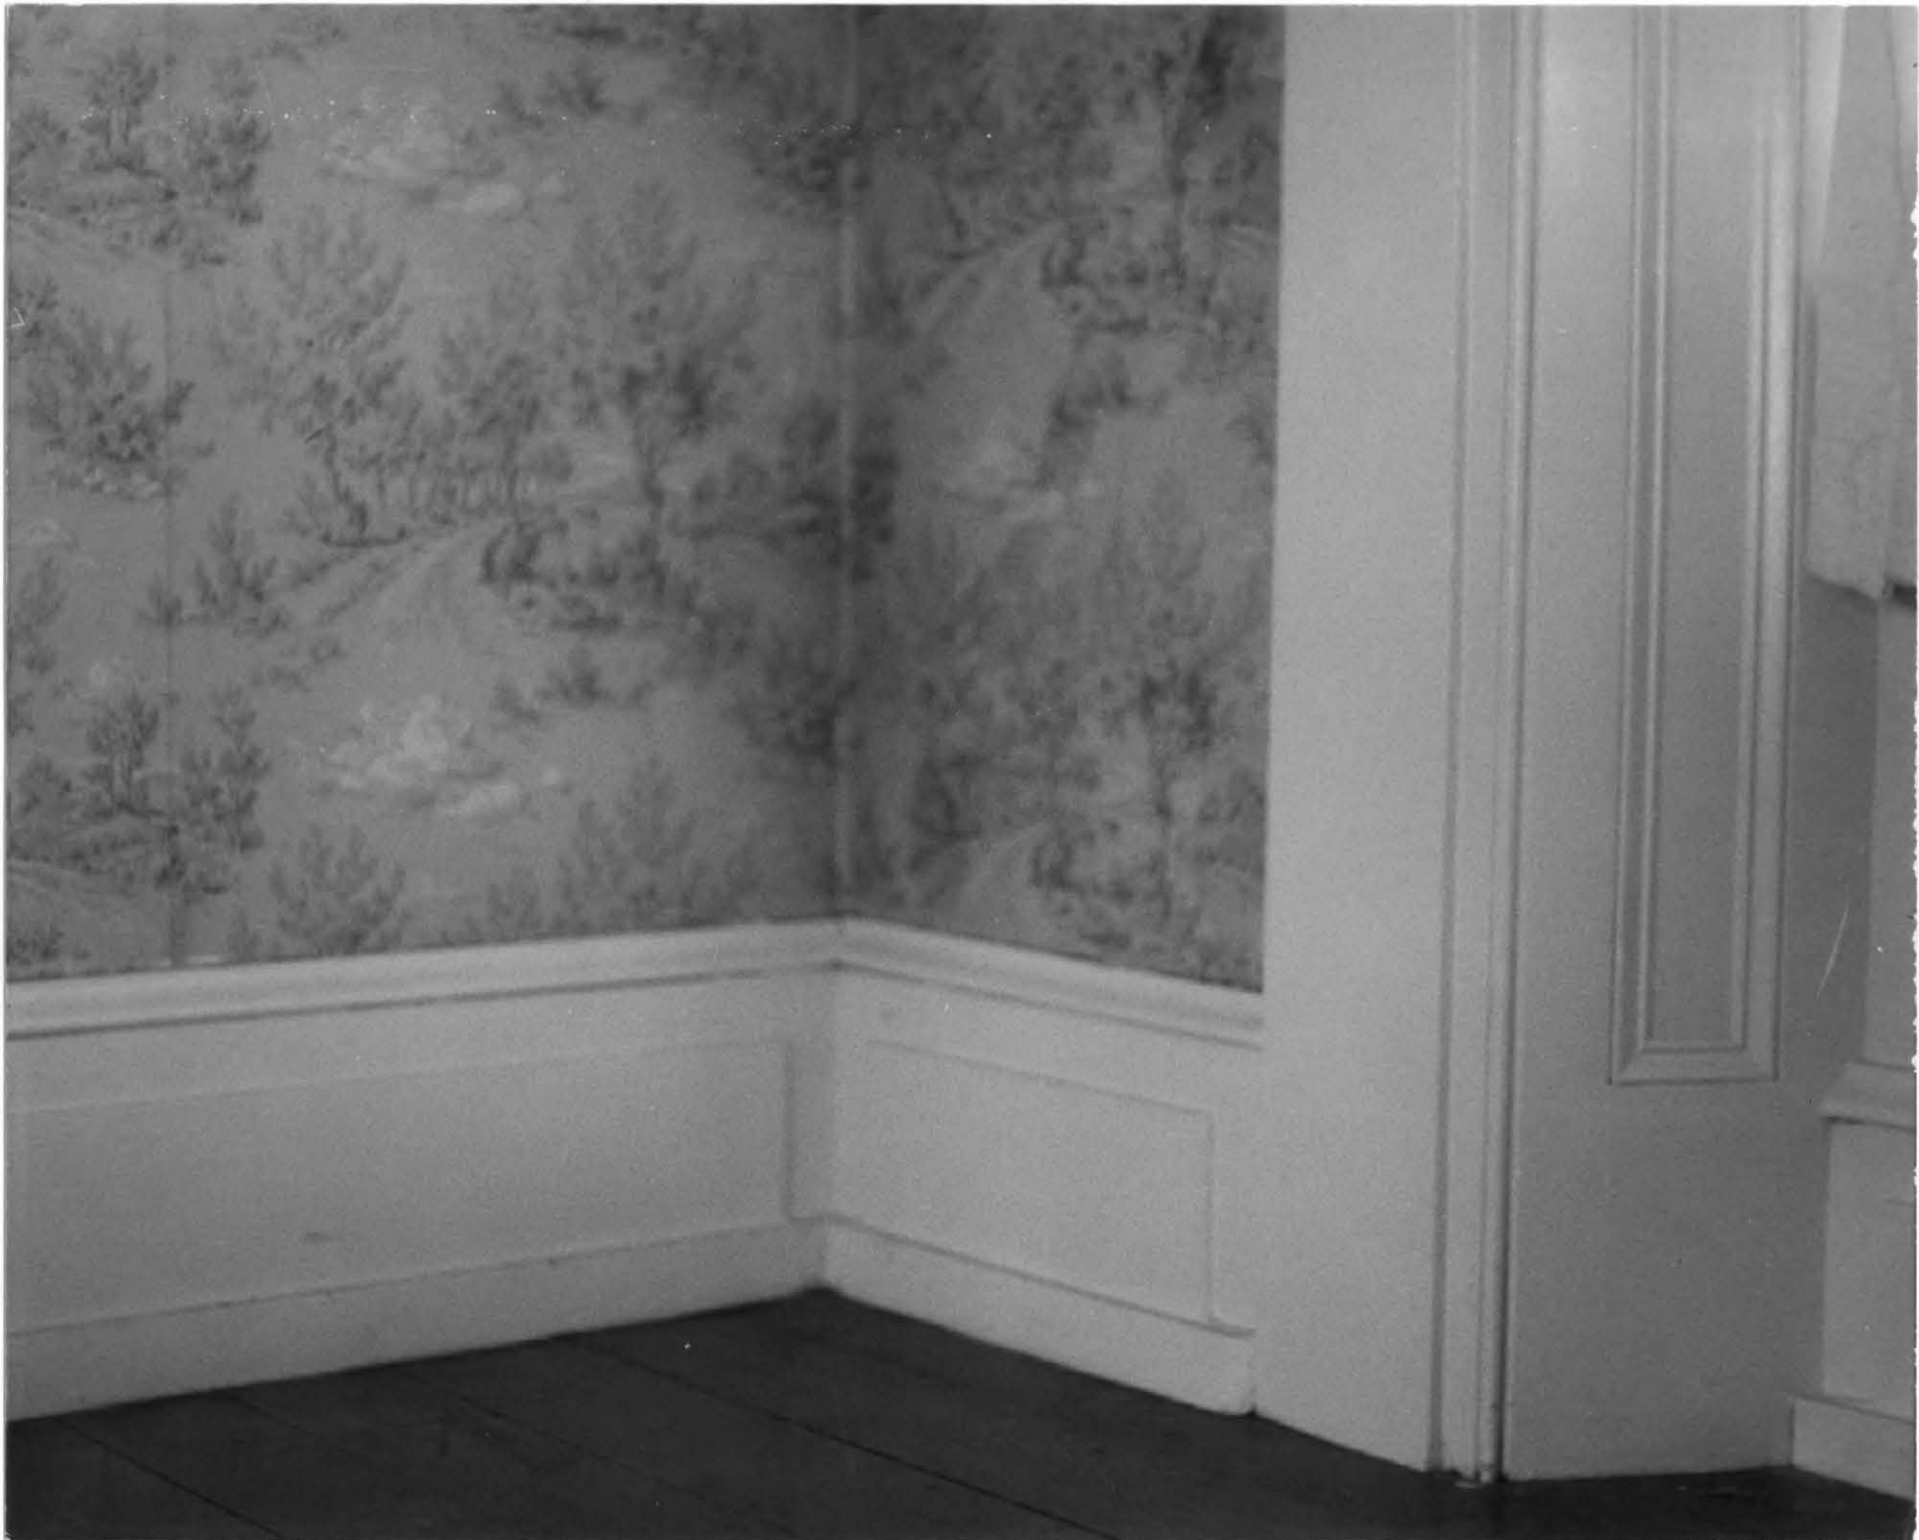
DESCRIPTION: BASE BOARD AND WINDOW REVEAL
Southwest Chamber, EAST Corner

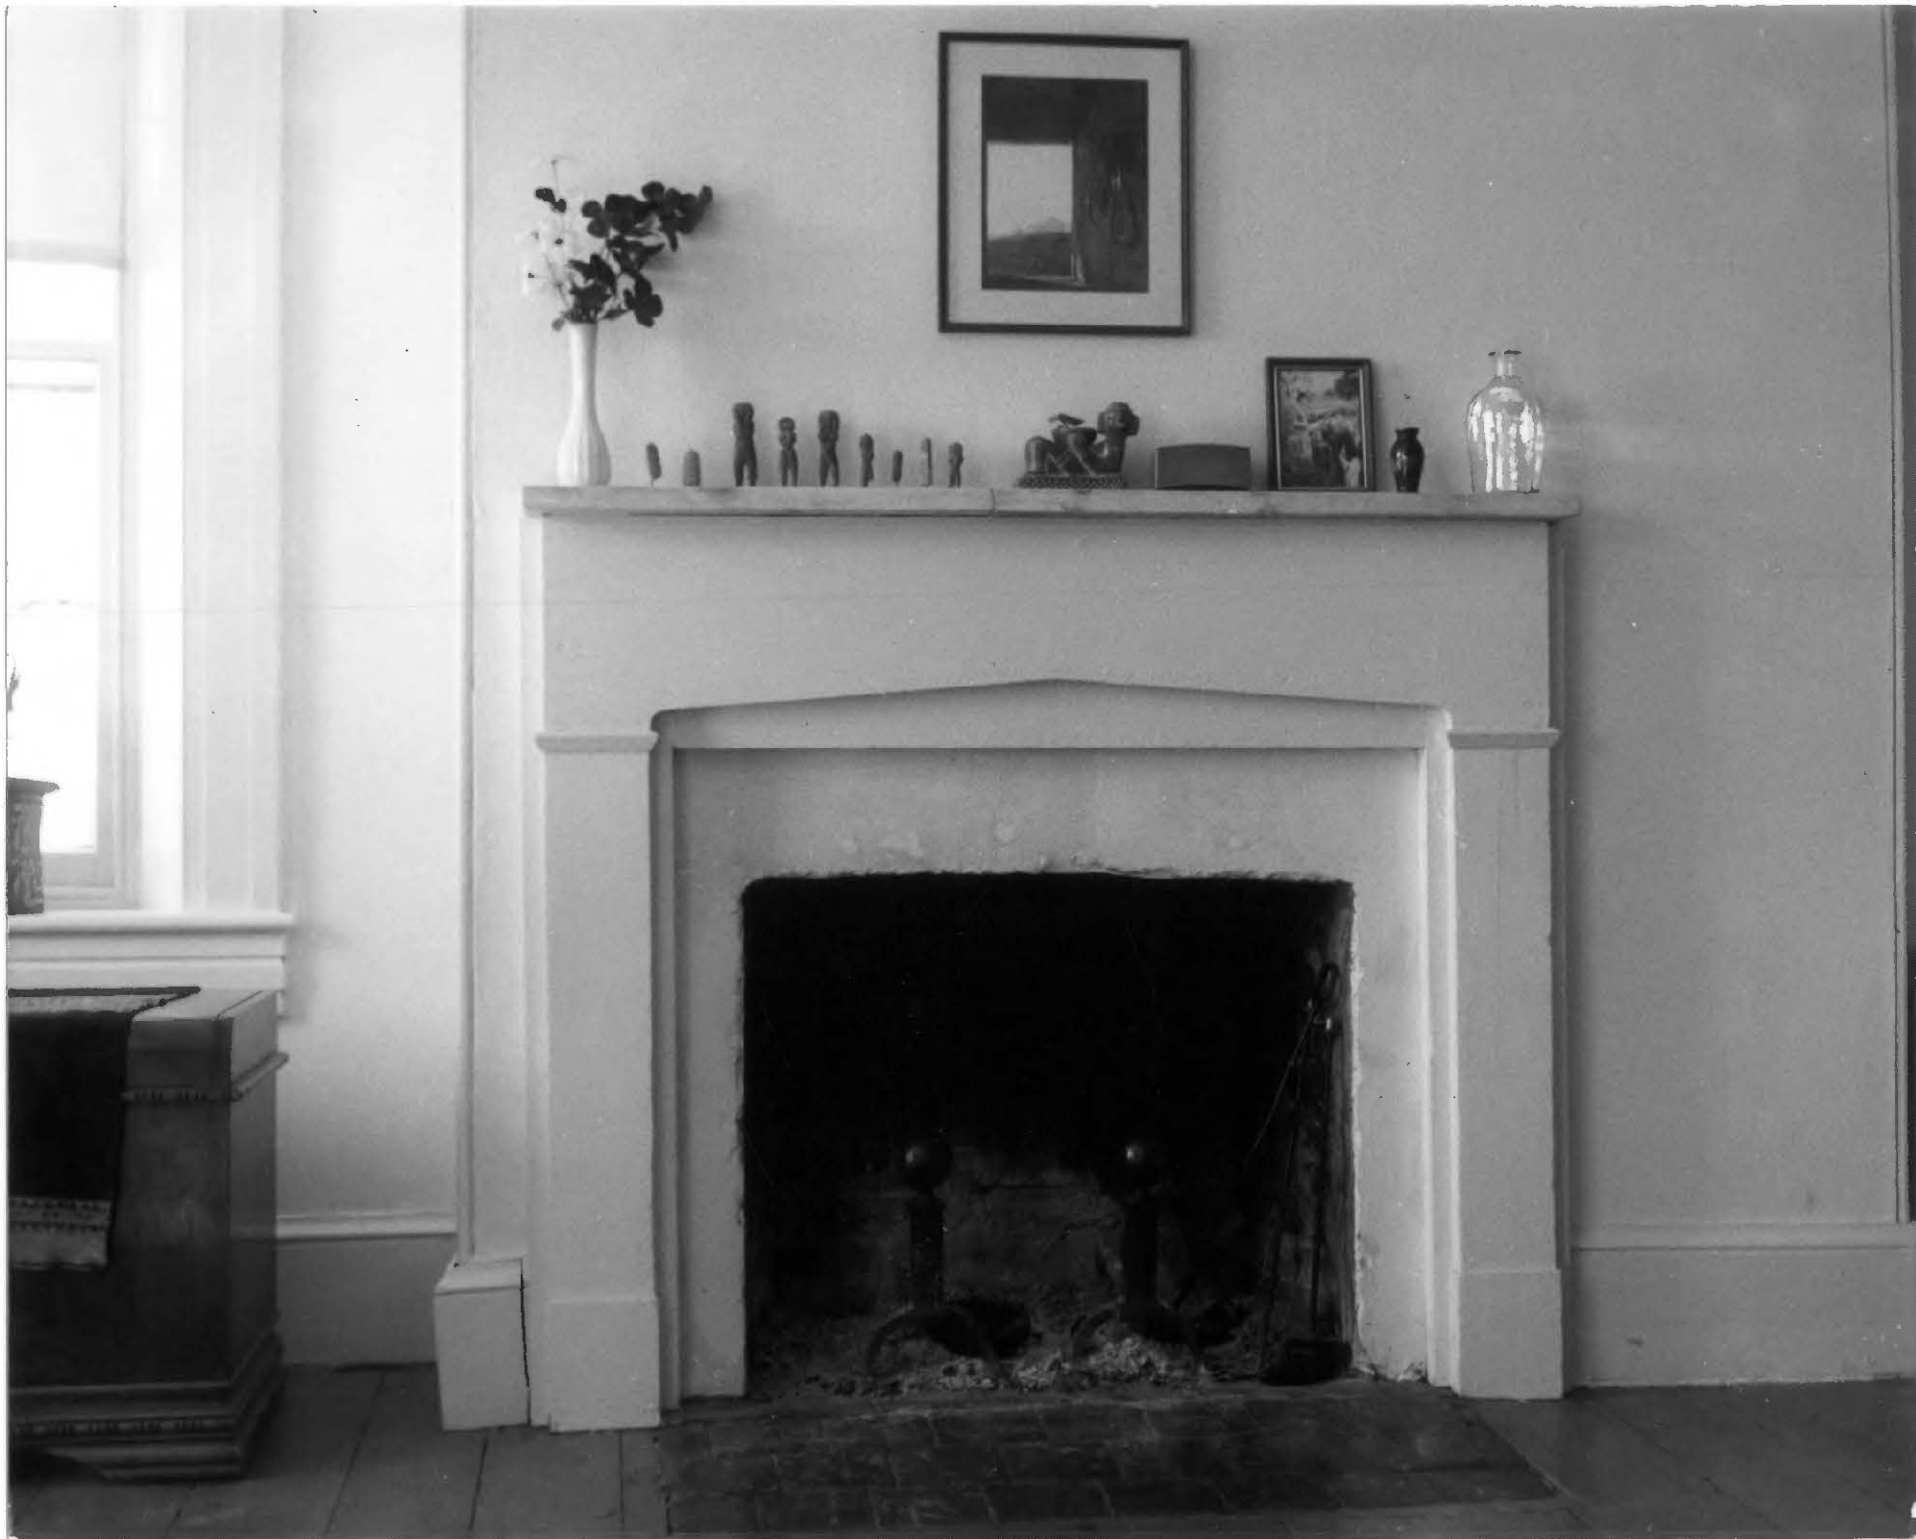
7-11
0

DESCRIPTION: Southwest Bed Chamber, SECOND STORY
FRAME MANTEL

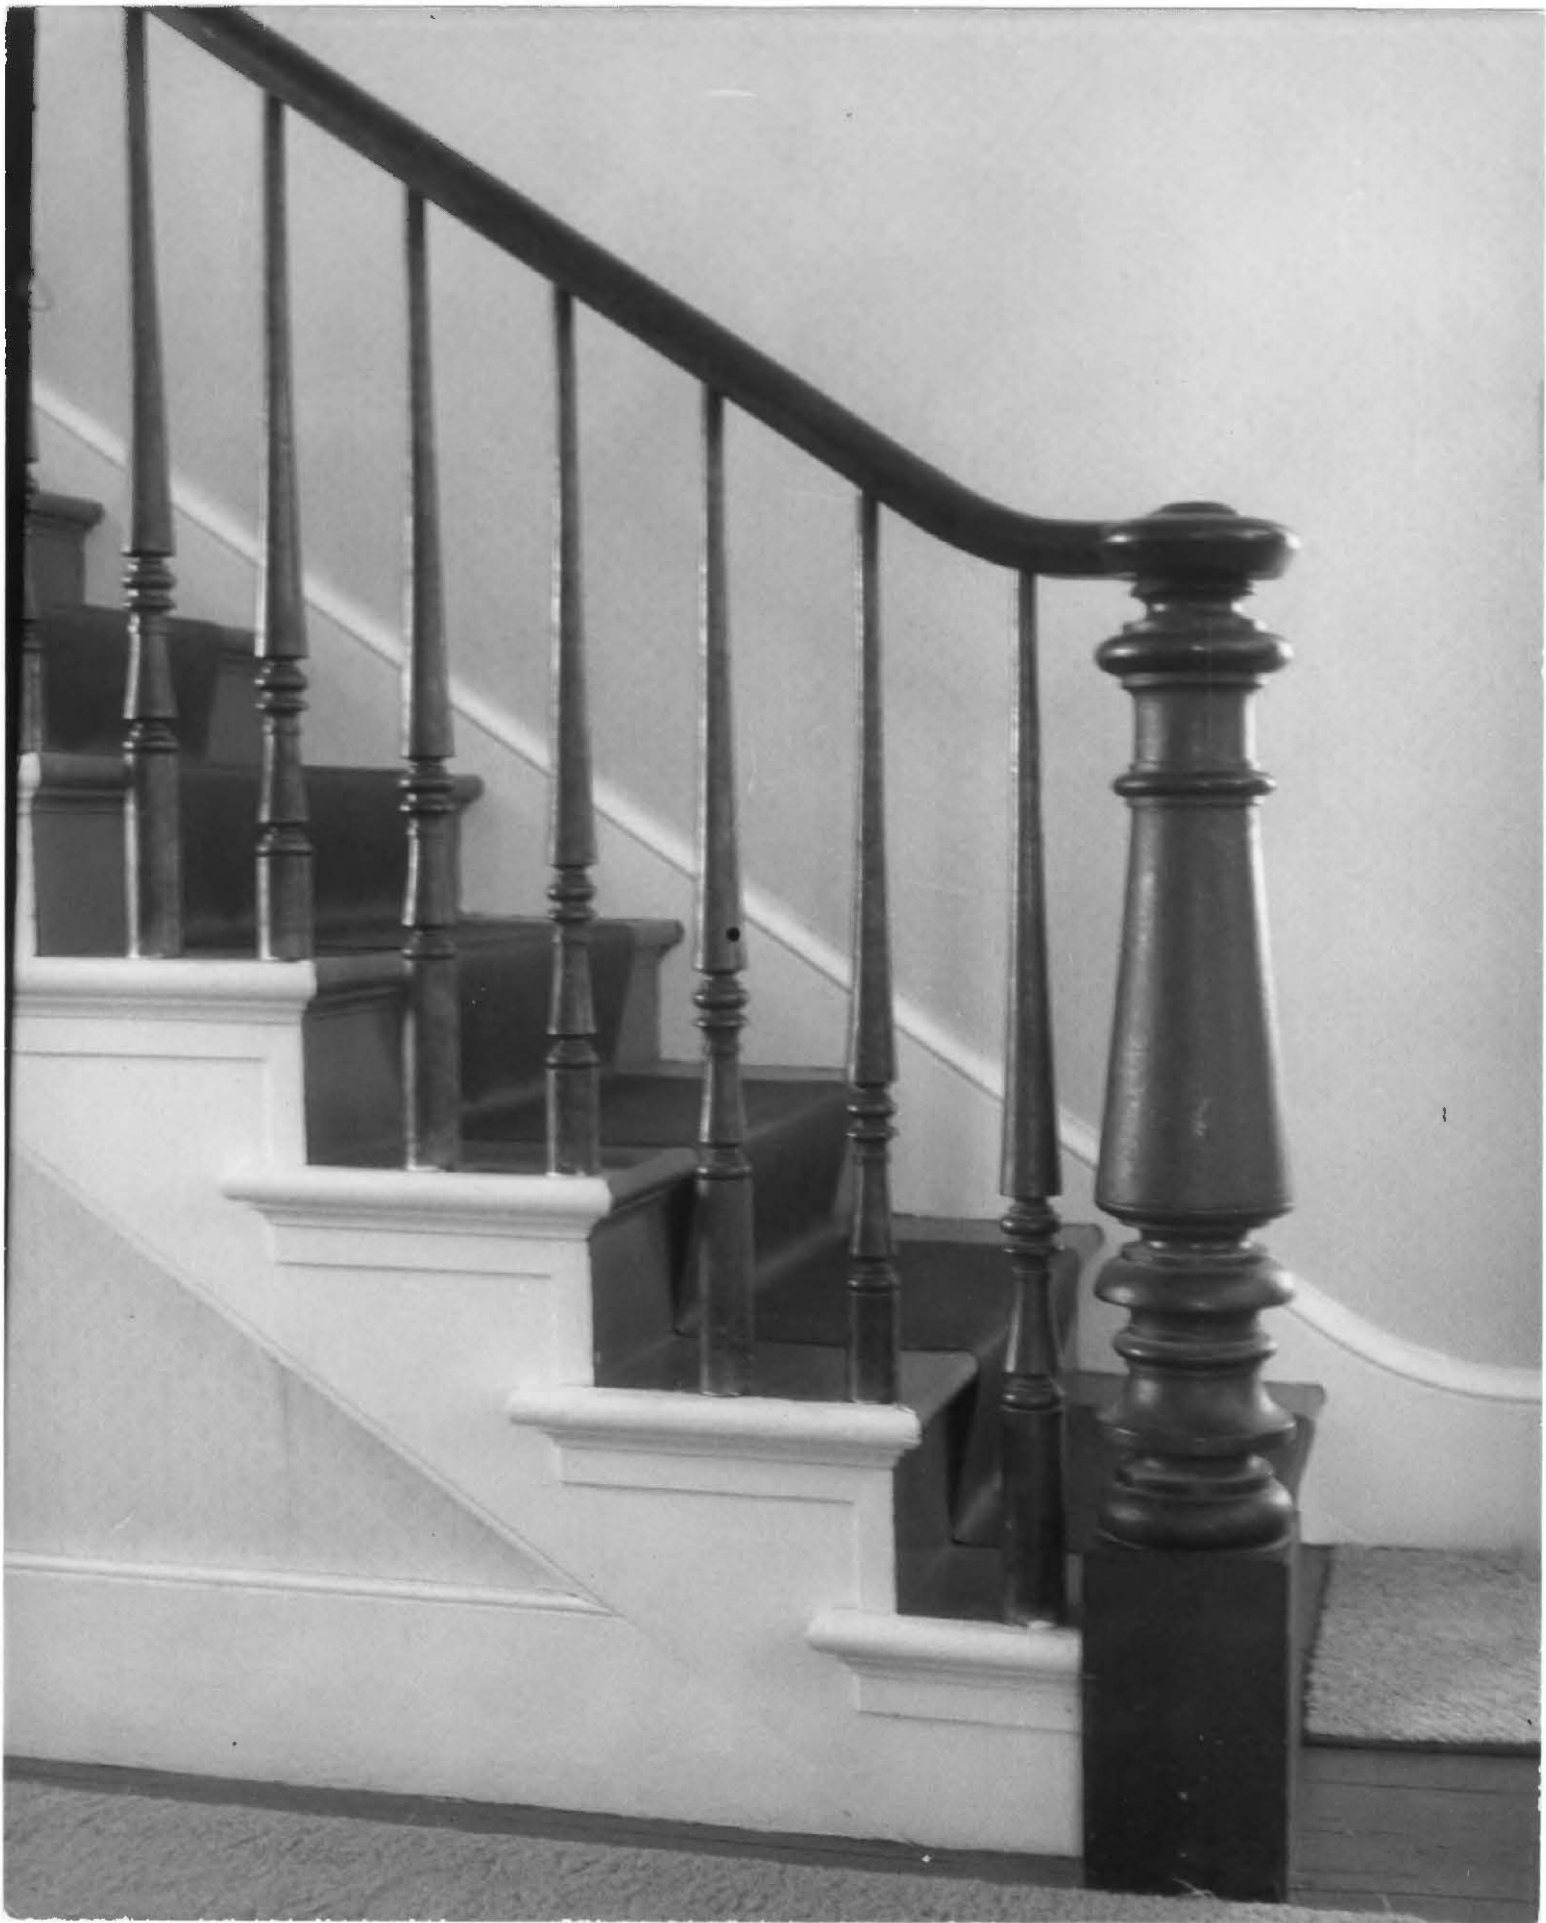
9 of 11

DESCRIPTION: BALUSTRADE ; CENTER HALL STAIR

flight, open well stair that has a turned newel post and grained and turned balusters. Other trim is more elaborate.

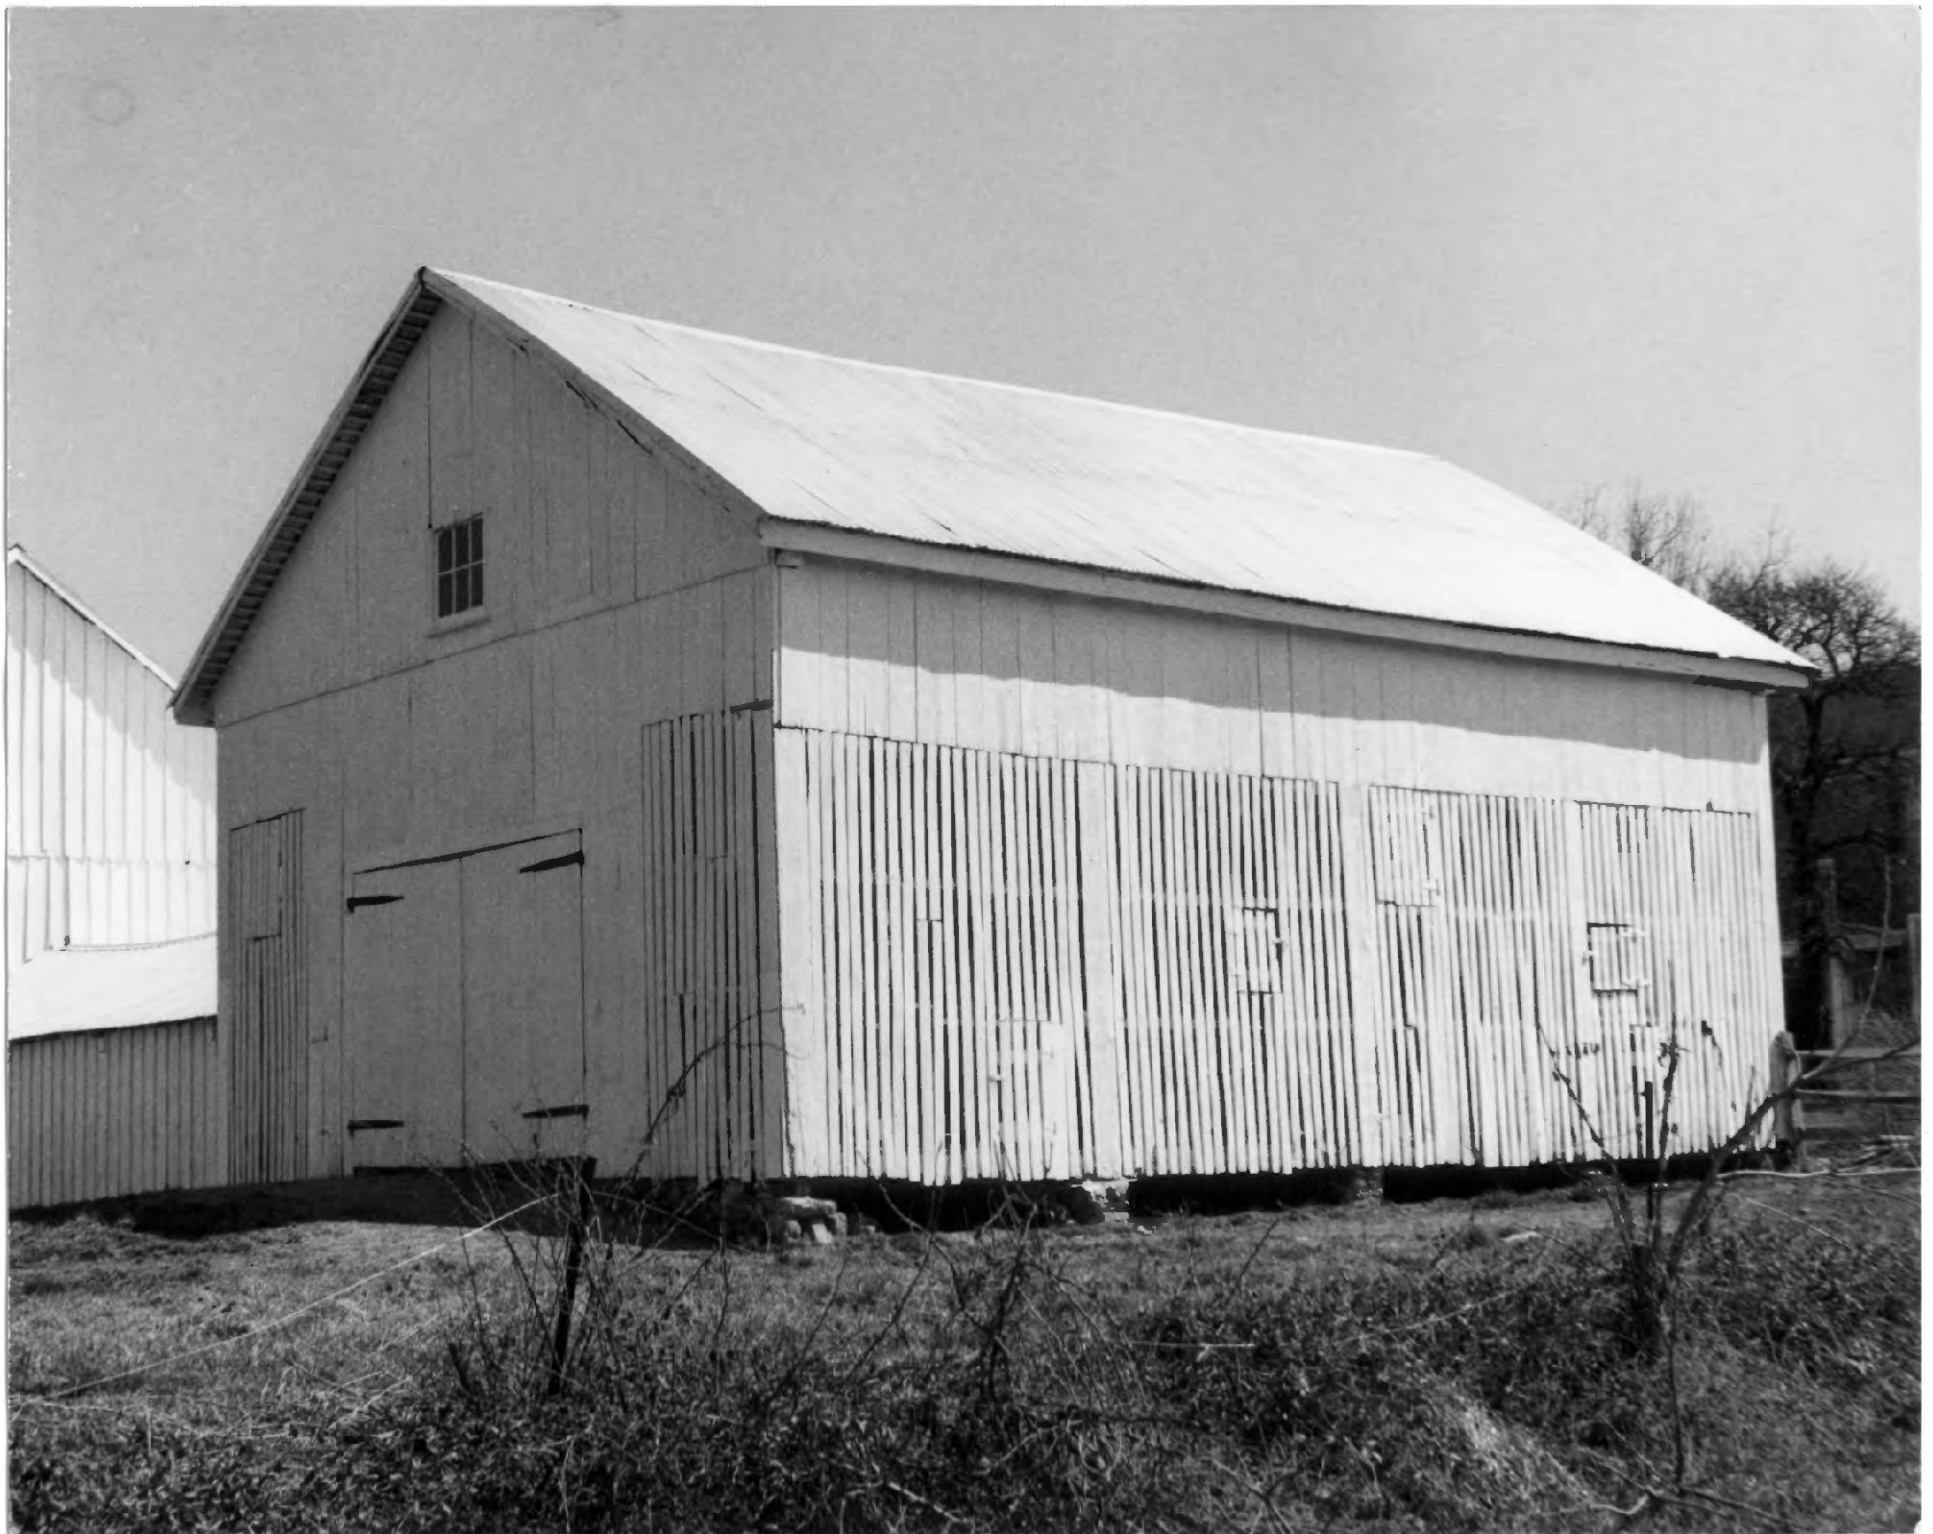
10/11

Description: Crib barn - View from West.

The oldest building, located adjacent and parallel to the road, is a two and one-half story crib barn built c. 1850. The rectangular building has large double doors on each gable end which are hung on long strap hinges. Siding consists mainly of vertical slats on the side elevations for the corn cribs, and vertical board elsewhere. The interior on the side elevations for the corn cribs, and vertical board elsewhere. The interior is divided into three longitudinal bays consisting of a center bay driveway flanked by corn cribs. A stairway in the east corner leads to the upper story which formerly contained grain bins. One bin is extant and is located in the south corner. The crib barn is of brace-framed construction with hewn principal and vertical sawn secondary timbers. The large joists of the granary are face-hewn log. Some of the joists also serve as girts and are square hewn on a four foot section on each end which corresponds to the width of the corn crib. Girts are additionally secured with U-shaped straps. Girts and rails are tenoned into seated mortises. The roofing system consists of common rafter with their apexes butted and nailed. Sometime in the twentieth century variably placed board collars were spiked on. Attached to the northeast elevation of the crib barn is an implement shed which is also attached to the cow barn. This building is being considered as an addition to the crib barn. It has a shed gable roof and is constructed with earthfast poles. Although nineteenth century in form and origin, this building was largely rebuilt in the mid-twentieth century and so cannot be considered as an independent contributing building.
