ARCHAEOLOGICAL AND HISTORICAL
PHASE I AND PHASE II SURVEYS IN CONNECTION WITH

MOUNT LEBANON ROAD AND ROCKLAND ROAD INTERSECTION IMPROVEMENTS
BRANDYWINE HUNDRED, NEW CASTLE COUNTY, DELAWARE
DELAWARE DEPARTMENT OF TRANSPORTATION PROJECT 84-041-03

DELAWARE DEPARTMENT OF TRANSPORTATION ARCHÆOLOGY SERIES NUMBER 96

HEITE CONSULTING CAMDEN, DELAWARE

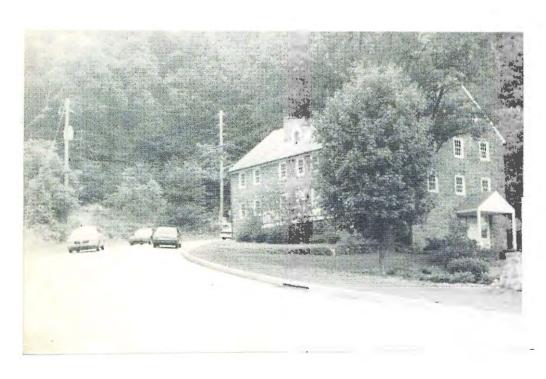
Plate 2 Rockland project area

At right is a surviving mill worker house, similar to the one investigated, looking eastward from a point opposite the entrance to the former mill building. The road in foreground is the road over Rockland bridge, the extension of which would have passed in front of the houses.

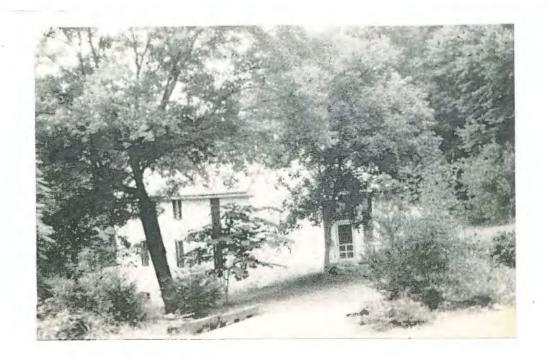
Plate 4

Stone
house
located
just above
the
project
right-of-way,
formerly
associated
with the mill

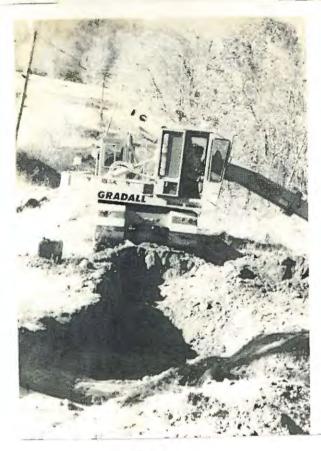
Plate 5
Excavating Test 2 with a Gradall

Test 2 was a machine-cut trench into the store site (PLATE 5). At a depth of five feet eight inches, an apparent natural clay layer was reached, which was tested another foot and a half, in order to confirm that it was natural. The bottom layer, resting on this clay, consisted of blacktop pavement and other very recent building debris. Between this test trench and the roads the ground has been further disturbed by extensive utility improvements, probably obliterating all meaningful traces of the store building.

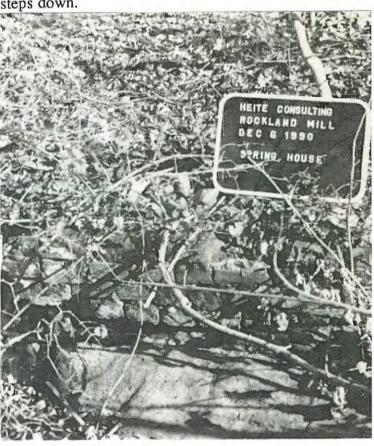
Plate 6
Remains of the spring house

At the opposite end of this plateau, alongside the channel, a small fragment or mortared stone wall was visible. When the debris in front of this wall was removed, it proved to be standing forty inches above the muck of the channel leading from the spring.

A dry-laid cross wall, eight feet long, stands athwart the channel, creating a waterfall about three feet high. as the stream steps down.

In the muck of the streambed were several identifiable ceramic artifacts, including slip-decorated red earthenware, printed and painted white earthenwares, and black-glazed red earthenwares. These are consistent with nineteenth-century workers' houseware.

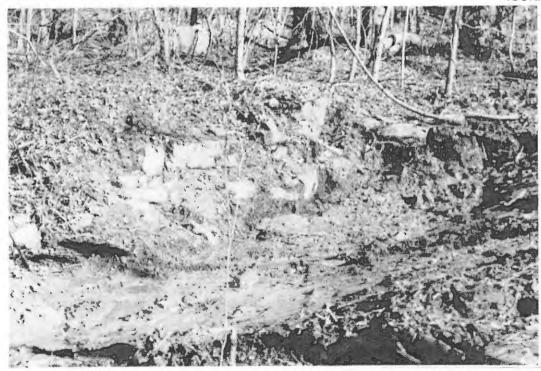
Excavated wall segment, looking northeast

The upper row of worker houses retains its archæological integrity, but the lower row has been severely damaged. The wall shown on Plate 8 is part of a stone platform on which stood the upper block of row. It also retained the spring branch.

No further archæological work is recommended for the area marked "heavily filled and disturbed" on figure 8. The house site, however, definitely warrants appropriate data-recovery treatment. The store site is apparently completely obliterated, and requires no further attention.

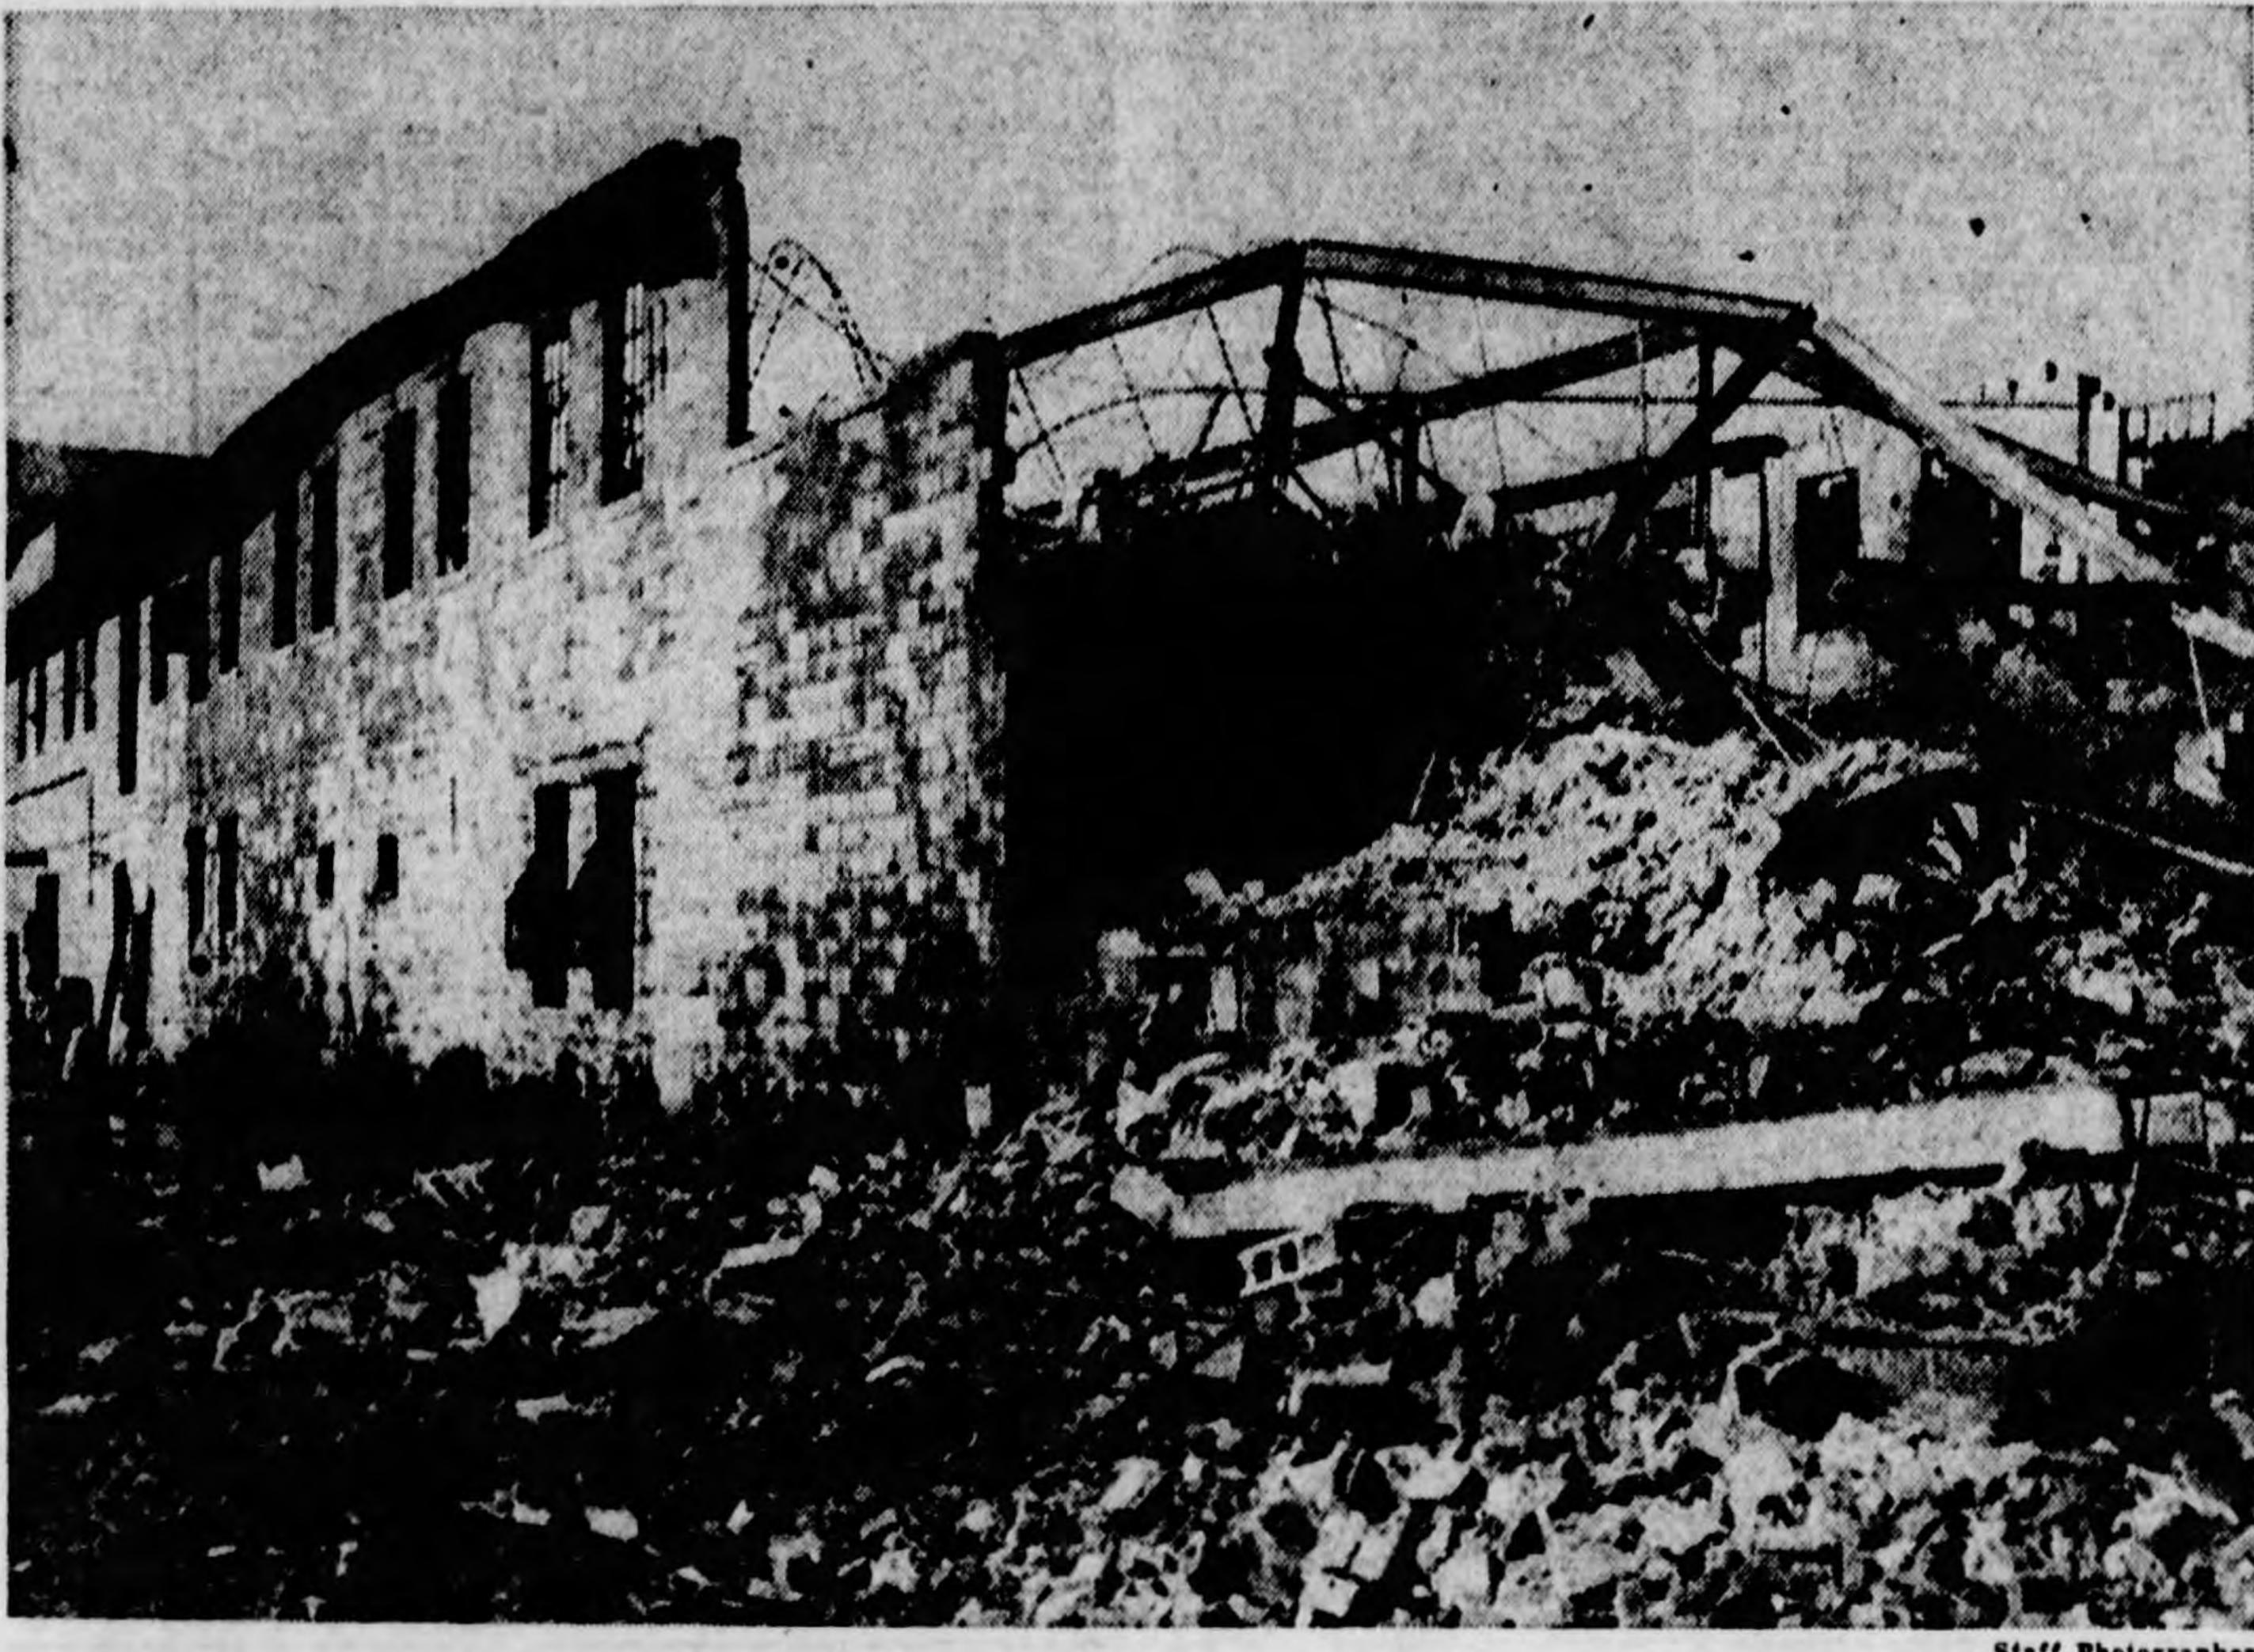
ROCKLAND FIRE RUBBLE—Here's what was left of the Doeskin Products, Inc., converting plant at Rockland this morning after a pre-dawn blaze that caused damage estimated at \$500,000. Building housed valuable machinery used to cut and package paper napkins and tissues.

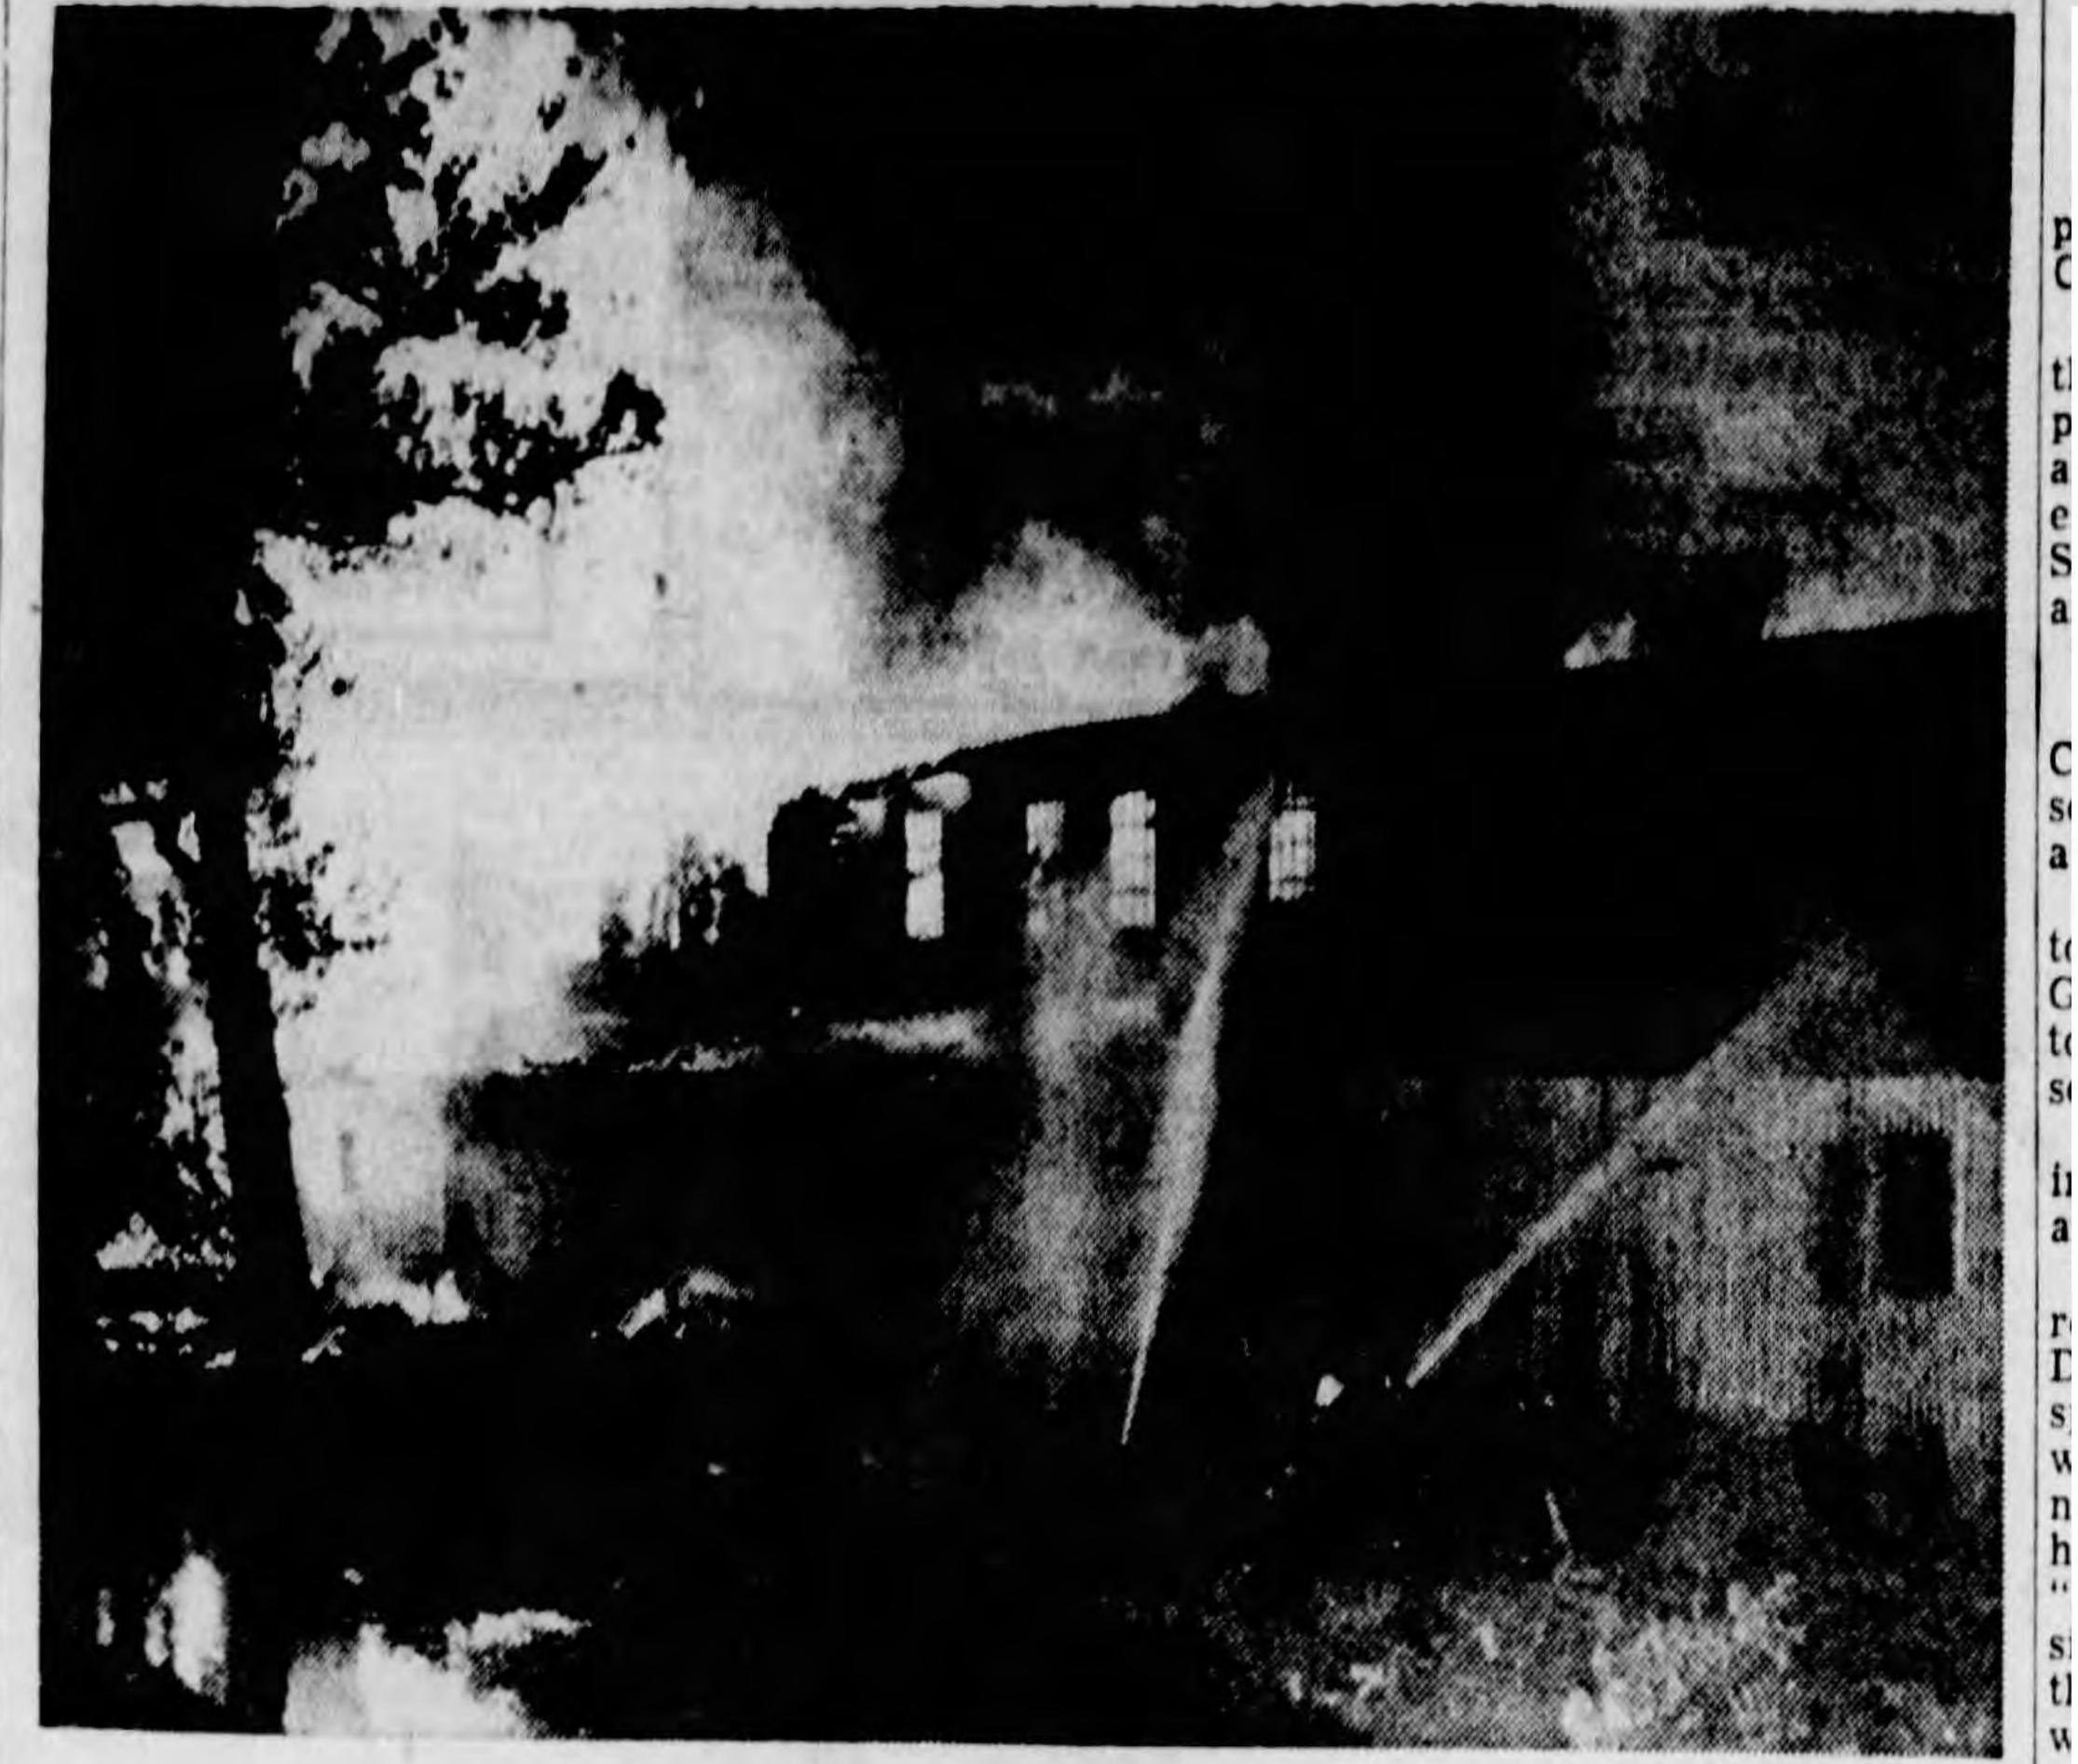
FIGHTING DOESKIN BLAZE-Flames light up the sky and dense smoke billows through collapsed roof as volunteer firemen direct hoses on the burning Doeskin Products converting plant at Rockland early this morning. Pre-dawn blaze could be seen for miles and caused damage estimated at \$500,000.

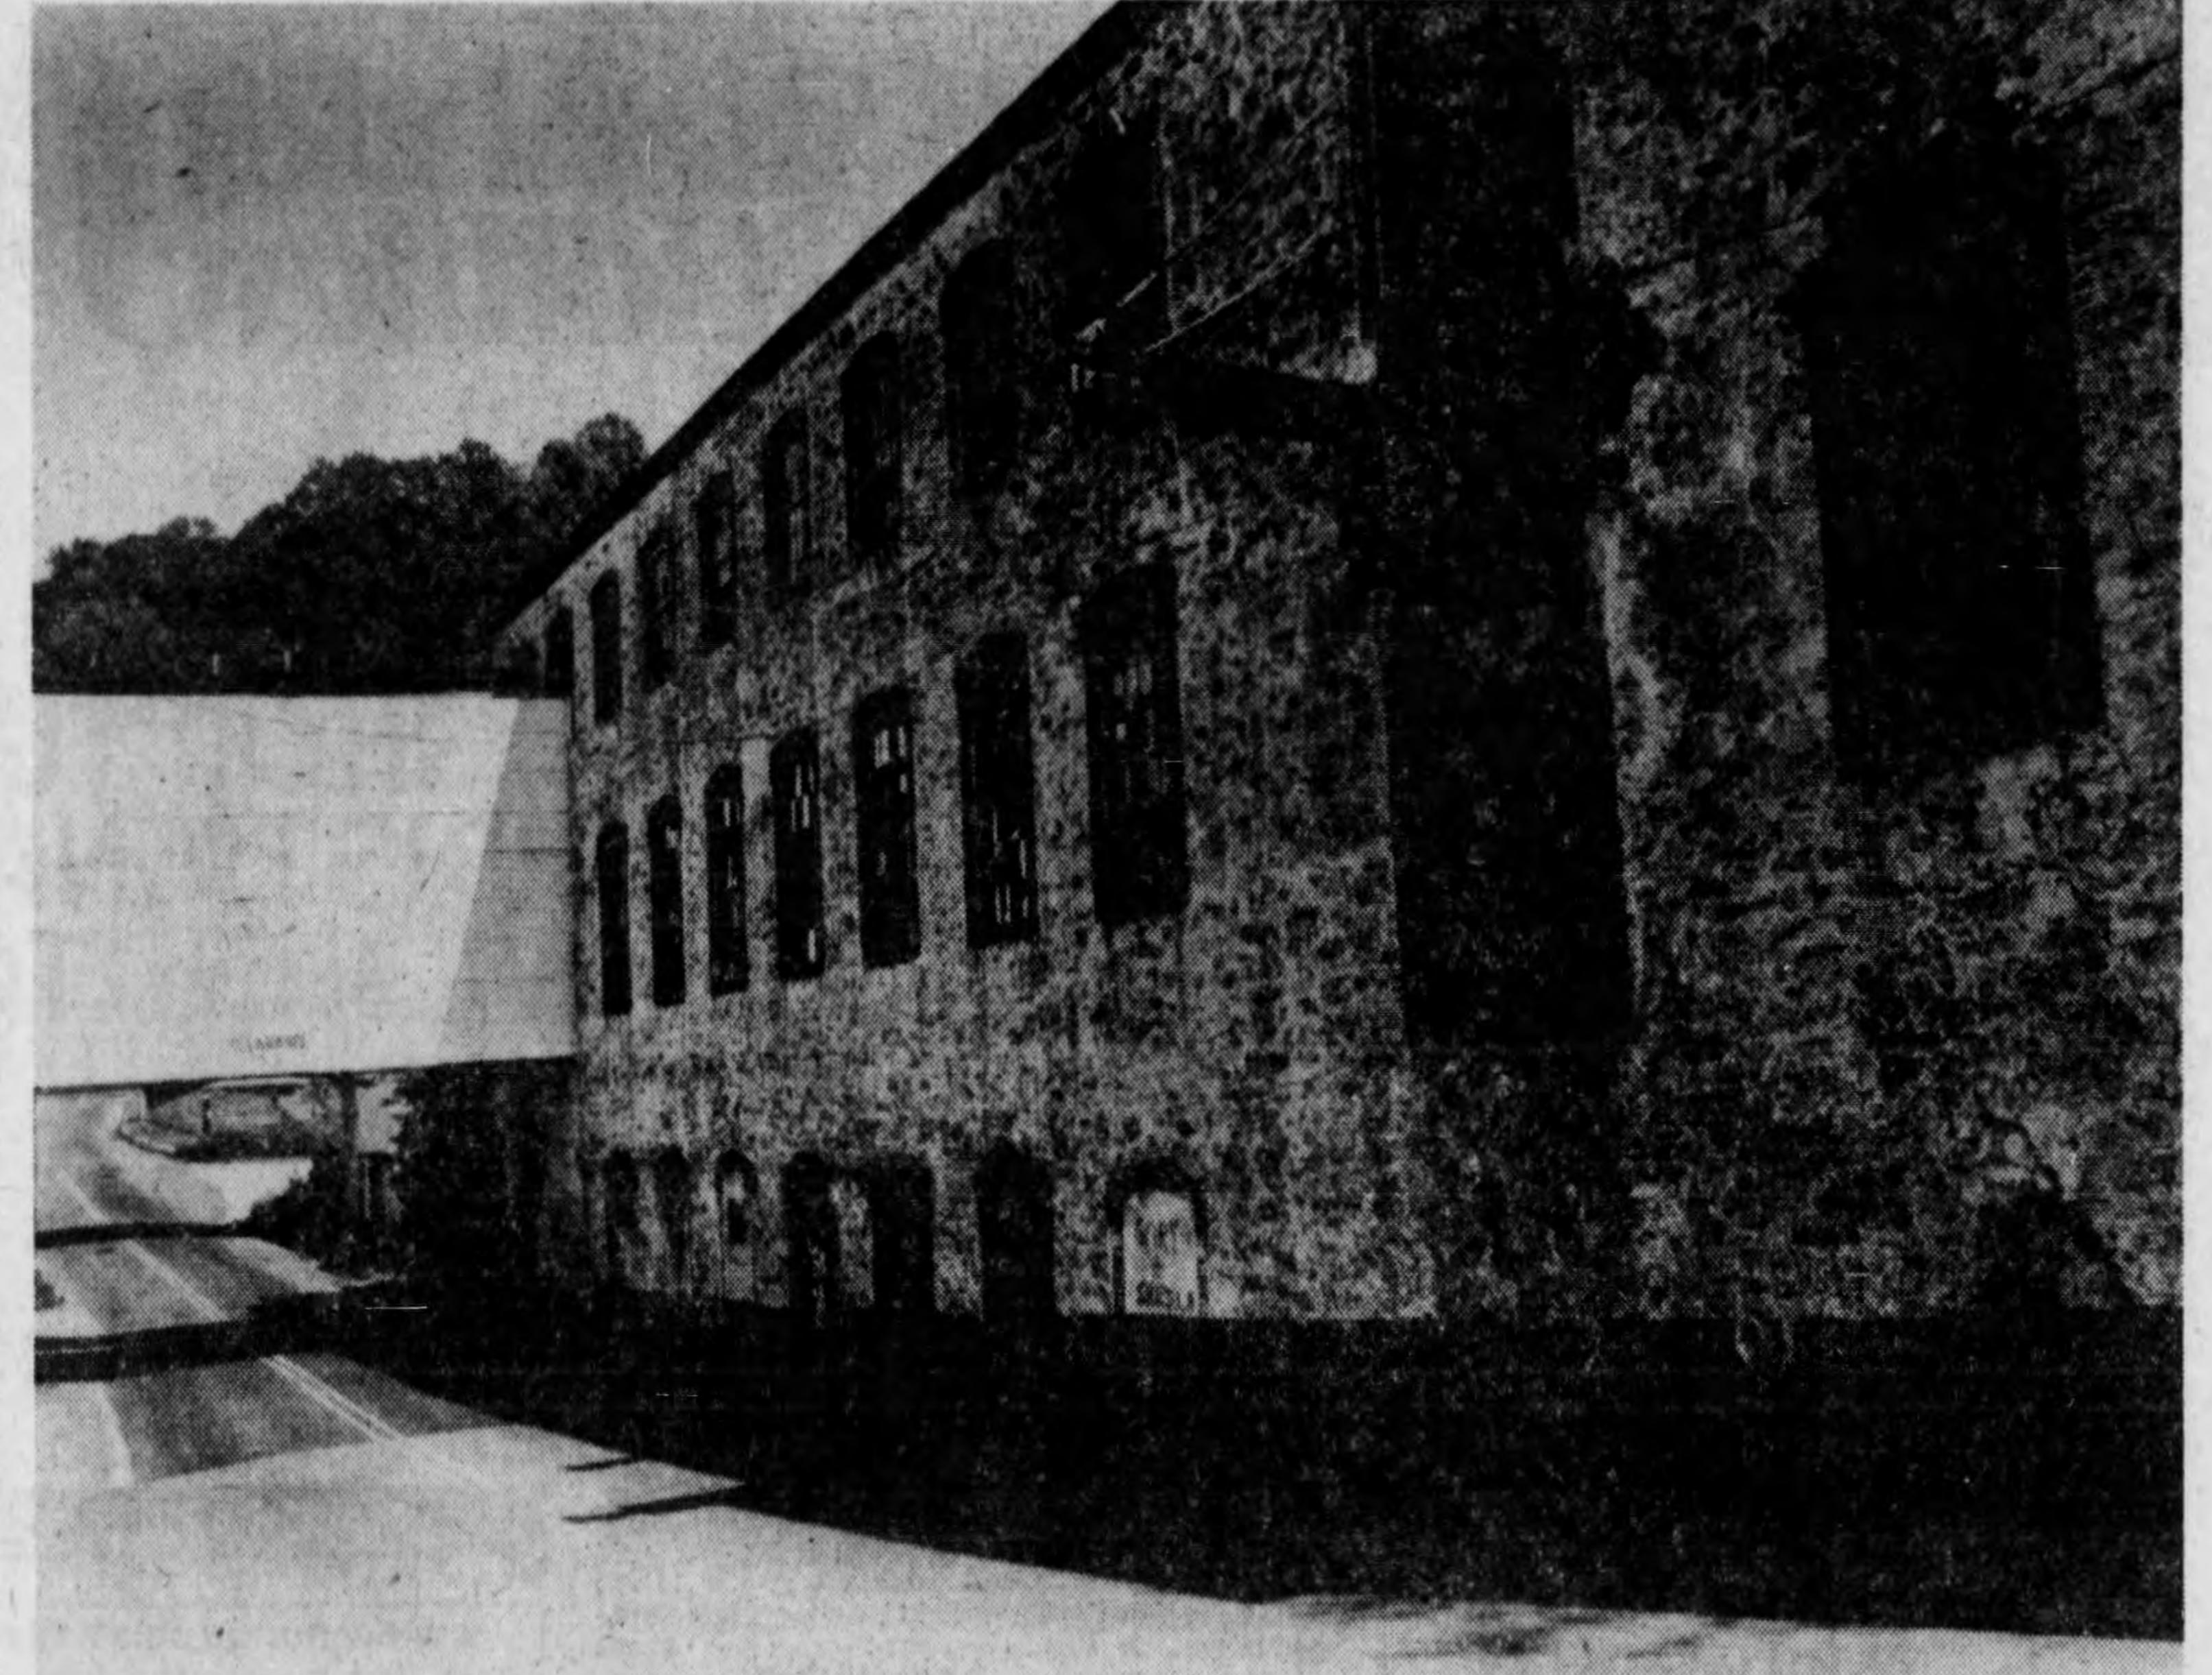
Broken windows and flaking paint emphasize the emptiness at the old Doeskin plant on Rockland Road.
