**National Register of Historic Places  
Inventory—Nomination Form**

historic Milton Historic District

city, town Milton

state Delaware

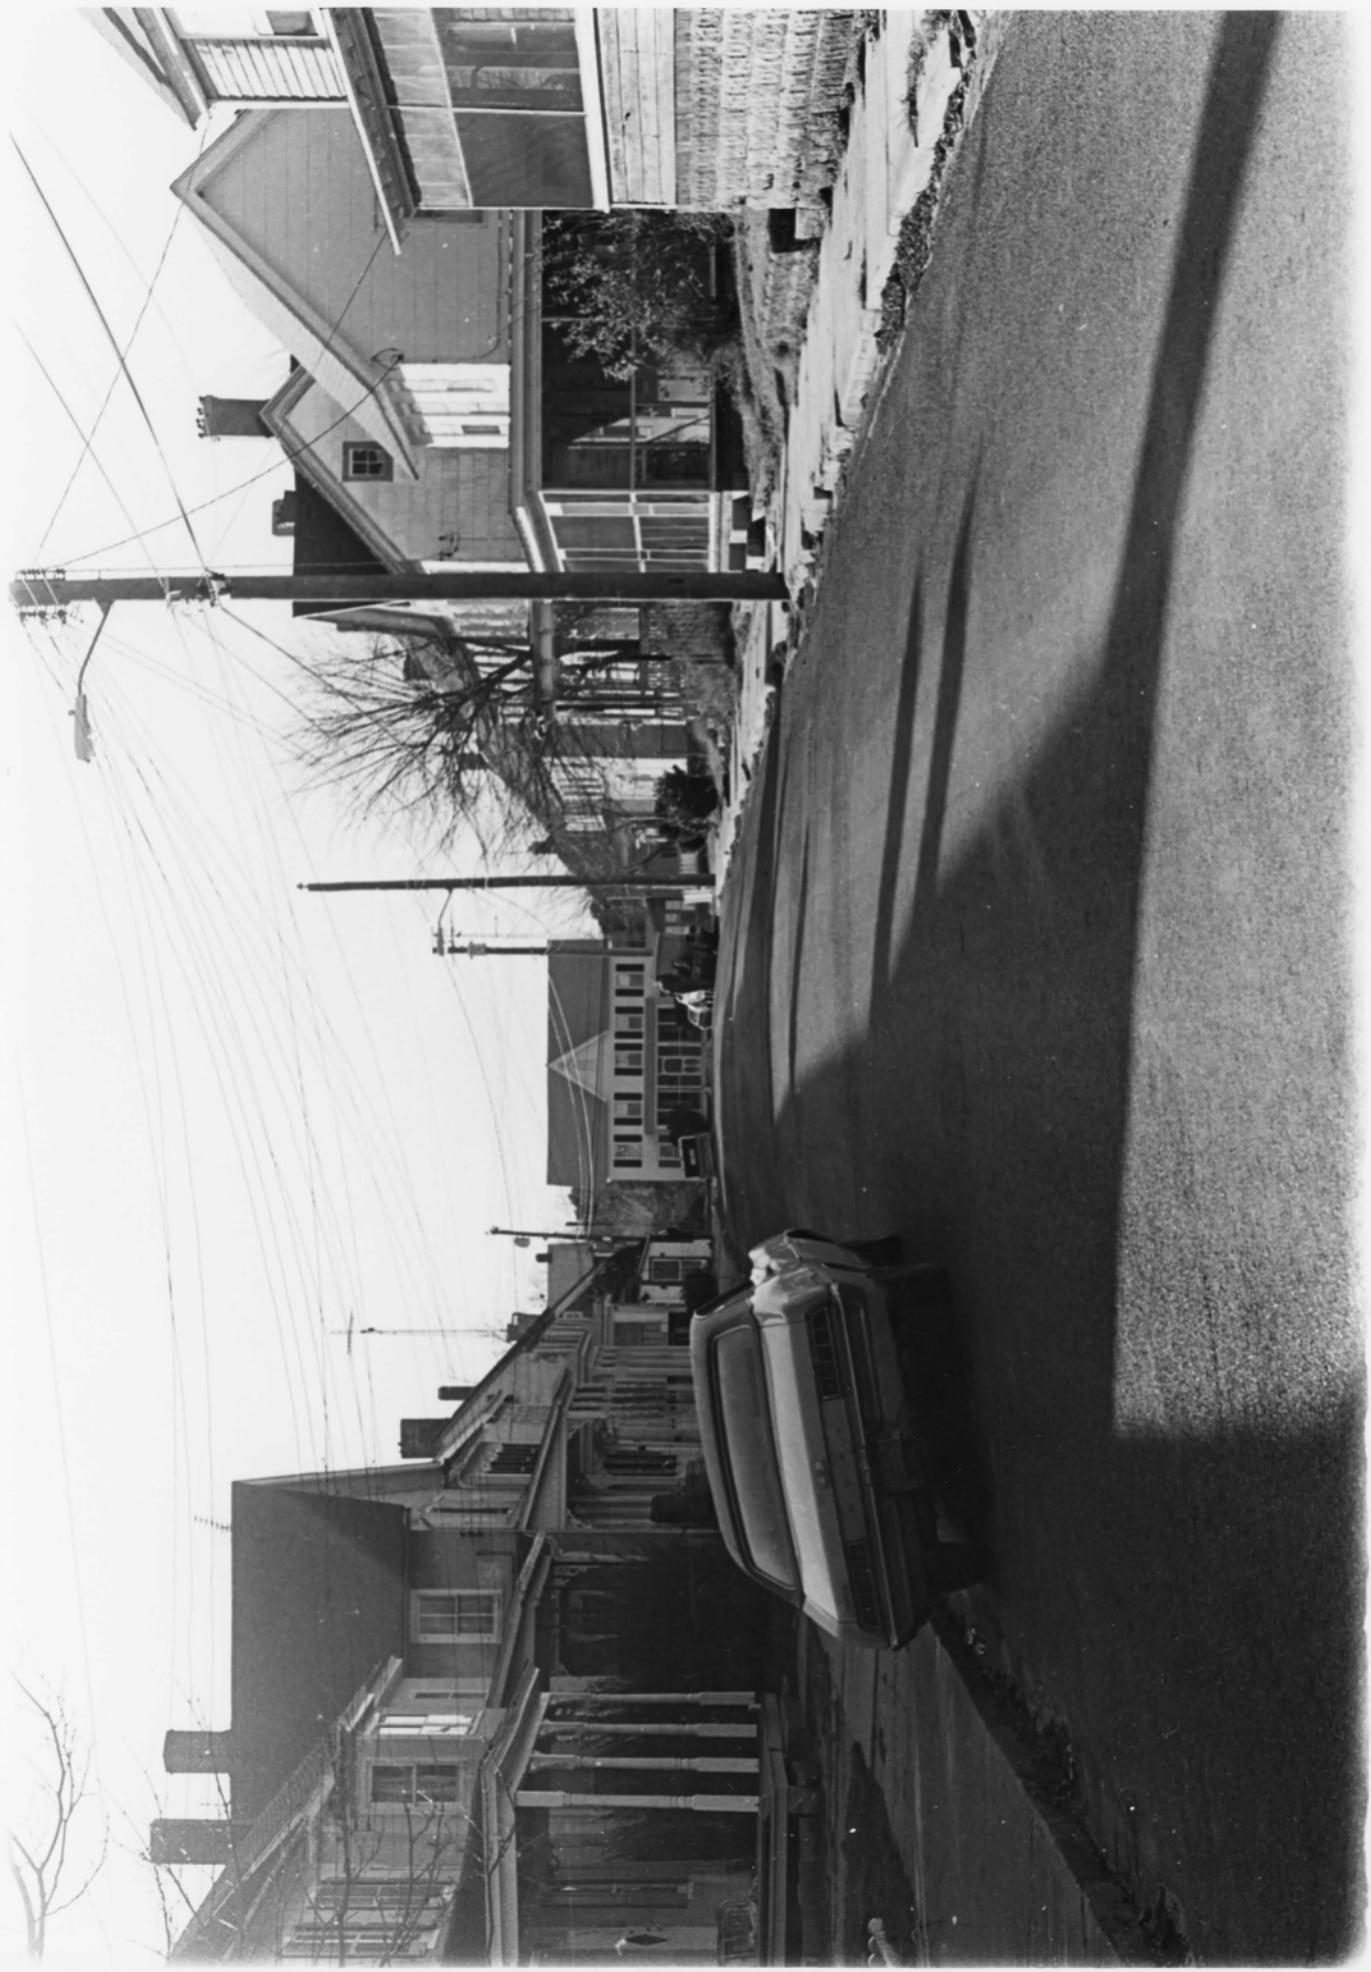
Name: Milton Historic District (streetscape A: west, southwest along Broad Street; site #114 at extreme right)

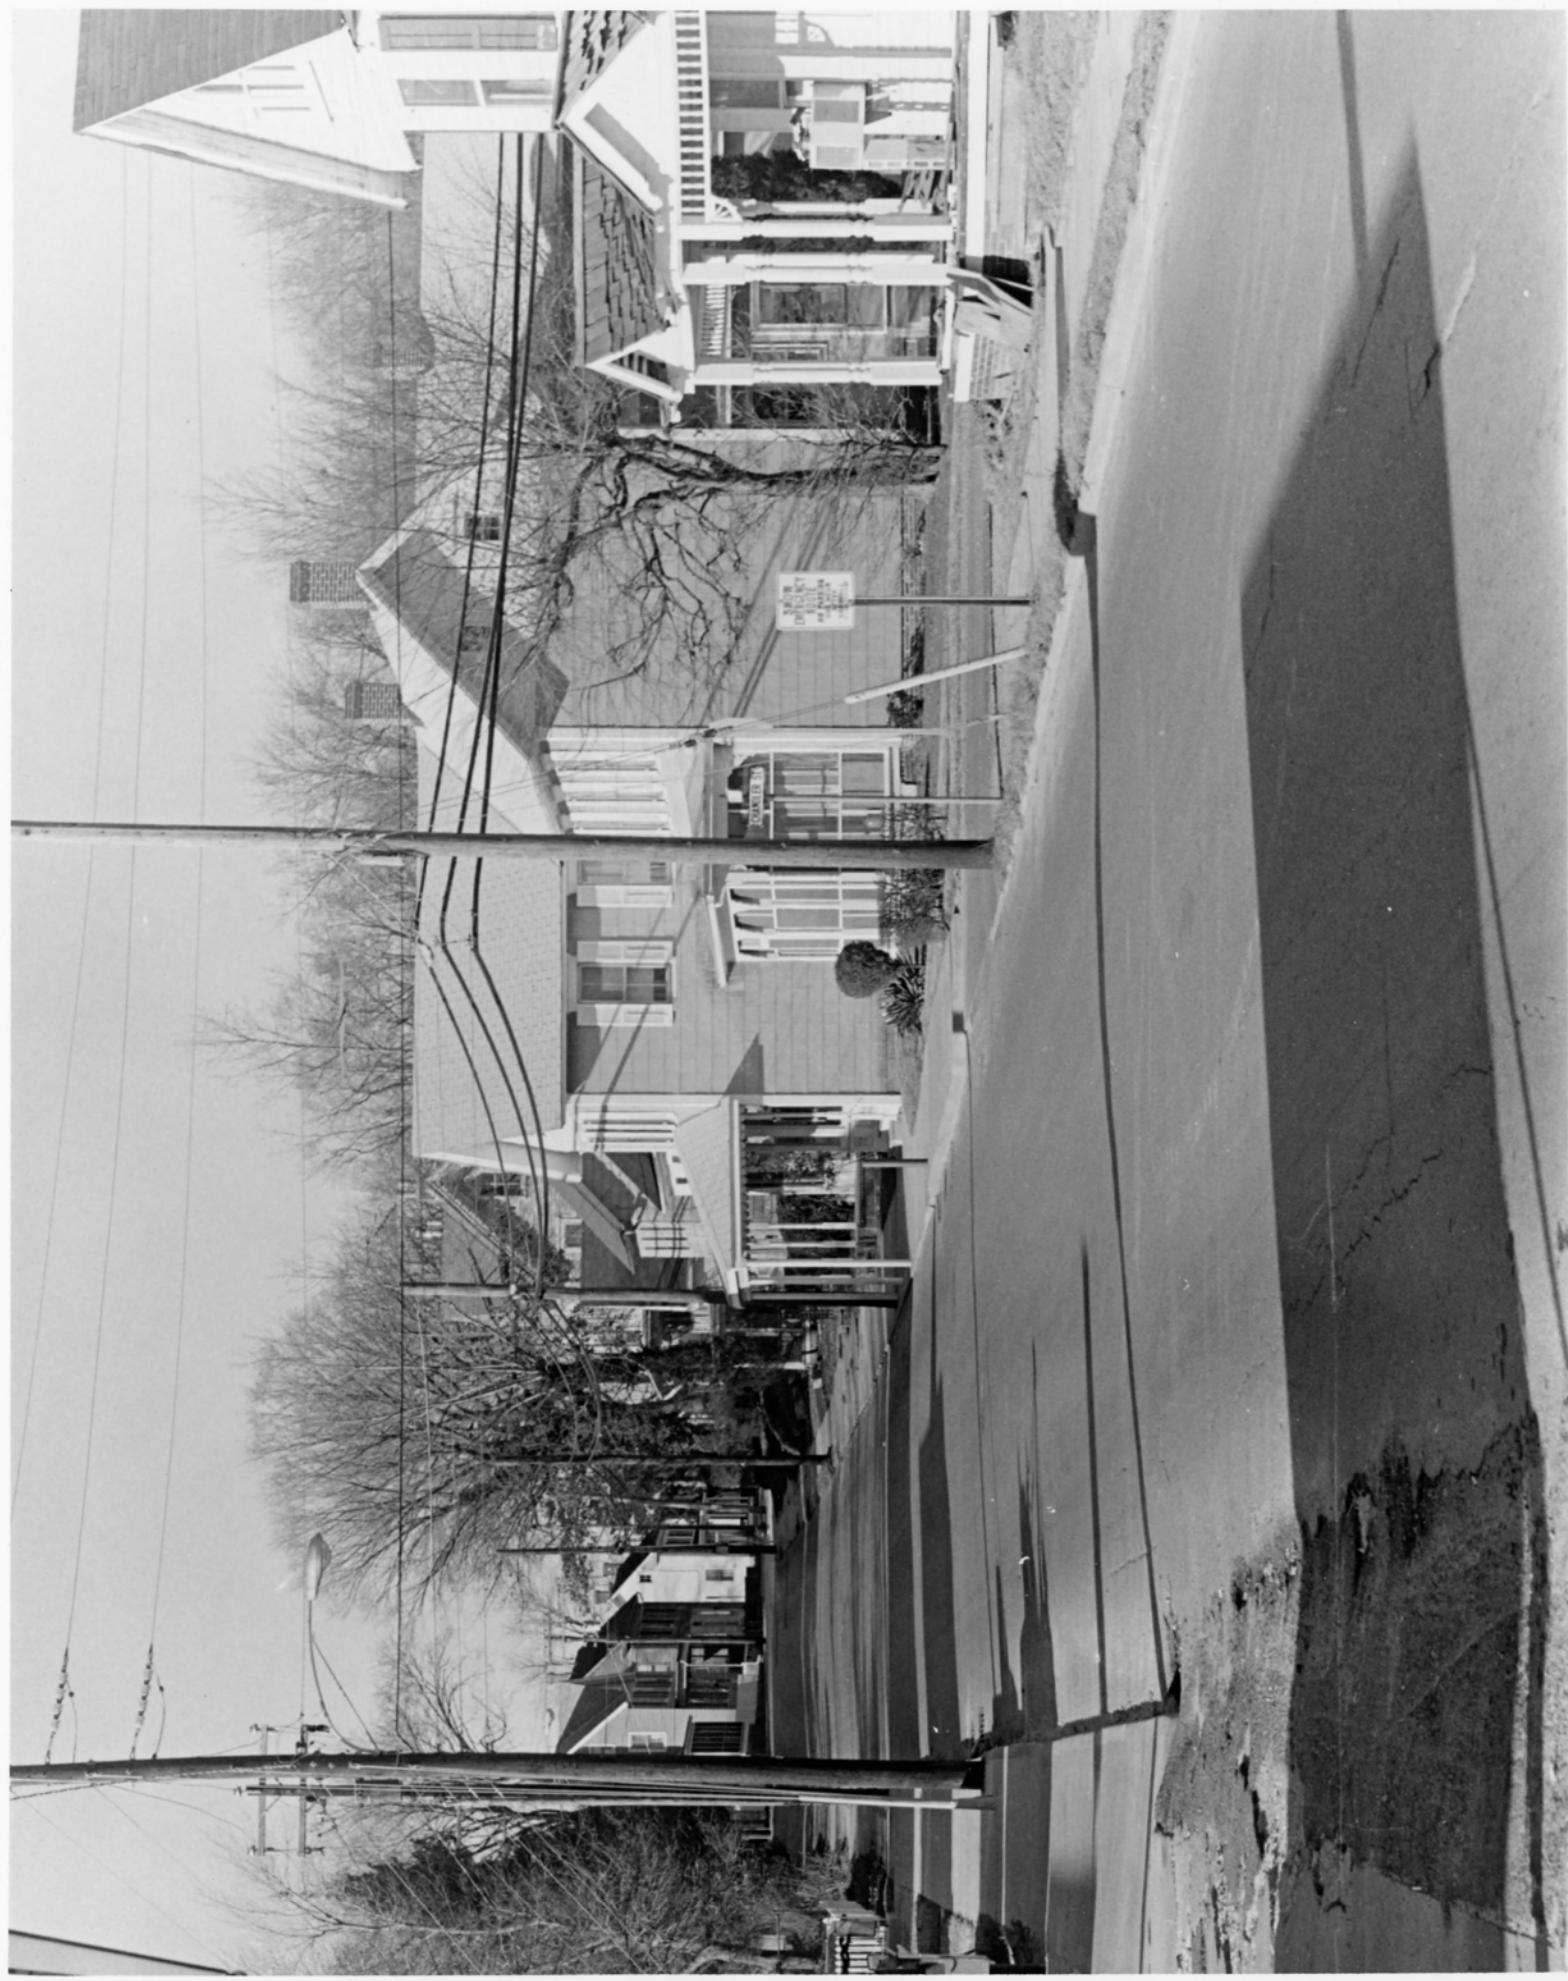
Name: Milton Historic District (streetscape B: north along Union Street, across Chandler Street, intersection; site # 93 at extreme right)

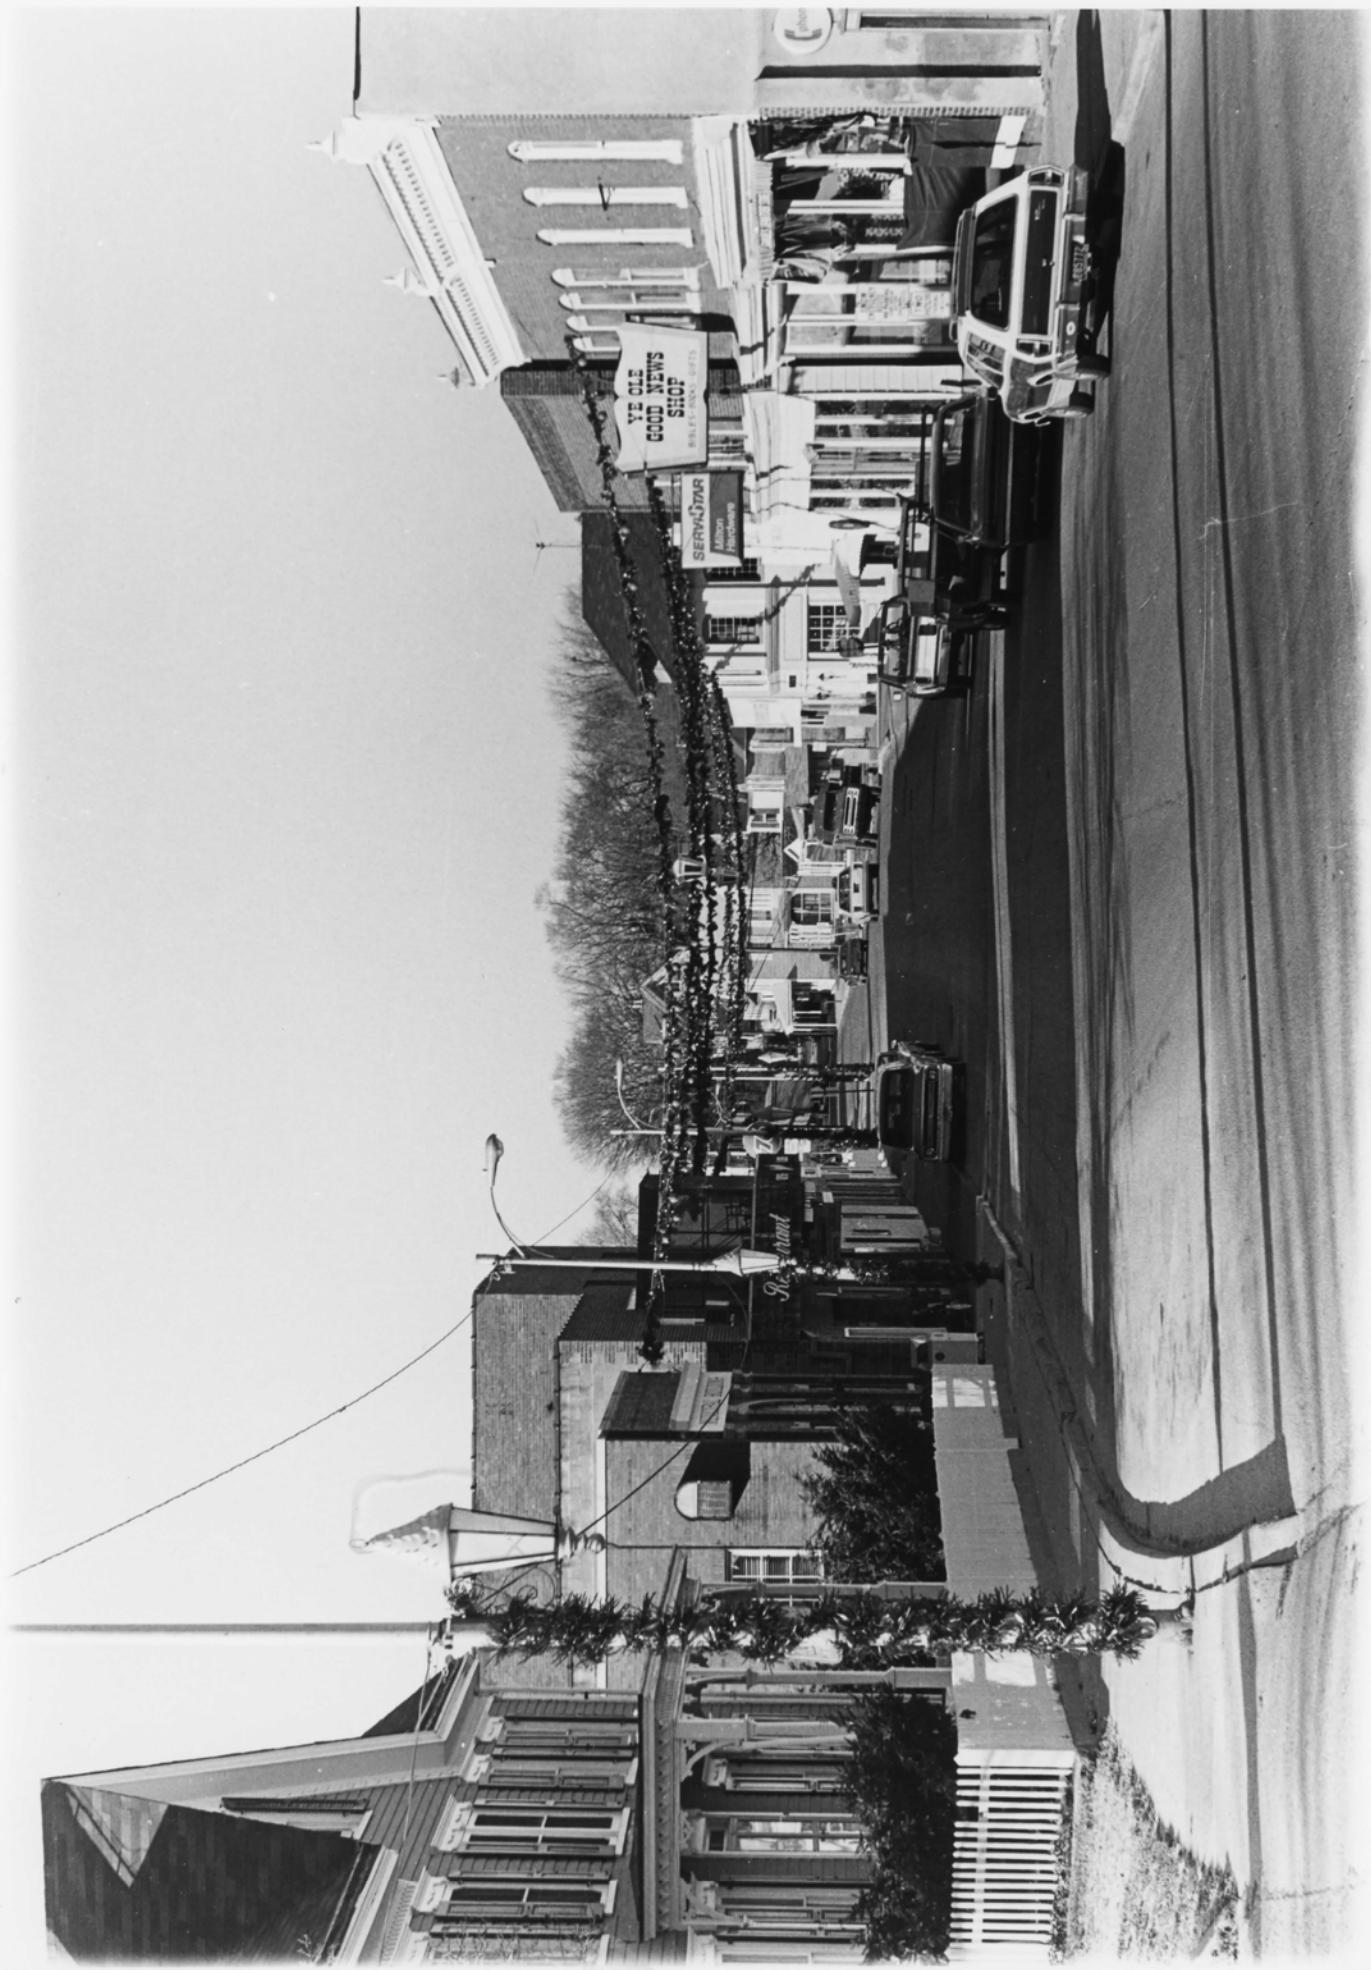
Name: Milton Historic District (streetscape C: Union Street, northwest from Front Street intersection; site # 86 at extreme right)

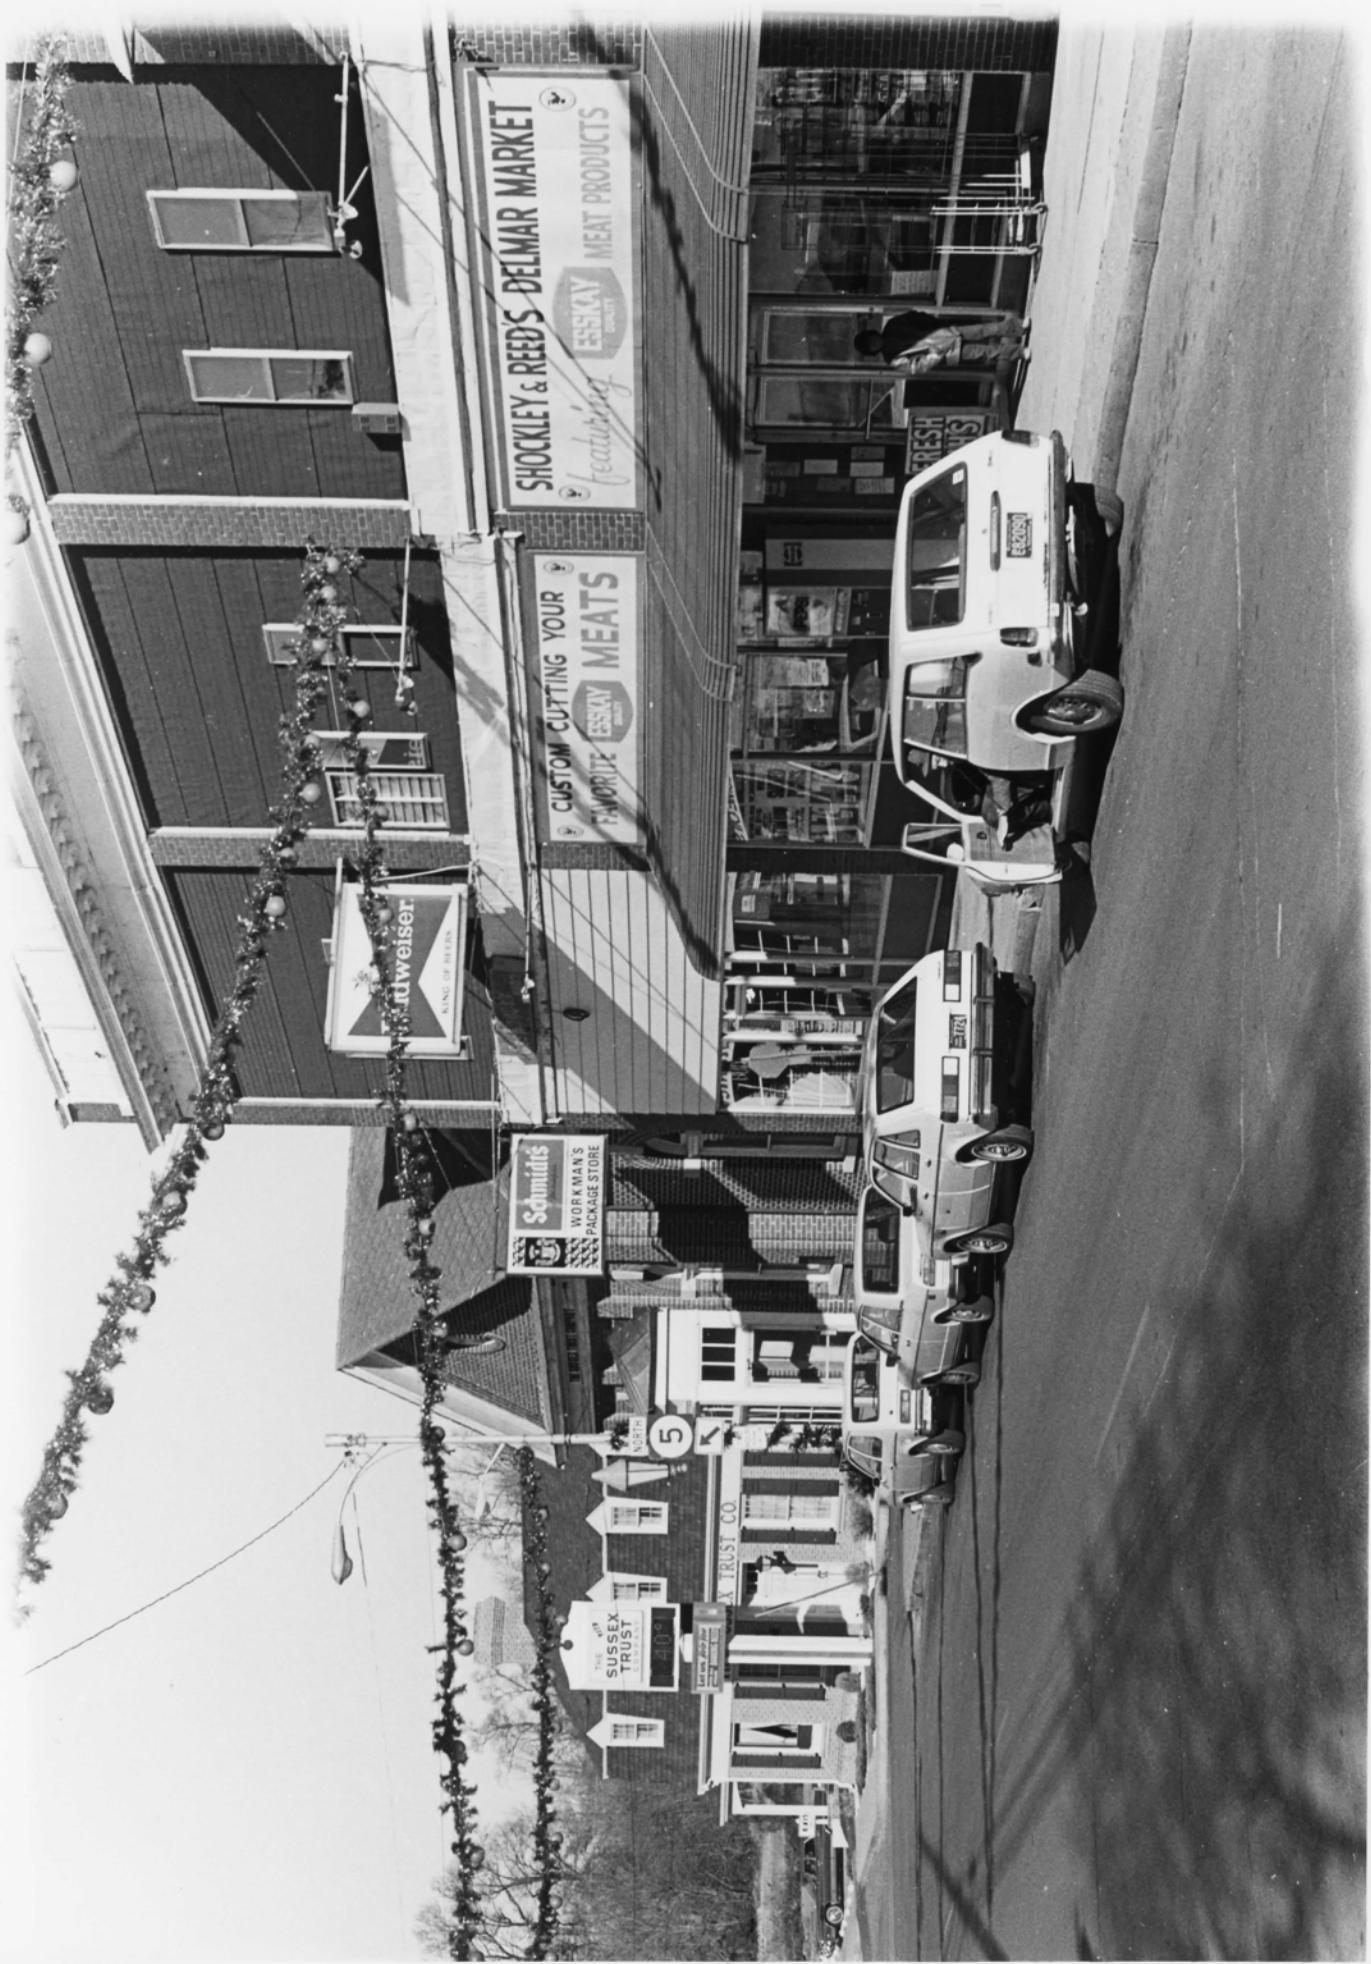
Name: Milton Historic District (streetscape D: east,  
side of Federal Street; northeast across  
Chandler Street intersection; site #83 at  
extreme right)

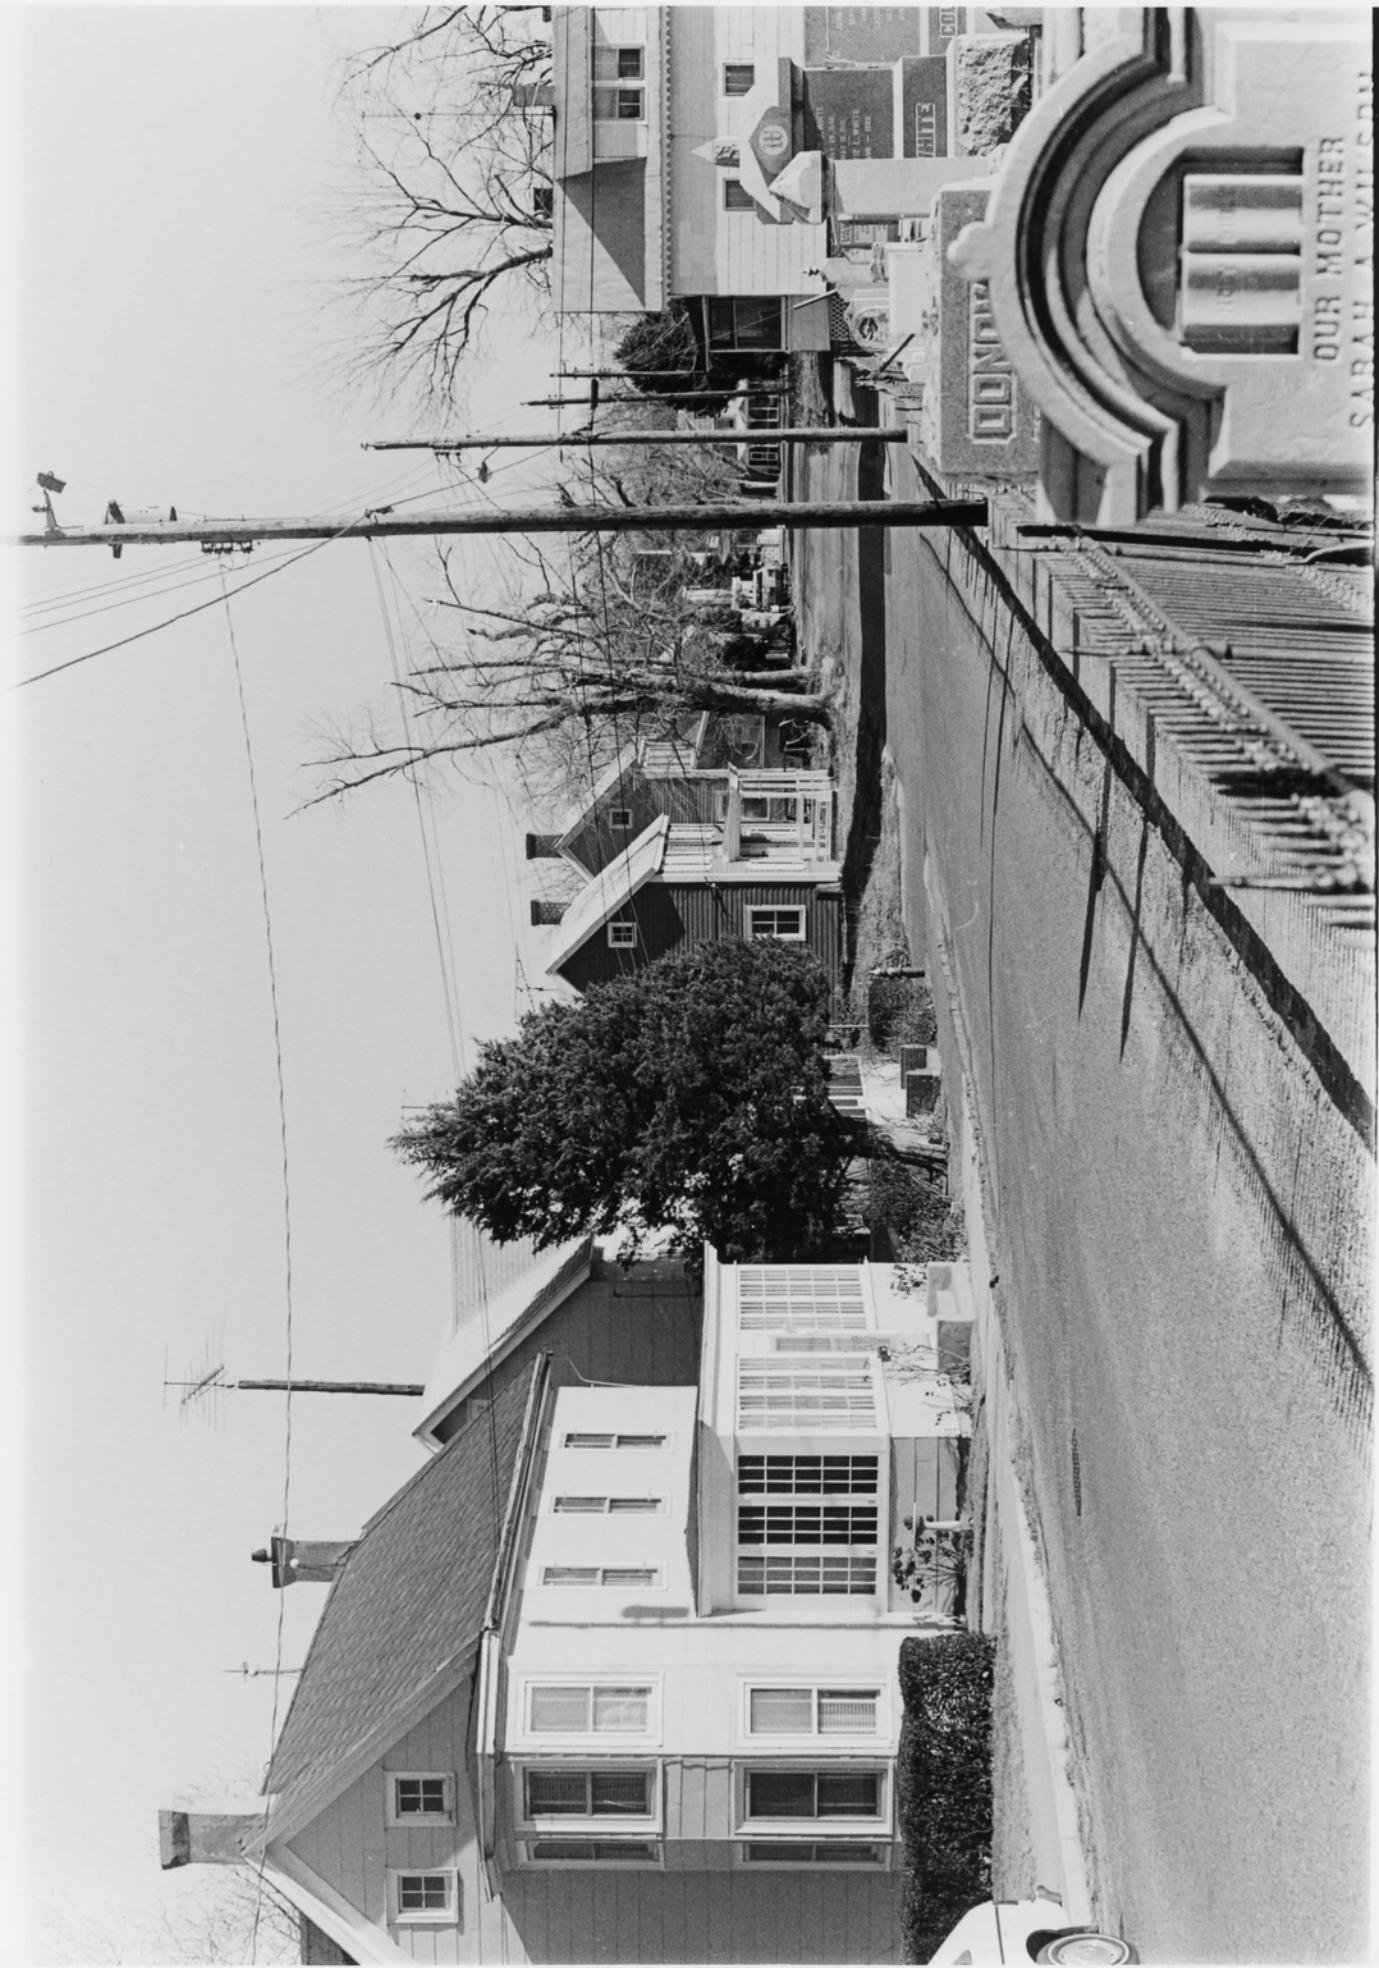
Name: Milton Historic District (streetscape E: east-northeast along Mill Street from site 135)

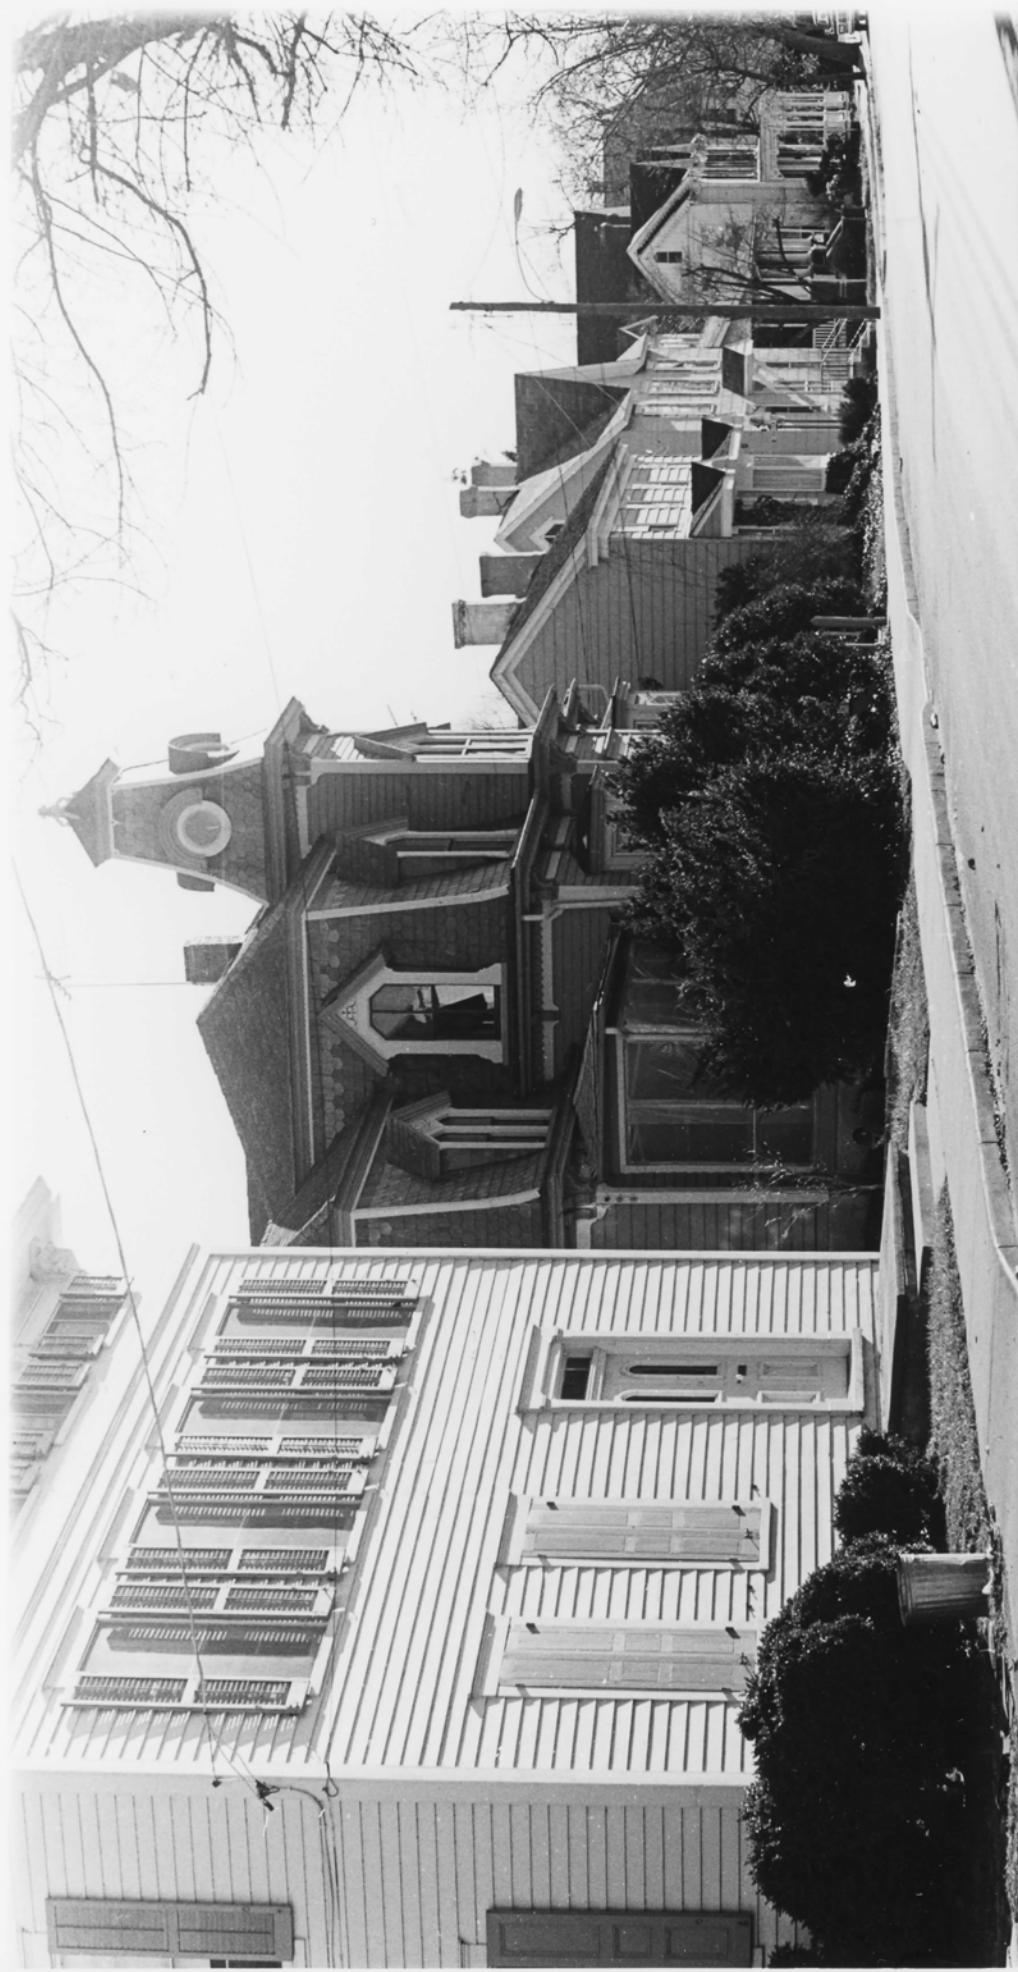
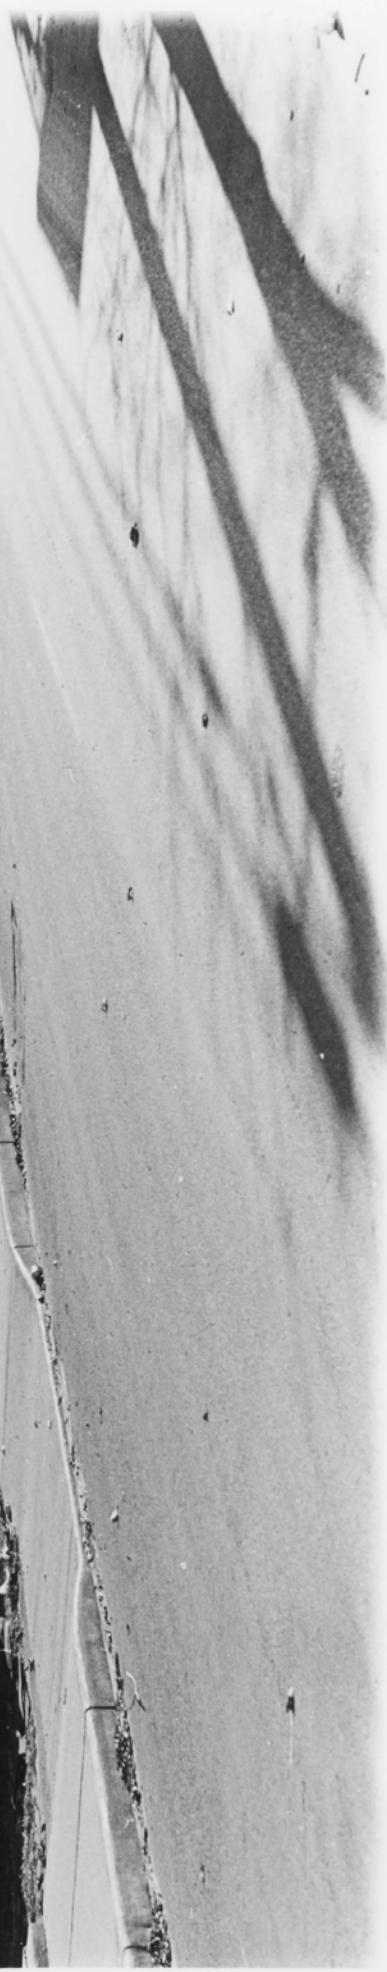
Name: Milton Historic District (streetscape F: east side of Federal Street, south-southeast across Coulter Street intersection; site #77 at extreme left)

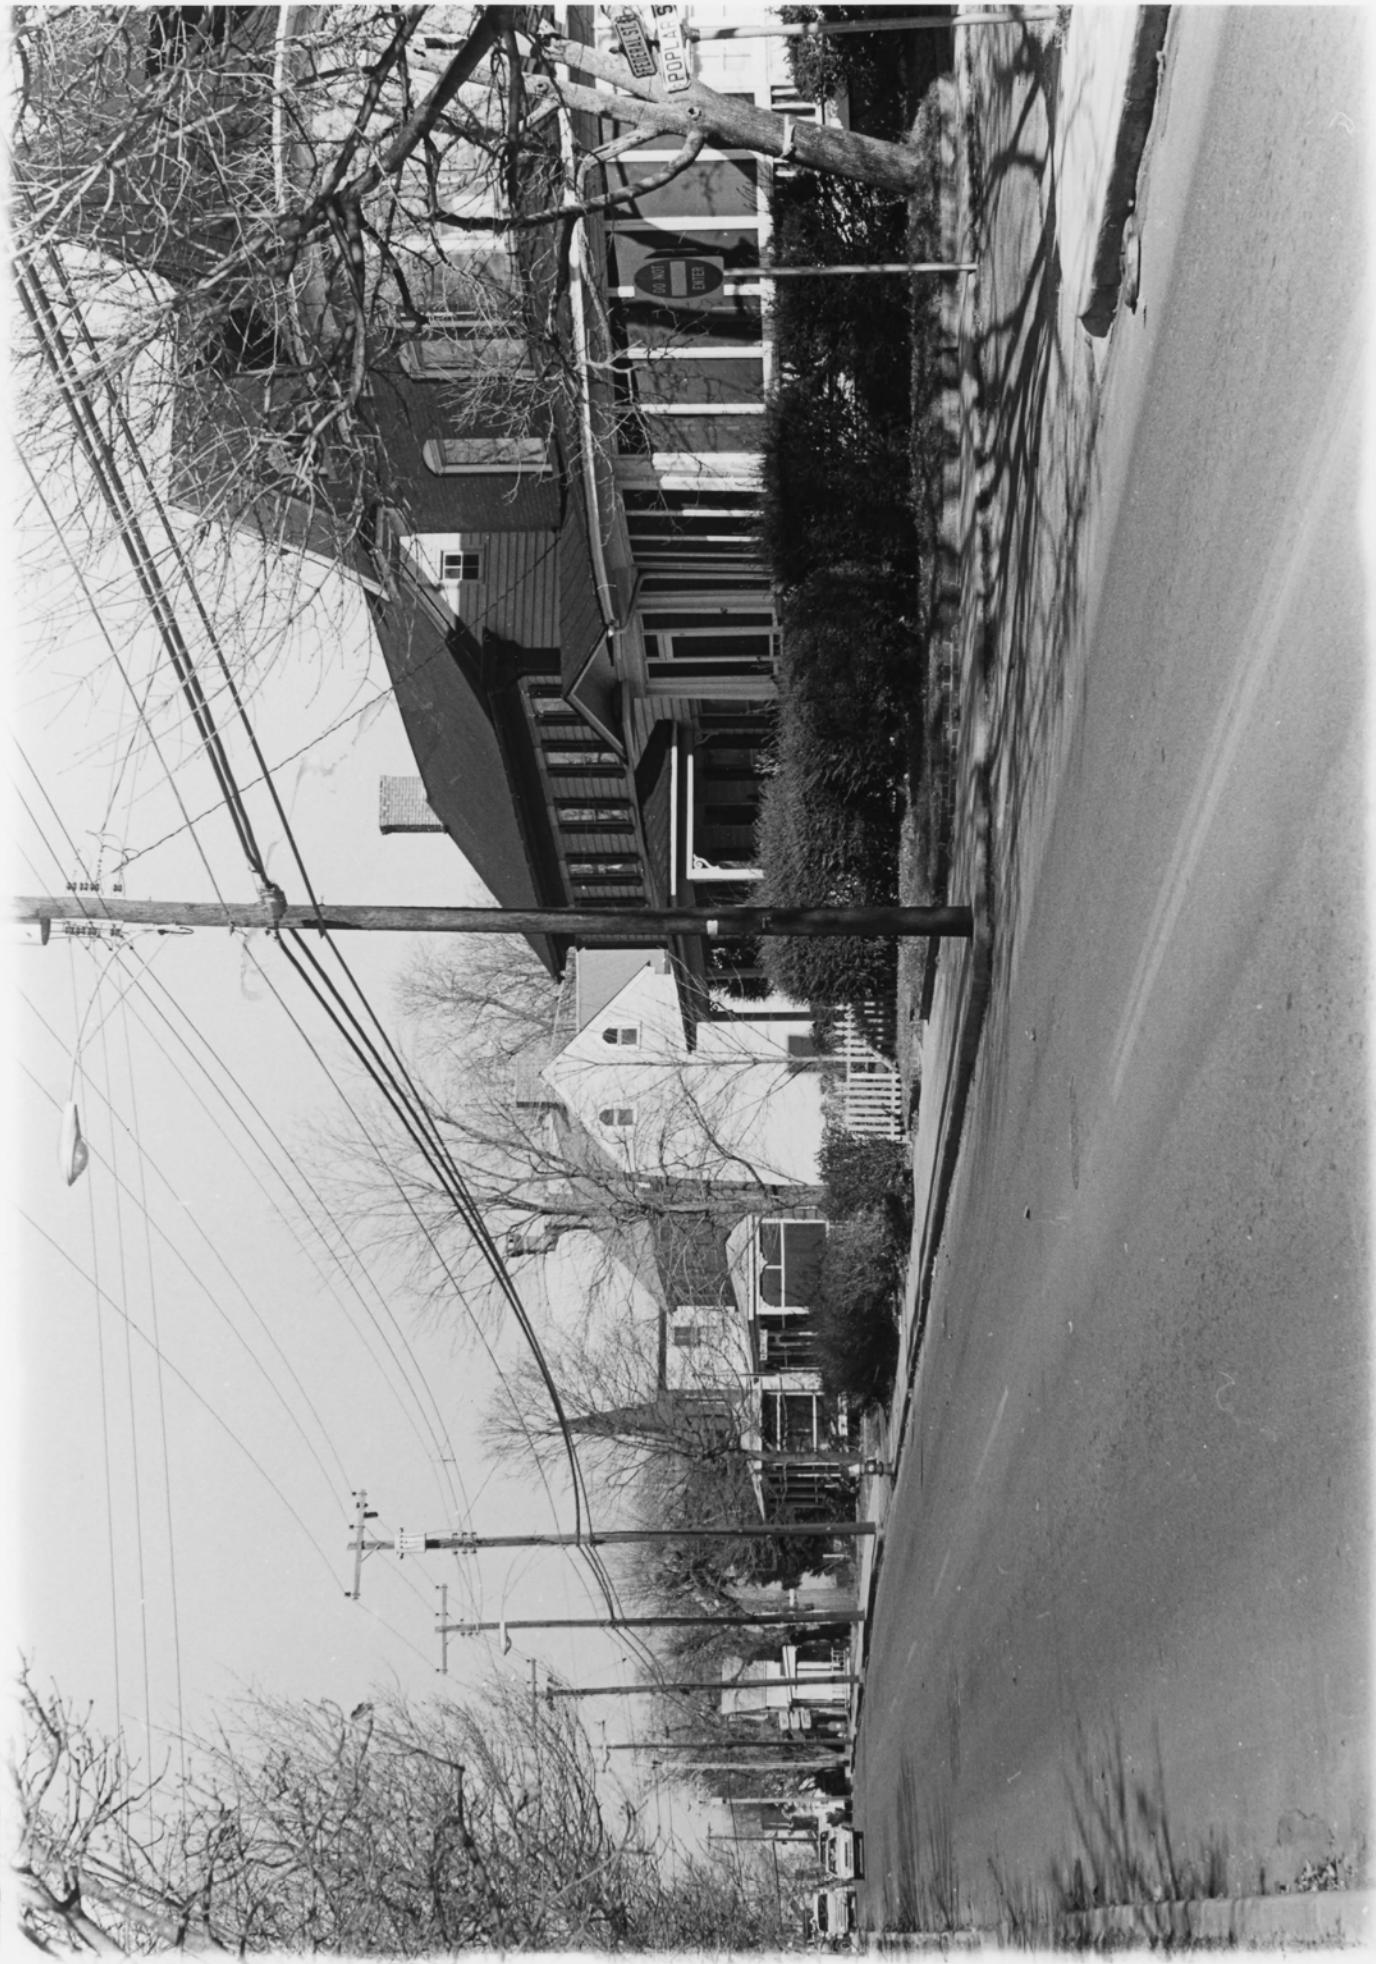
Name: Milton Historic District (streetscape G: east side of Federal Street, north-northeast from Poplar Street intersection; site #63 at extreme right)

63. 417 Federal Street. Ca. 1900. Large Queen Anne style, modified "T"-shape with base of "T" facing street. Turret at front southwest corner. Brick construction. Pedimented entry porch with circular porch extending around turret and leading to side porch. Curved Queen Anne balusters on porch railings. Porch columns on brick pedestals. Soffited cornice with frieze, partial returns roofed, flared eaves. Segmentally-arched window and door openings. Large stained glass window in northeast gable end. Horizontal two-light casements in gable ends, segmentally arched. Two sheds, garage and privy in rear contemporary with house. Structure now vacant.

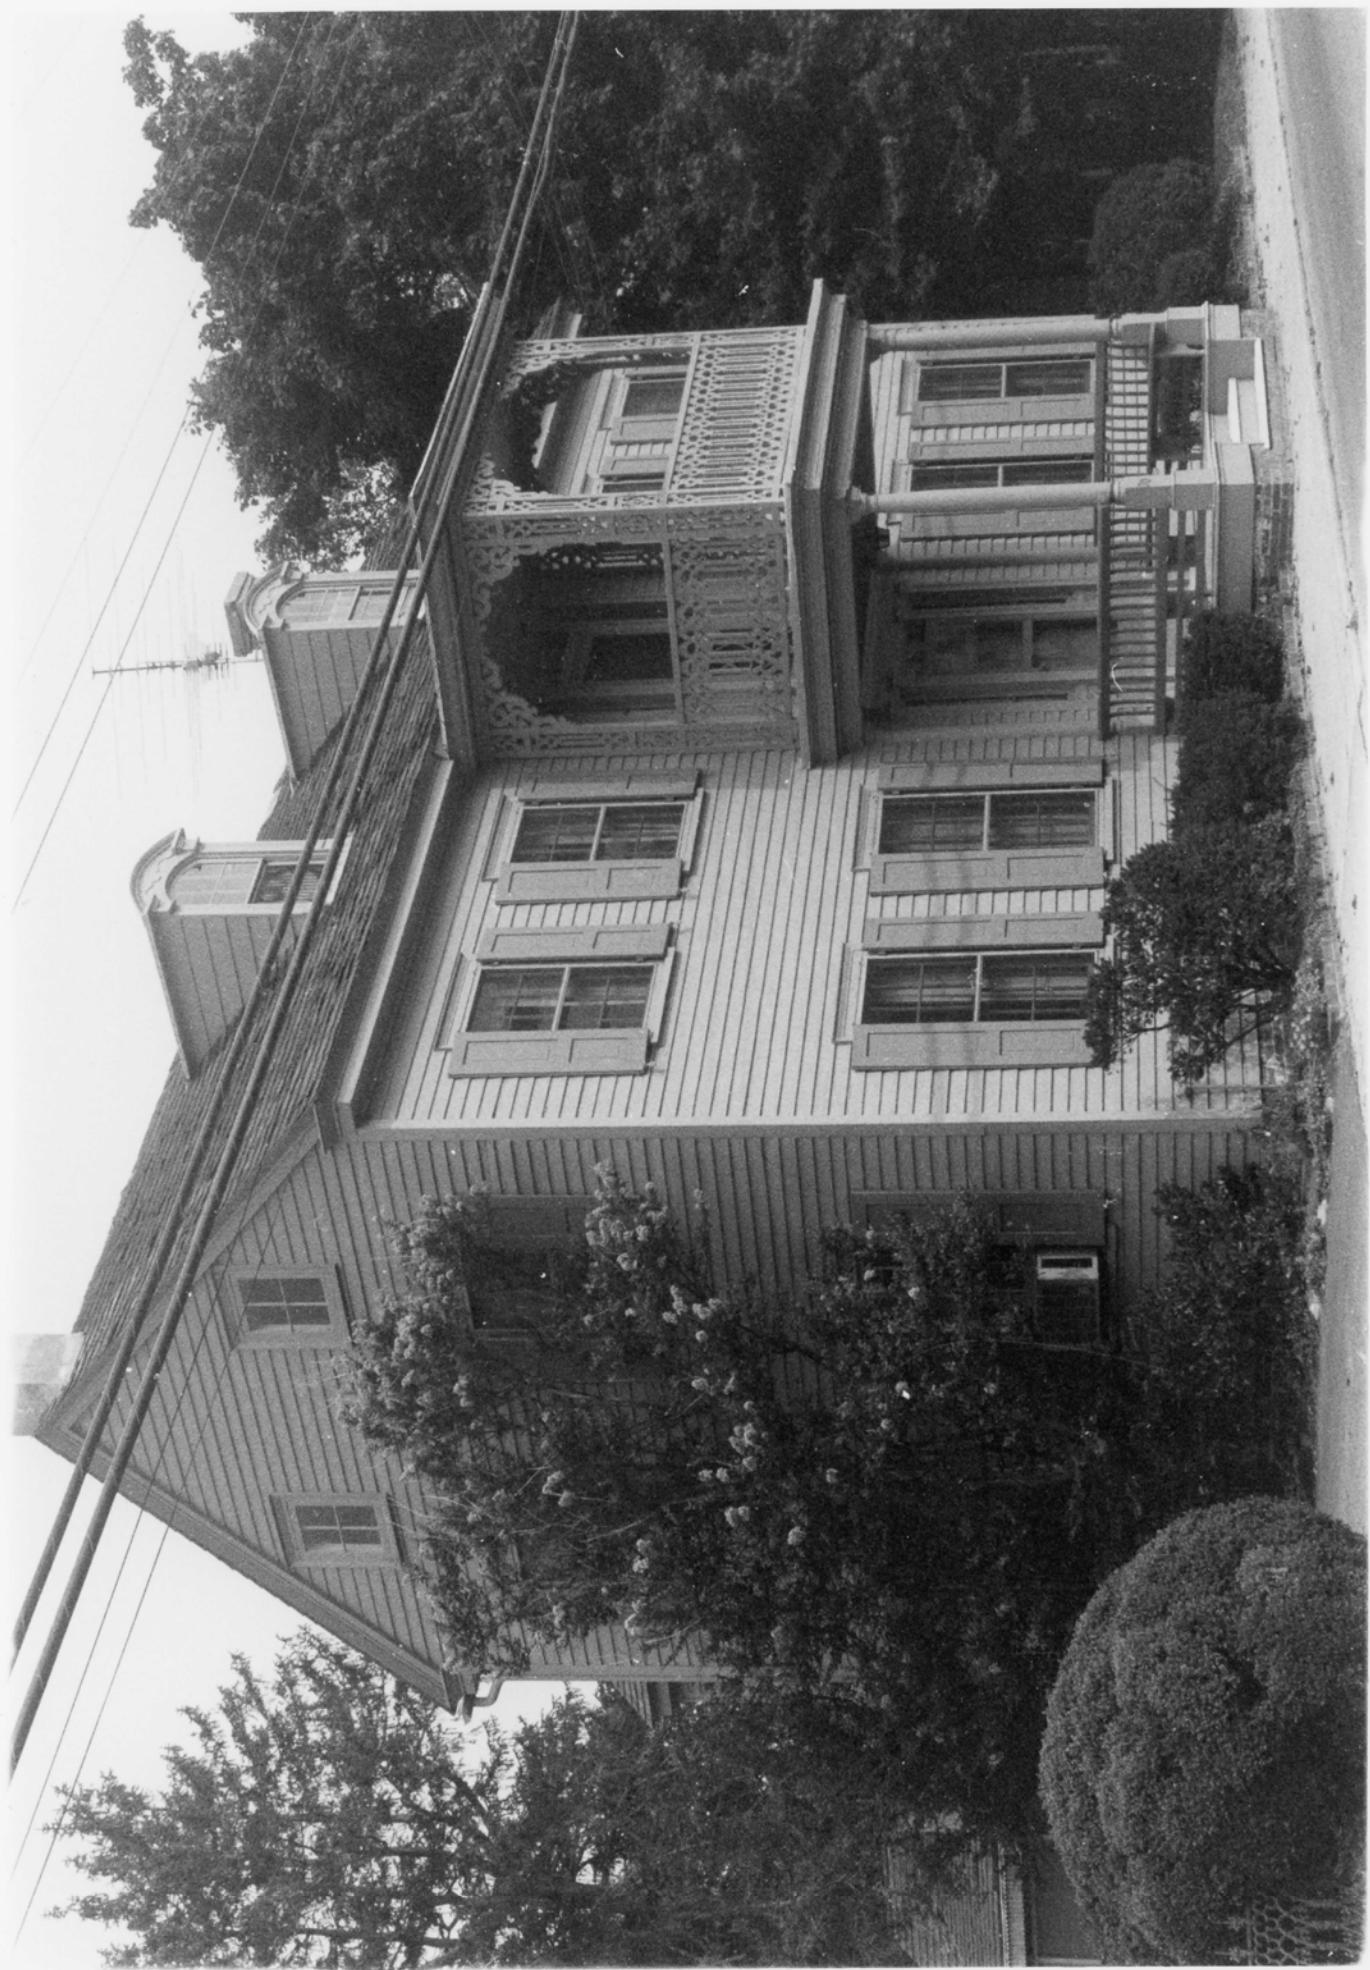
Name: Milton Historic District (Draper-Atkins house,  
site #39)

The area along Federal Street between Mill Street and the Mulberry Street intersection contains many of the town's finest mid-to-late nineteenth century homes. The Draper-Atkins House at 206 Federal Street (No. 39 in the inventory) is earlier, dating from the Federal period. As previously noted it is one of three structures in town already listed in the National Register. Next door at 208 Federal Street is a modern, non-conforming one-story home built in 1957. At 308 Federal Street (No. 44 in the inventory) is one of the town's better examples of Victorian Gothic architecture. This house incorporates double cross gables, a motif which appeared on several Milton homes of this period.
