**National Register of Historic Places  
Inventory—Nomination Form**

historic Milton Historic District

city, town Milton

state Delaware

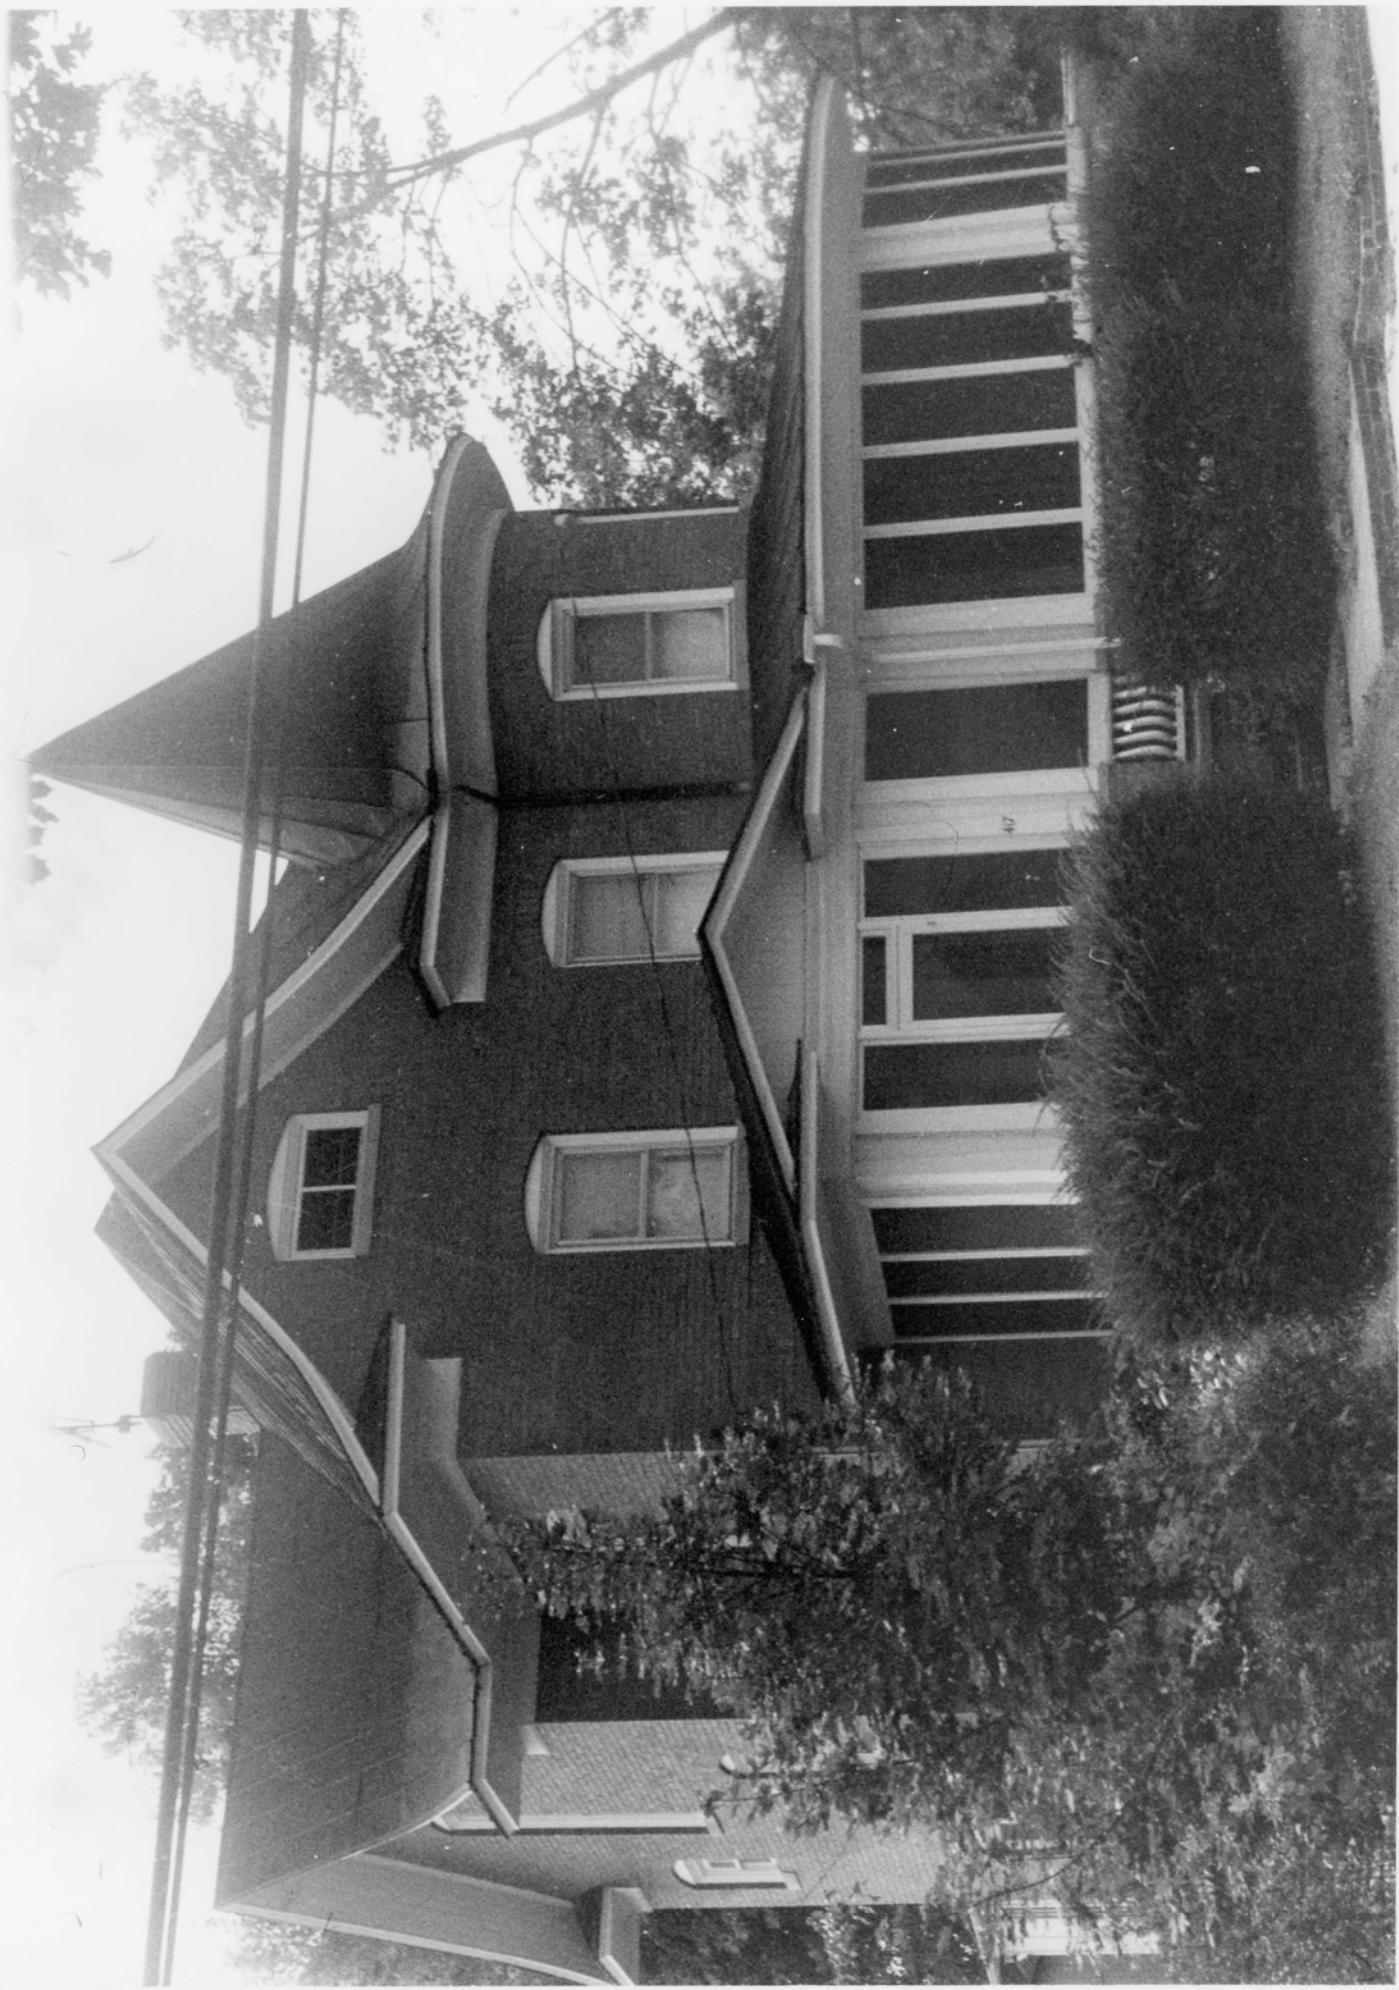
Name: Milton Historic District (Ca. 1900 Queen Ann house,  
site #63)

63. 417 Federal Street. Ca. 1900. Large Queen Anne style, modified "T"-shape with base of "T" facing street. Turret at front southwest corner. Brick construction. Pedimented entry porch with circular porch extending around turret and leading to side porch. Curved Queen Anne balusters on porch railings. Porch columns on brick pedestals. Soffited cornice with frieze, partial returns roofed, flared eaves. Segmentally-arched window and door openings. Large stained glass window in northeast gable end. Horizontal two-light casements in gable ends, segmentally arched. Two sheds, garage and privy in rear contemporary with house. Structure now vacant.

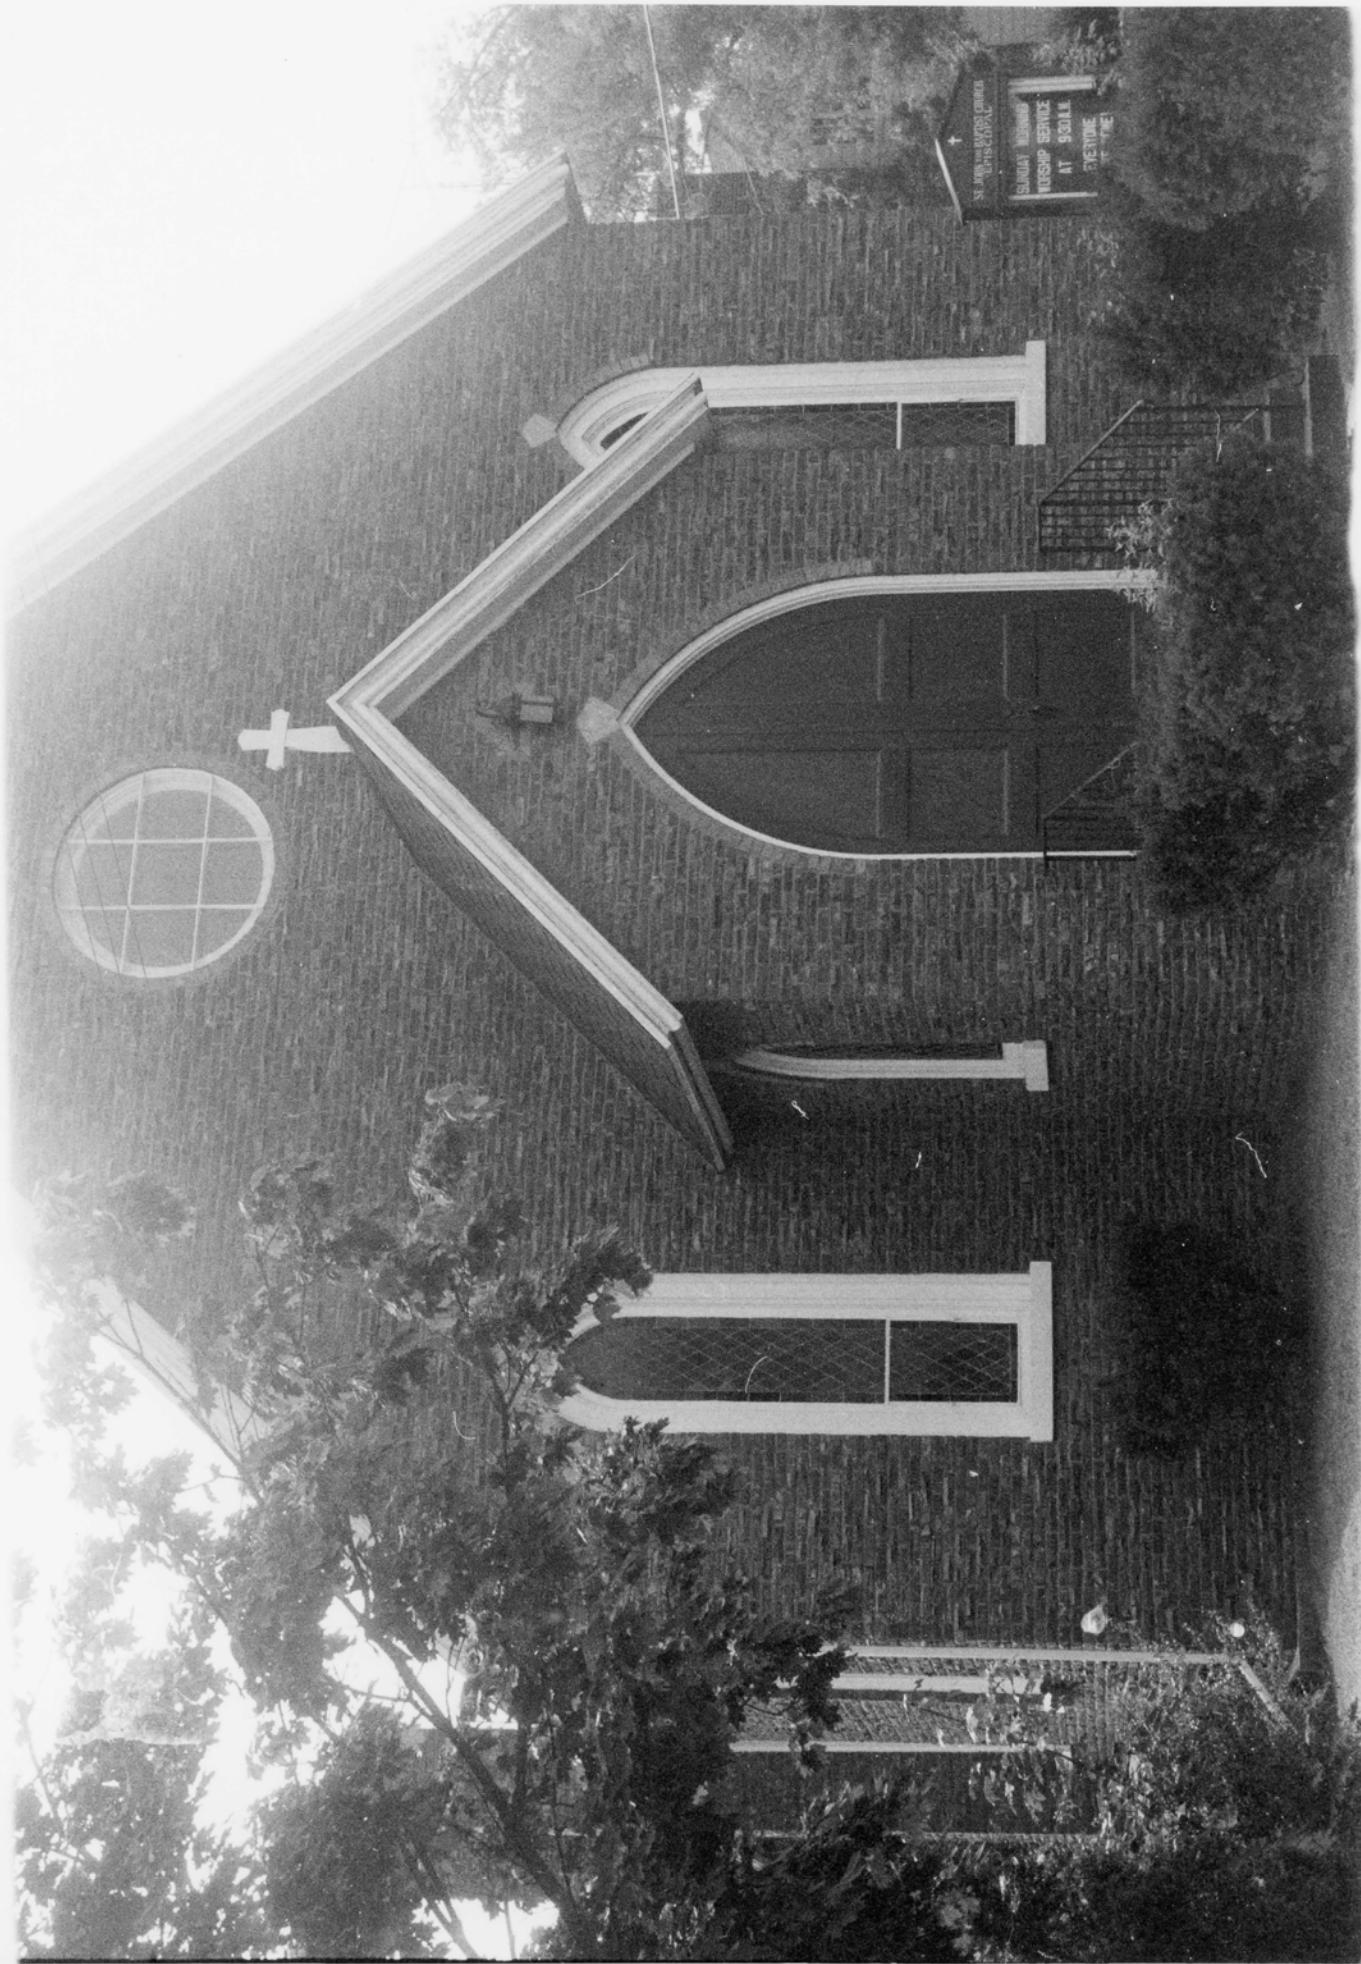
Name: Milton Historic District (St. John the Baptist,  
site #71)

71. 307 Federal Street. Original construction 1877 but much altered. St. John the Baptist Episcopal Church. Main core is rectangular gable-roofed Gothic church structure with gable end facing street. Frame structure with brick veneer added in 1936. Gable-roofed frame and shingle parish hall in rear connected by gable-roofed covered wing to church added in 1941. On each side of church building are four double trefoil arched windows with diamond panes in lower section. Chancel window is rose pattern over twelve-light stained glass window. Front facade has diamond-paned lancet window on either side with diamond keystones. Gable-roofed vestibule with lancet doorway and small lancet windows on each side. Structure is latest in a succession of buildings dating back to early-eighteenth century.

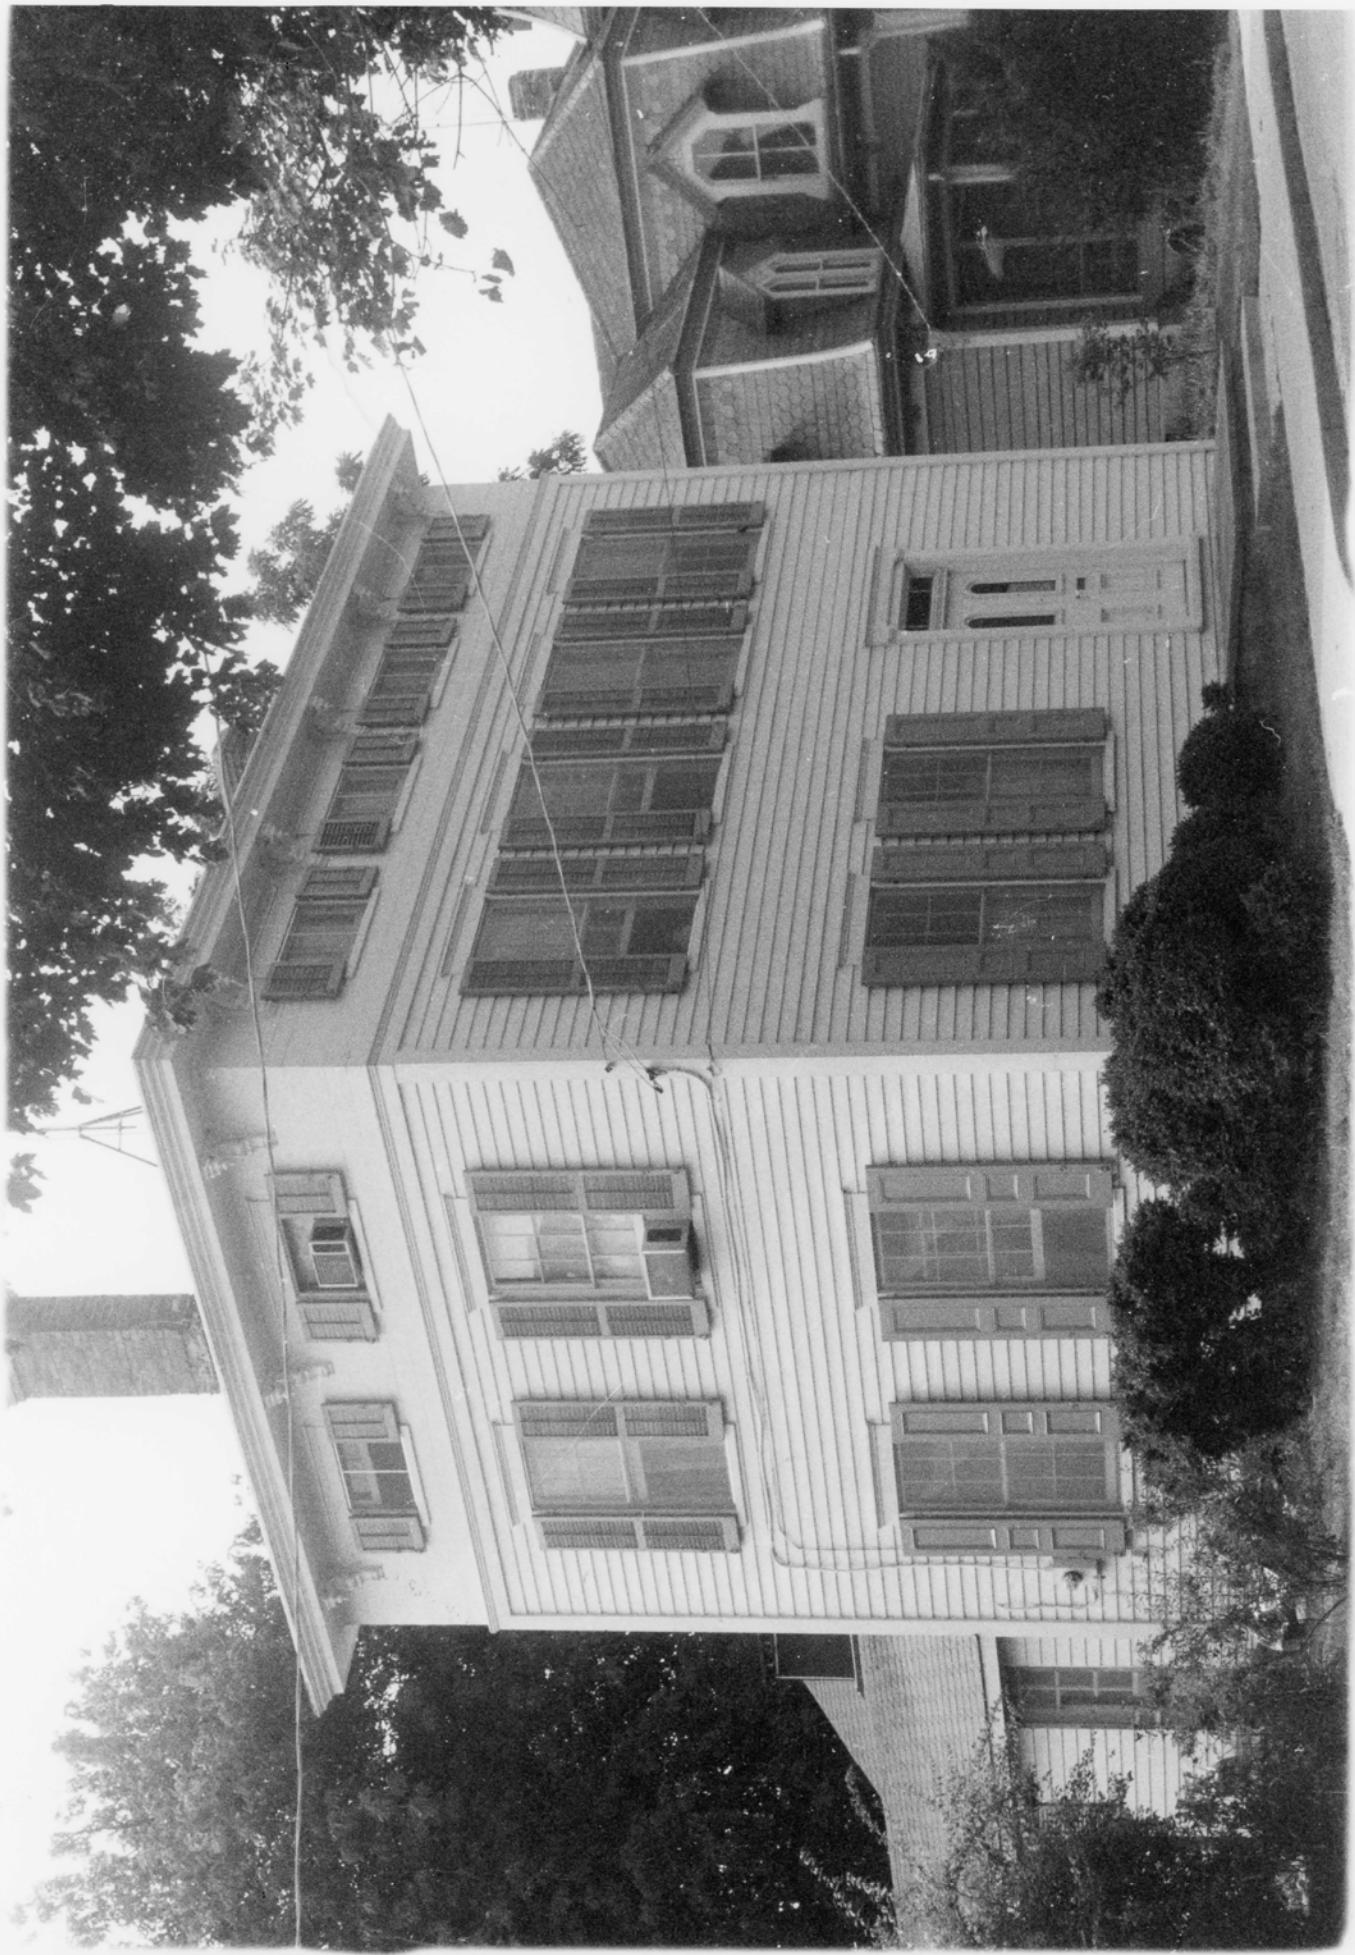
Name: Milton Historic District (Dr. Hopkins house  
site #78)

Several of Milton's late-nineteenth-century houses are among the finest and most imaginative Victorian structures in lower Delaware. The Second Empire-style Dr. James A. Hopkins House is one example. The 1845 W. C. Prettyman House is one of the best classic Greek Revival homes in the county. The Robert Hood Carey carriage house, as noted previously, is unique in Sussex County, and the D. W. Burton House on Federal Street with its gable on hip-on-hip roof and triangular bay window is extremely unusual, not to say odd, by any standard of measurement.
