**National Register of Historic Places
Inventory—Nomination Form**

historic Milton Historic District

Milton

Delaware

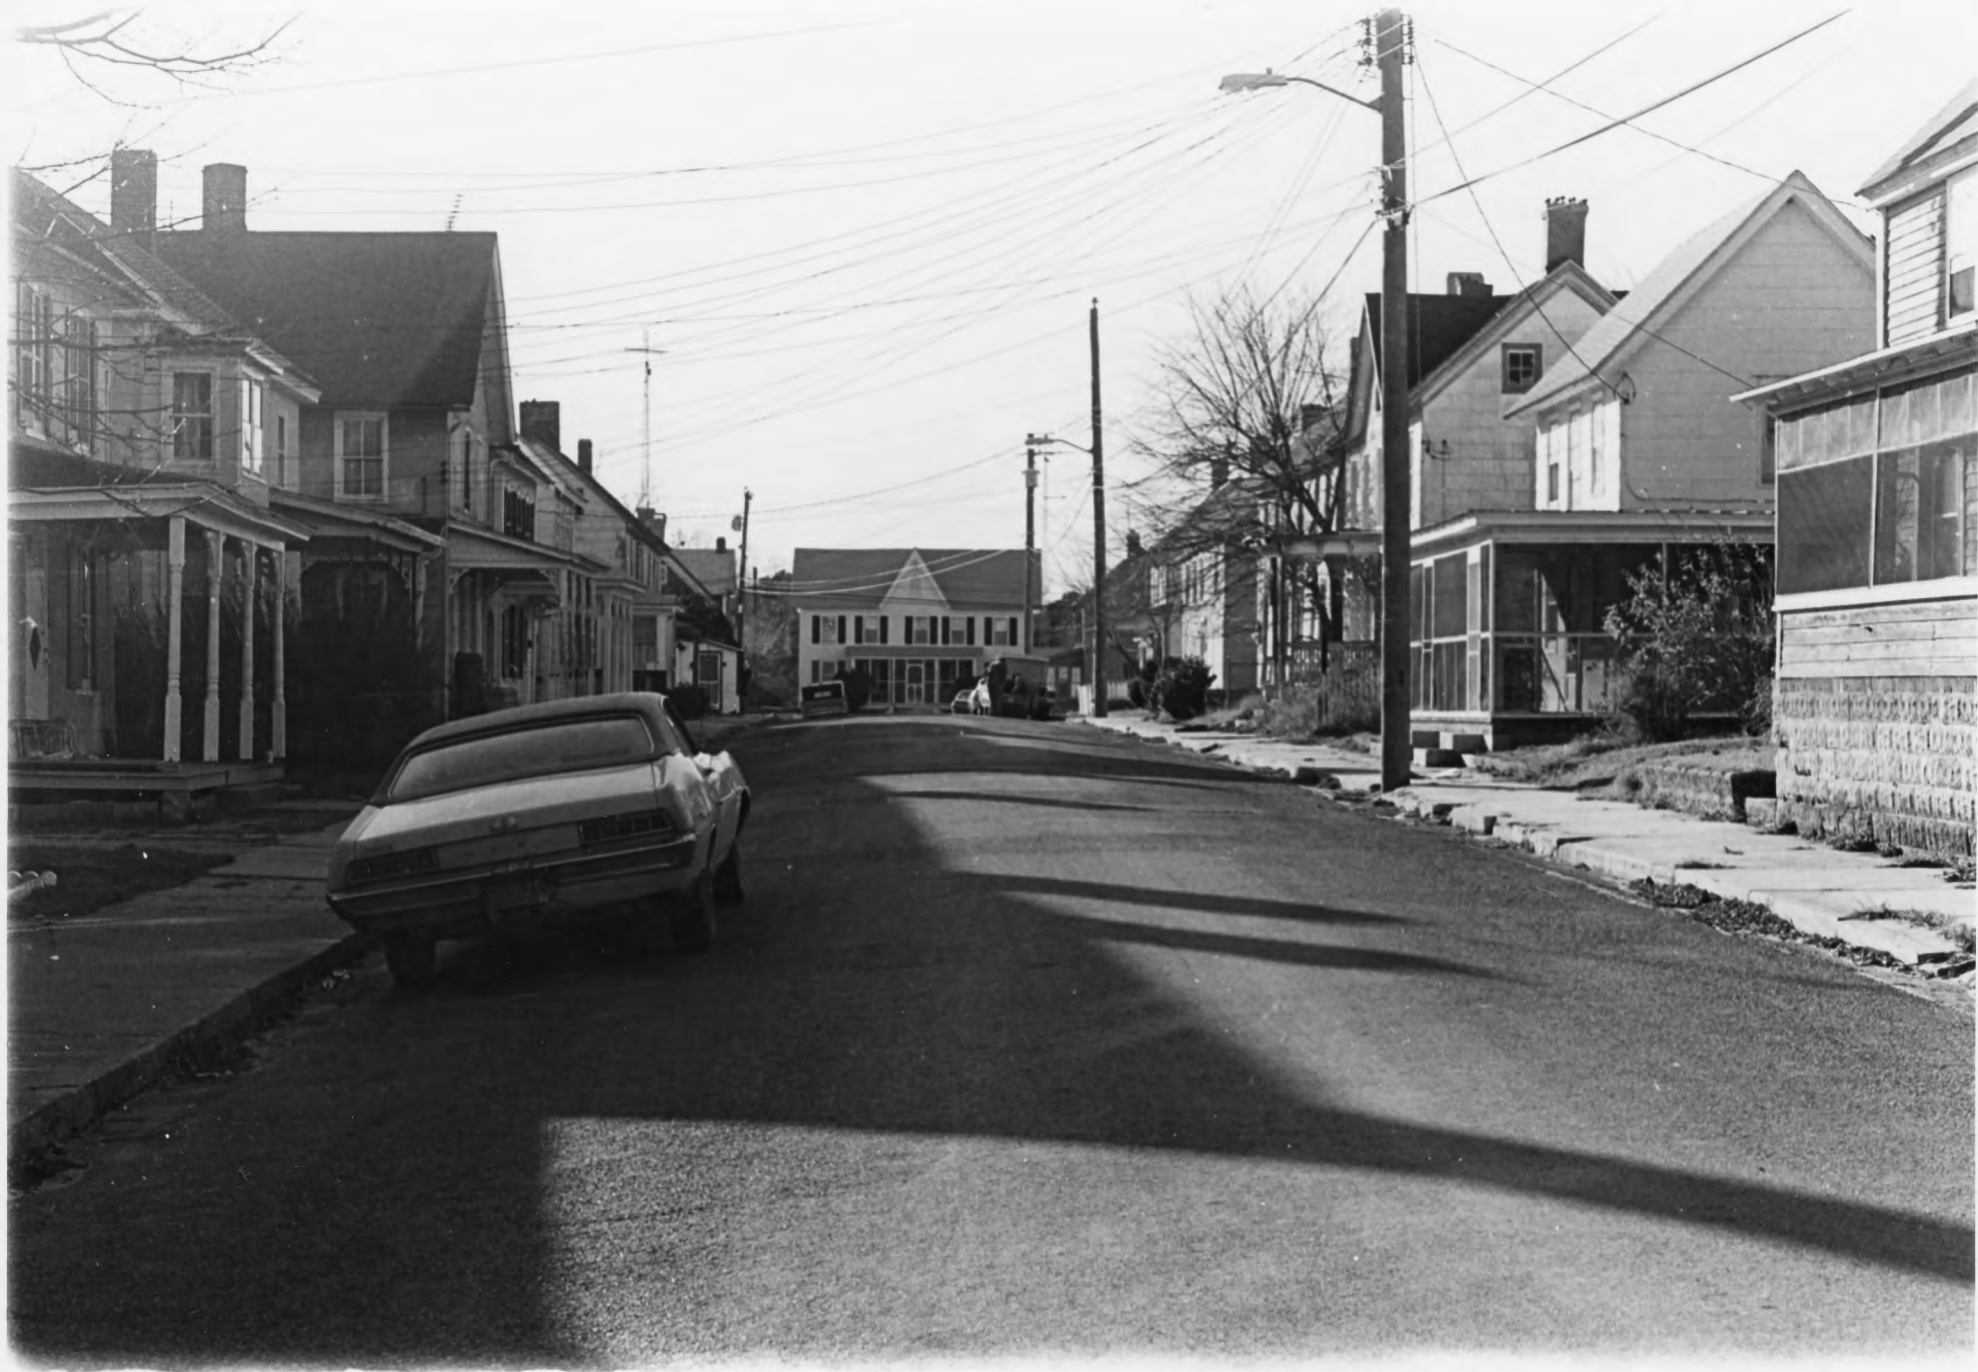
Photograph Number: / of 38

Name: Milton Historic District (streetscape A: west,
southwest along Broad Street; site #114 at extreme
right)

Description: view from east-northeast

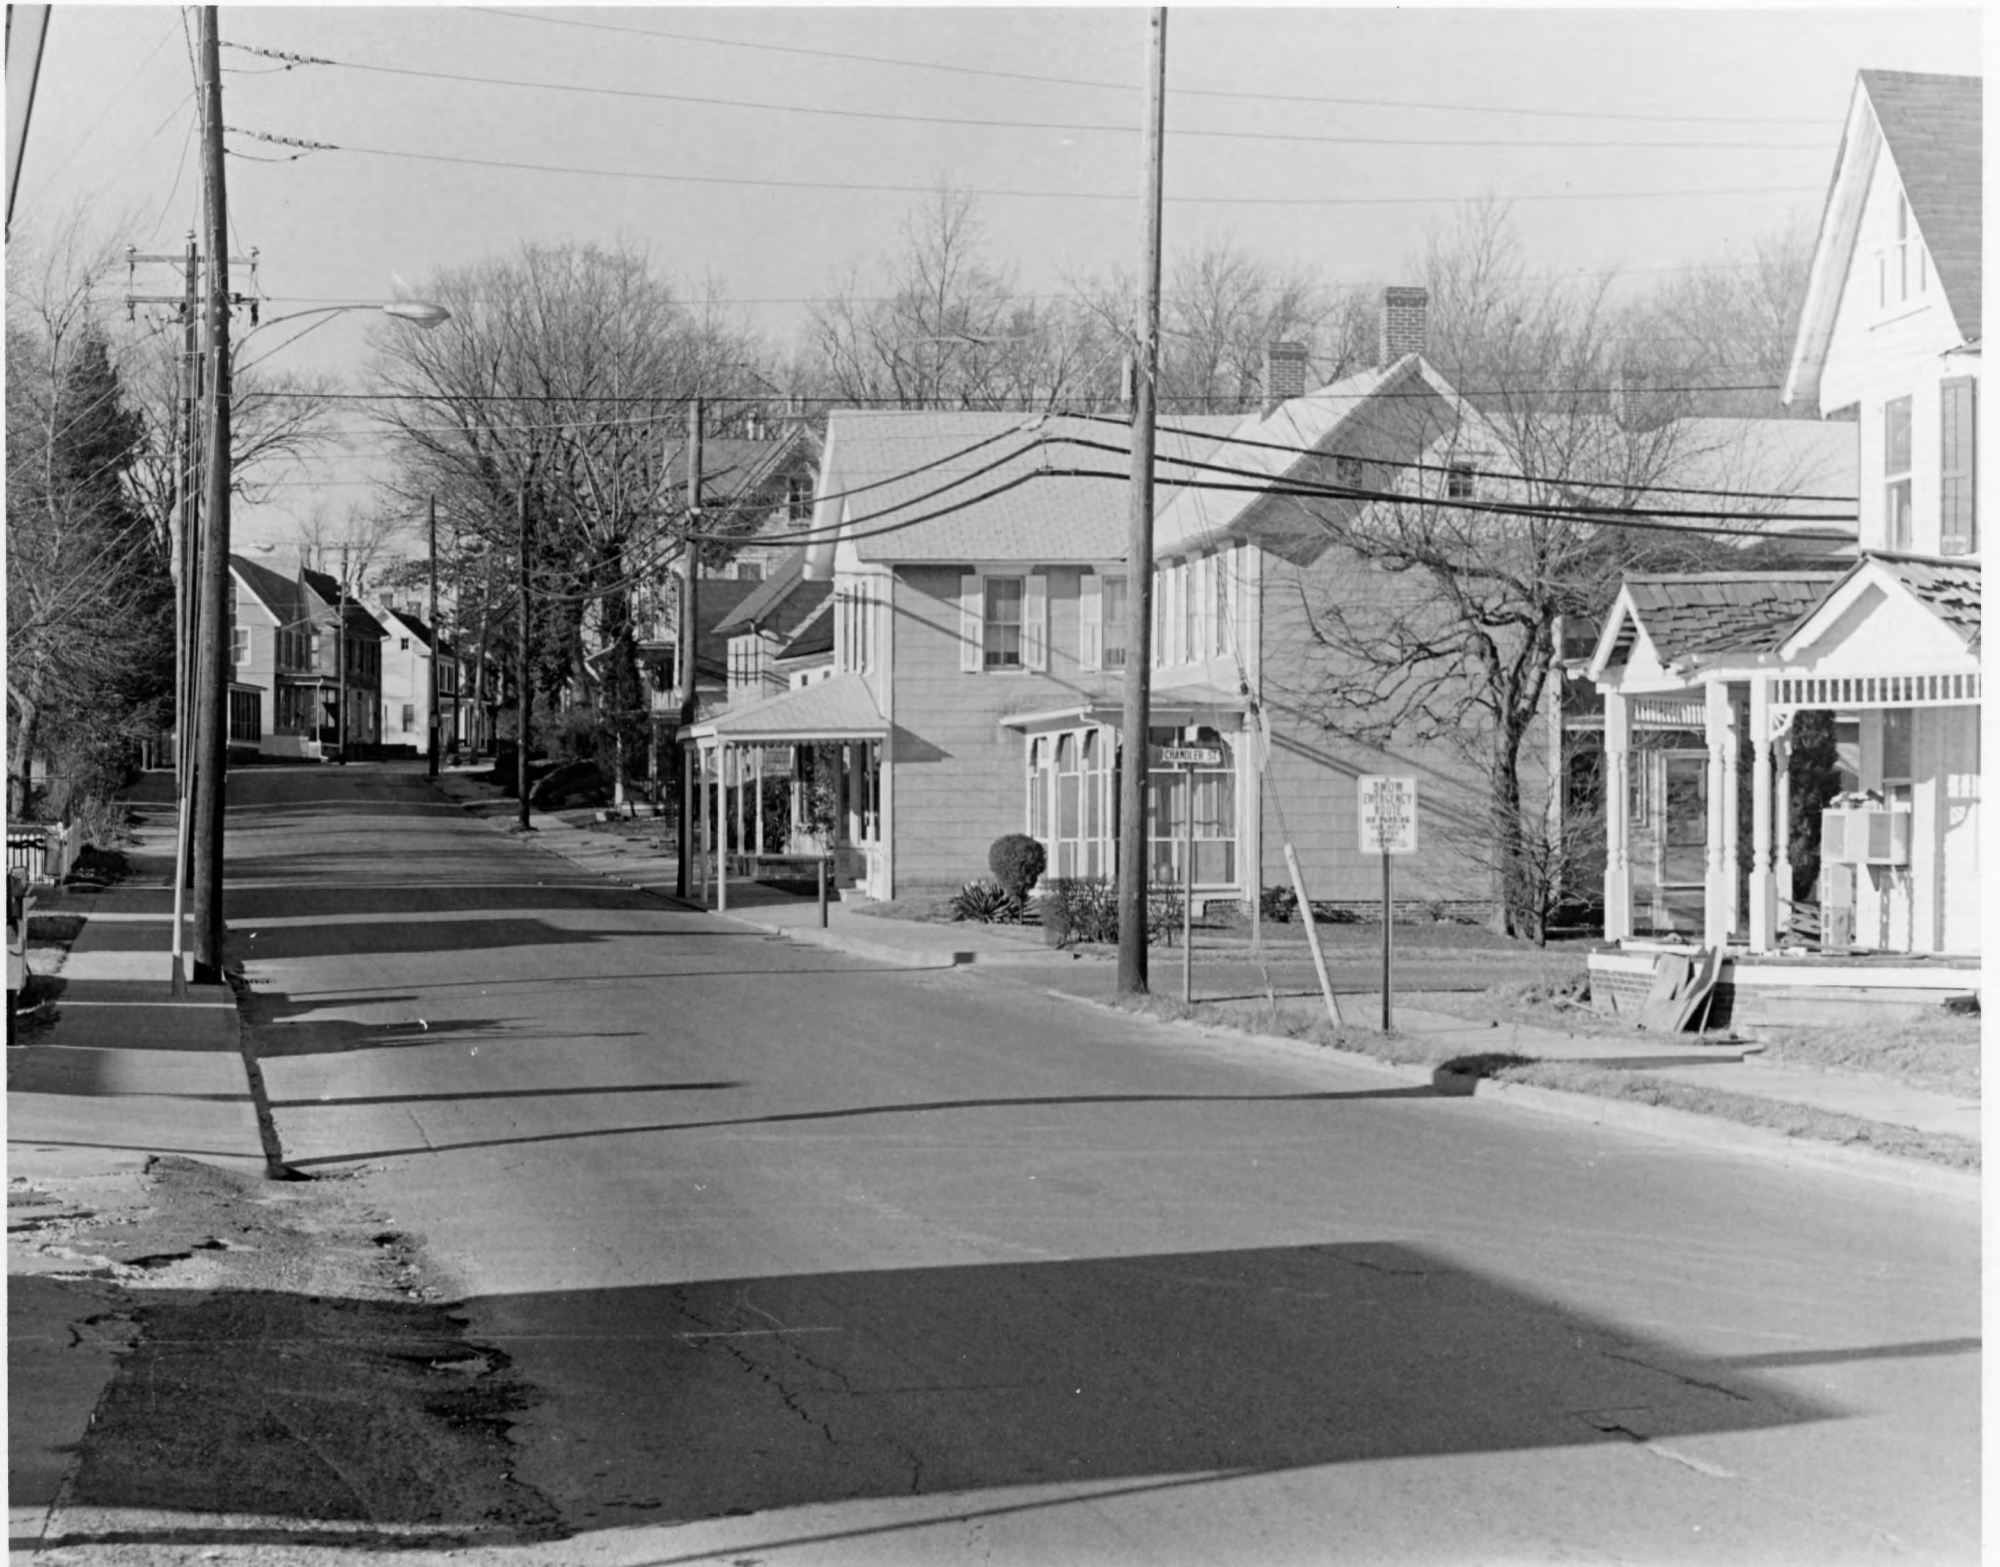
Photograph Number: 2 of 38

Name: Milton Historic District (streetscape B: north
along Union Street, across Chandler Street,
intersection; site # 93 at extreme right)

Description: view from south

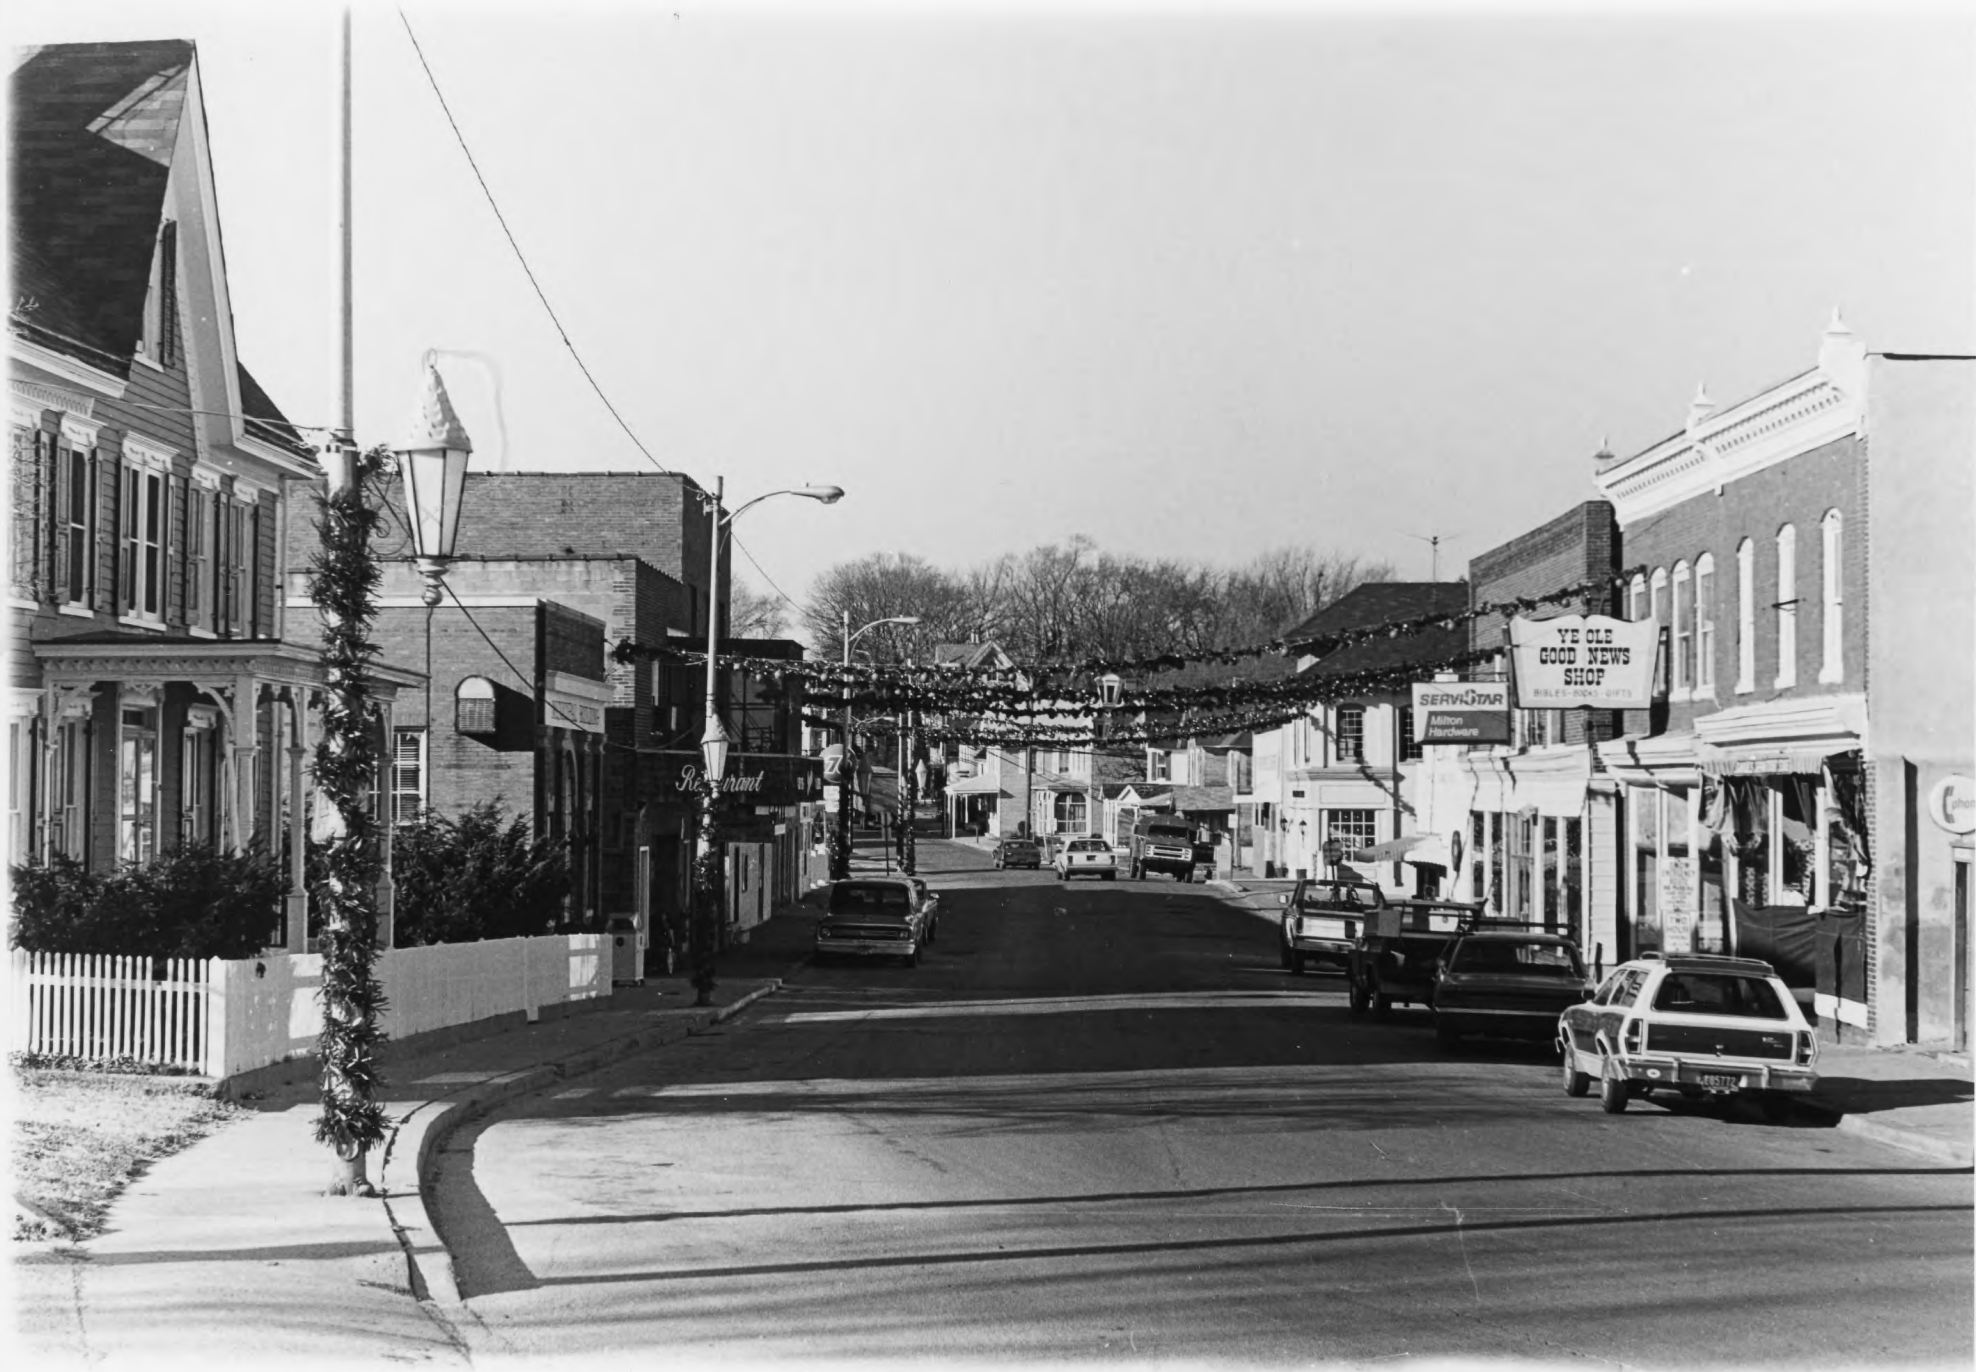
Photograph Number: 3 of 38

Name: Milton Historic District (streetscape C: Union
Street, northwest from Front Street intersection;
site # 86 at extreme right)

Descripton: view from northeast

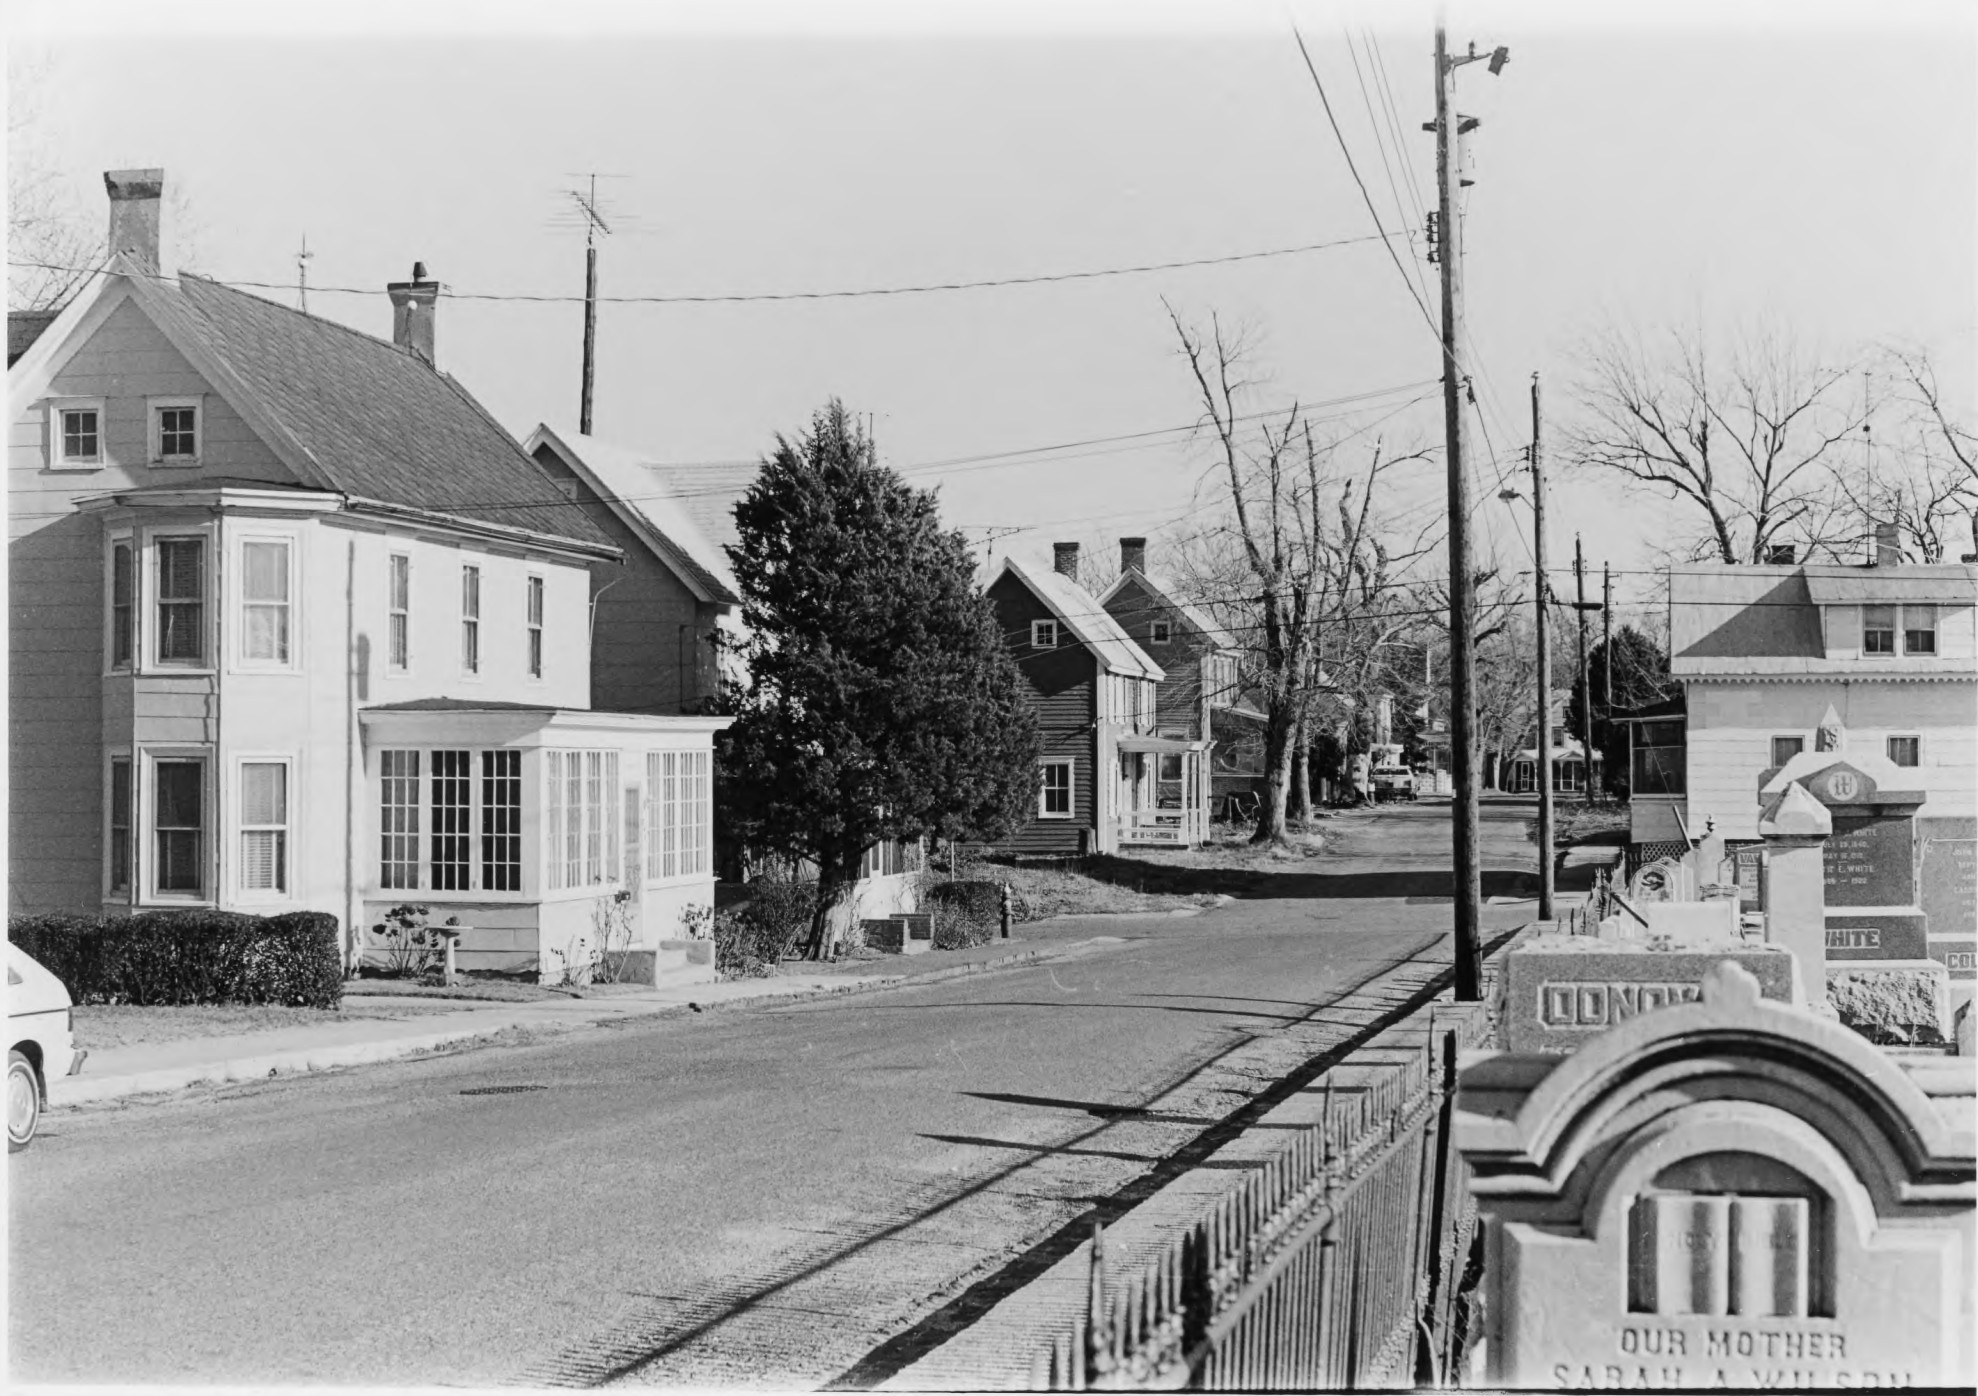
Photograph Number: 5 of 38

Name: Milton Historic District (streetscape E: east-northeast along Mill Street from site 135)

Description: view from west-southwest

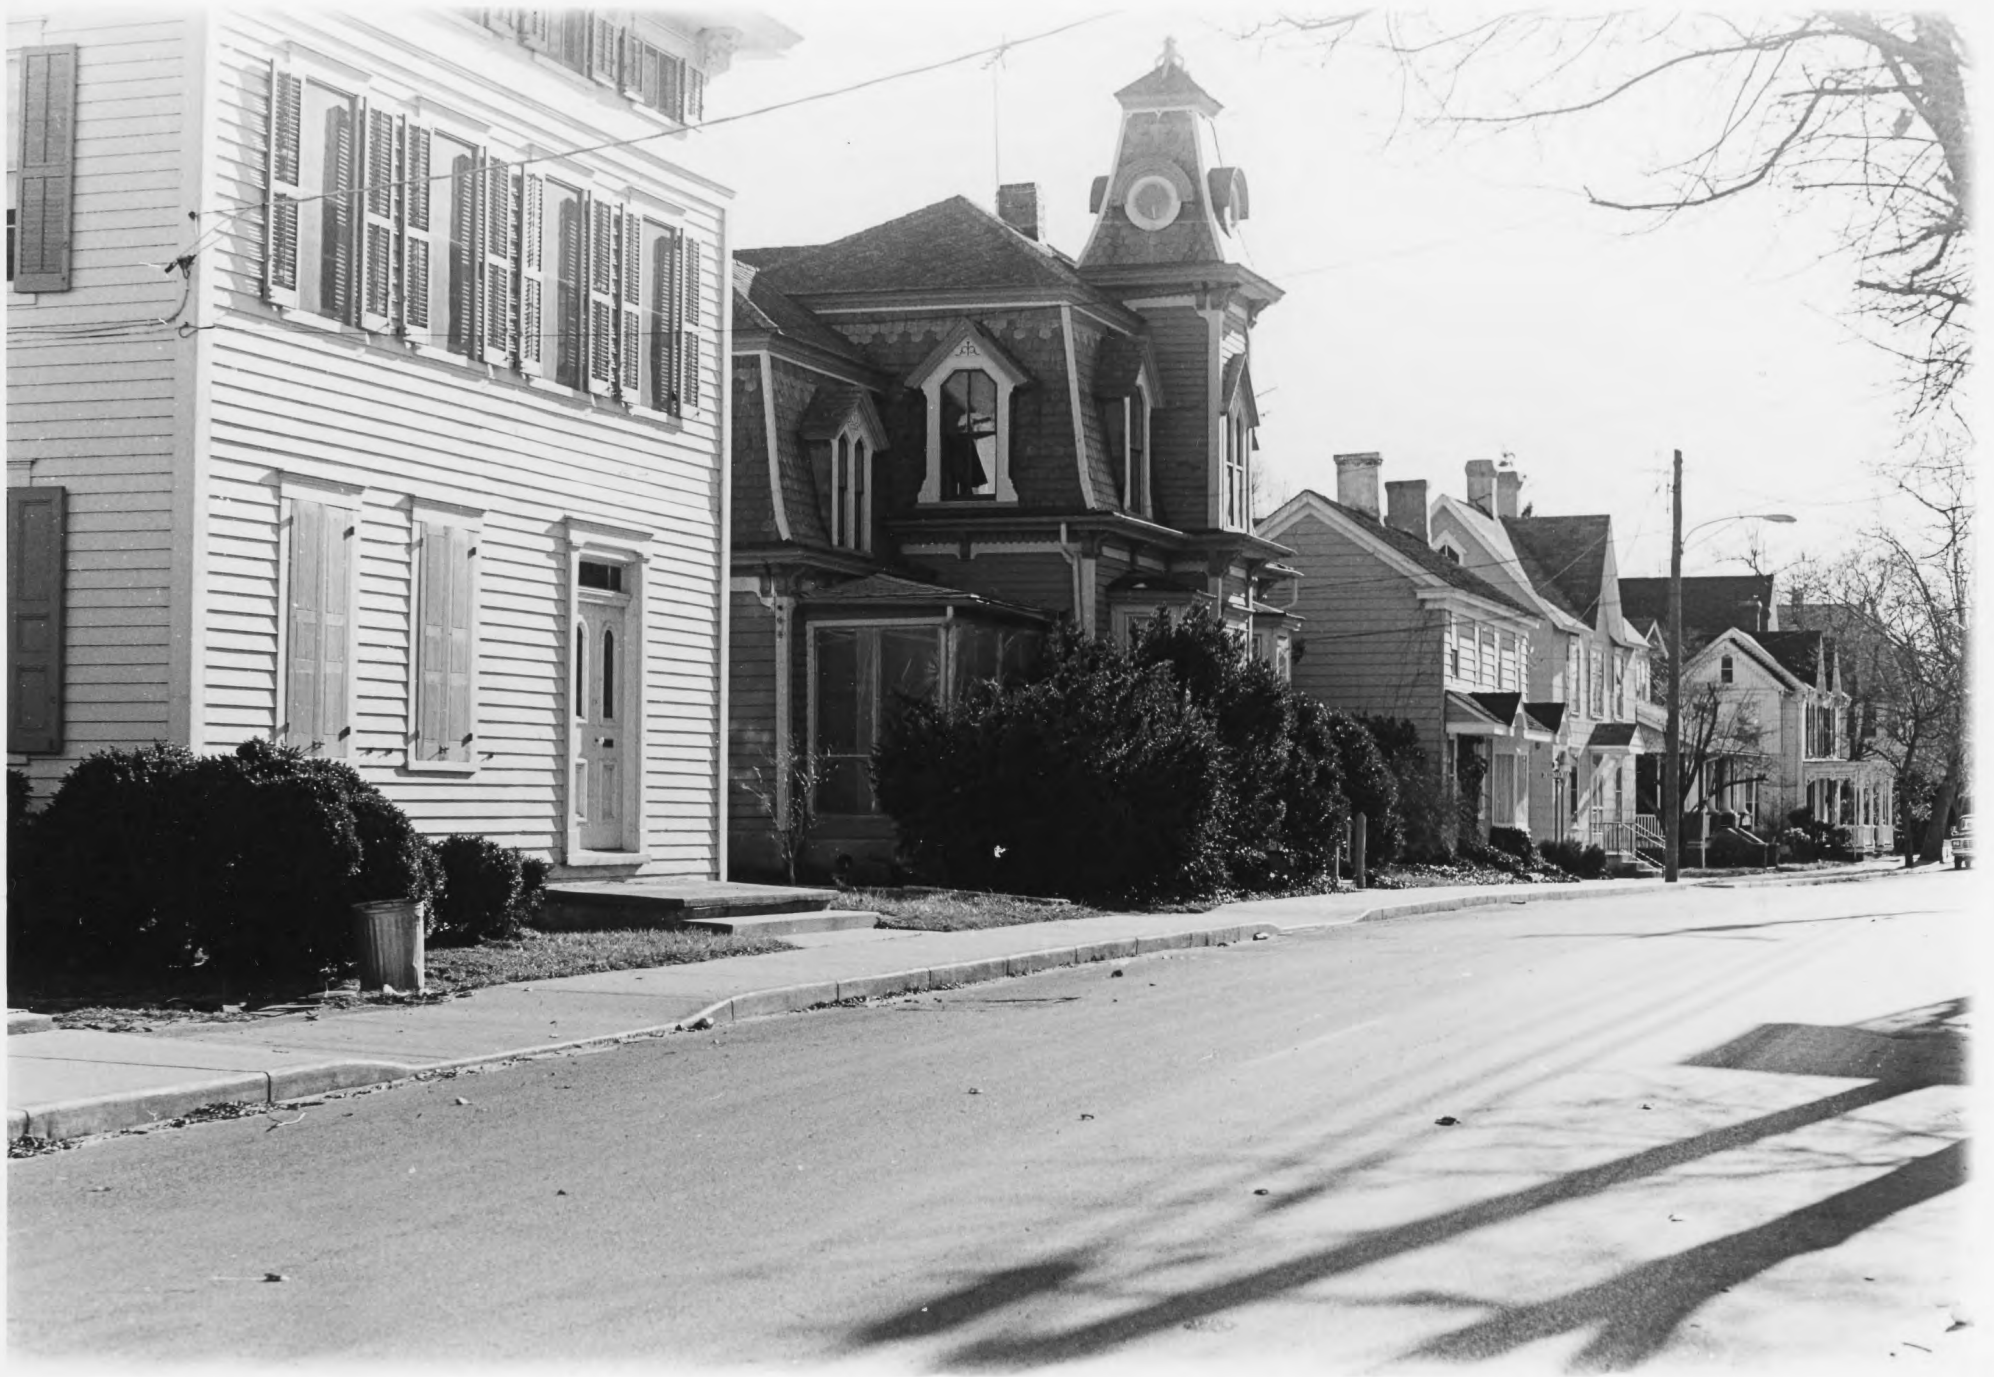
Photograph Number: 6 of 38

Name: Milton Historic District (streetscape F: east side of Federal Street, south-southeast across Coulter Street intersection; site #77 at extreme left)

Description: view from north-northeast

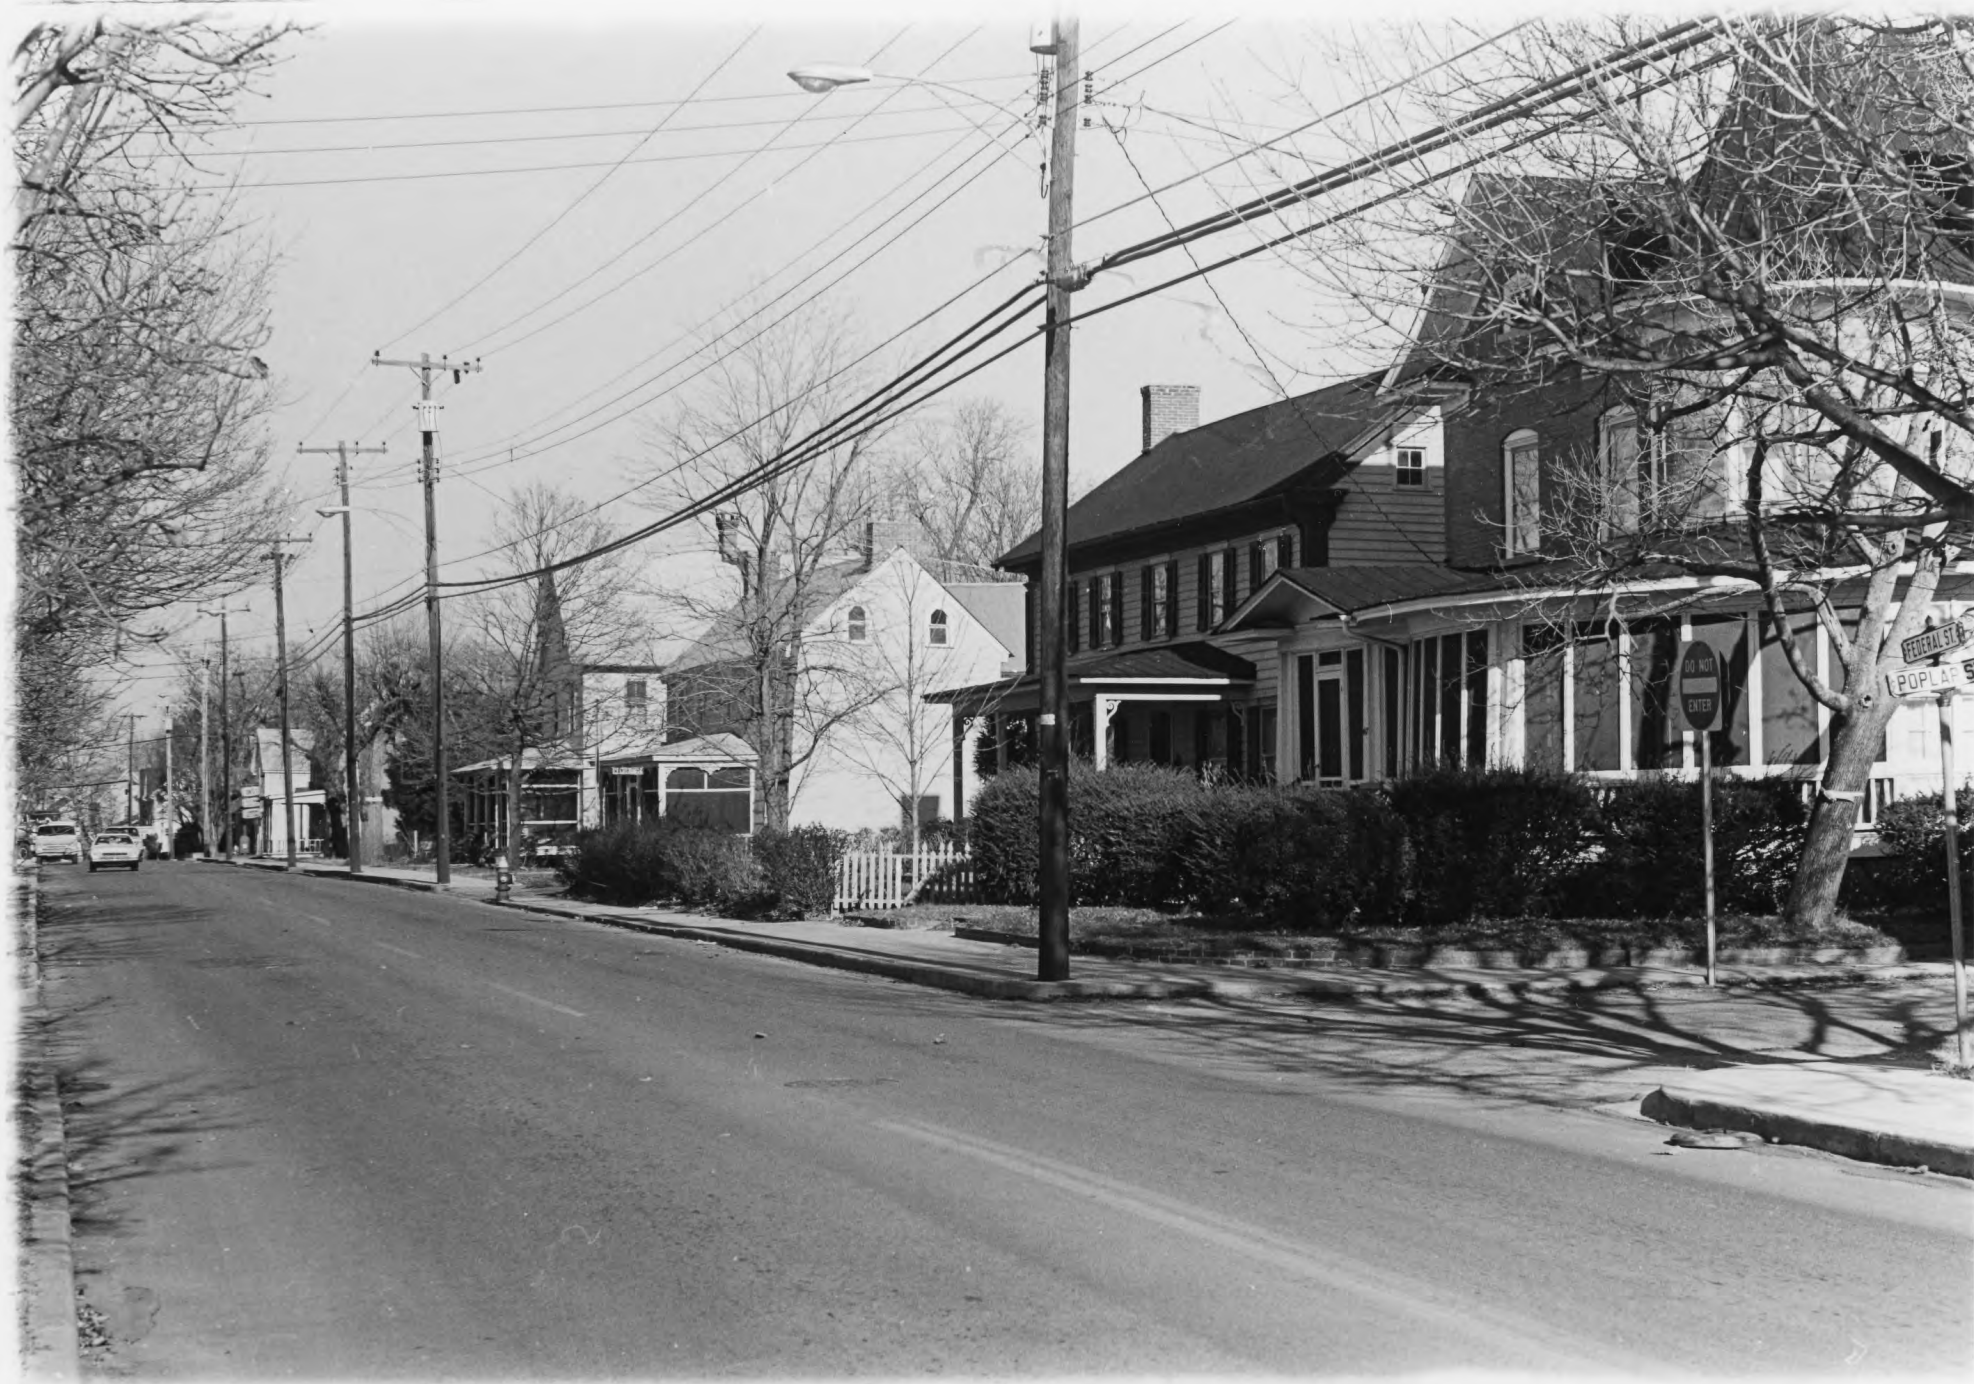
Name: Milton Historic District (streetscape G: east side of Federal Street, north-northeast from Poplar Street intersection; site #63 at extreme right)

63. 417 Federal Street. Ca. 1900. Large Queen Anne style, modified "T"-shape with base of "T" facing street. Turret at front southwest corner. Brick construction. Pedimented entry porch with circular porch extending around turret and leading to side porch. Curved Queen Anne balusters on porch railings. Porch columns on brick pedestals. Soffited cornice with frieze, partial returns roofed, flared eaves. Segmentally-arched window and door openings. Large stained glass window in northeast gable end. Horizontal two-light casements in gable ends, segmentally arched. Two sheds, garage and privy in rear contemporary with house. Structure now vacant.

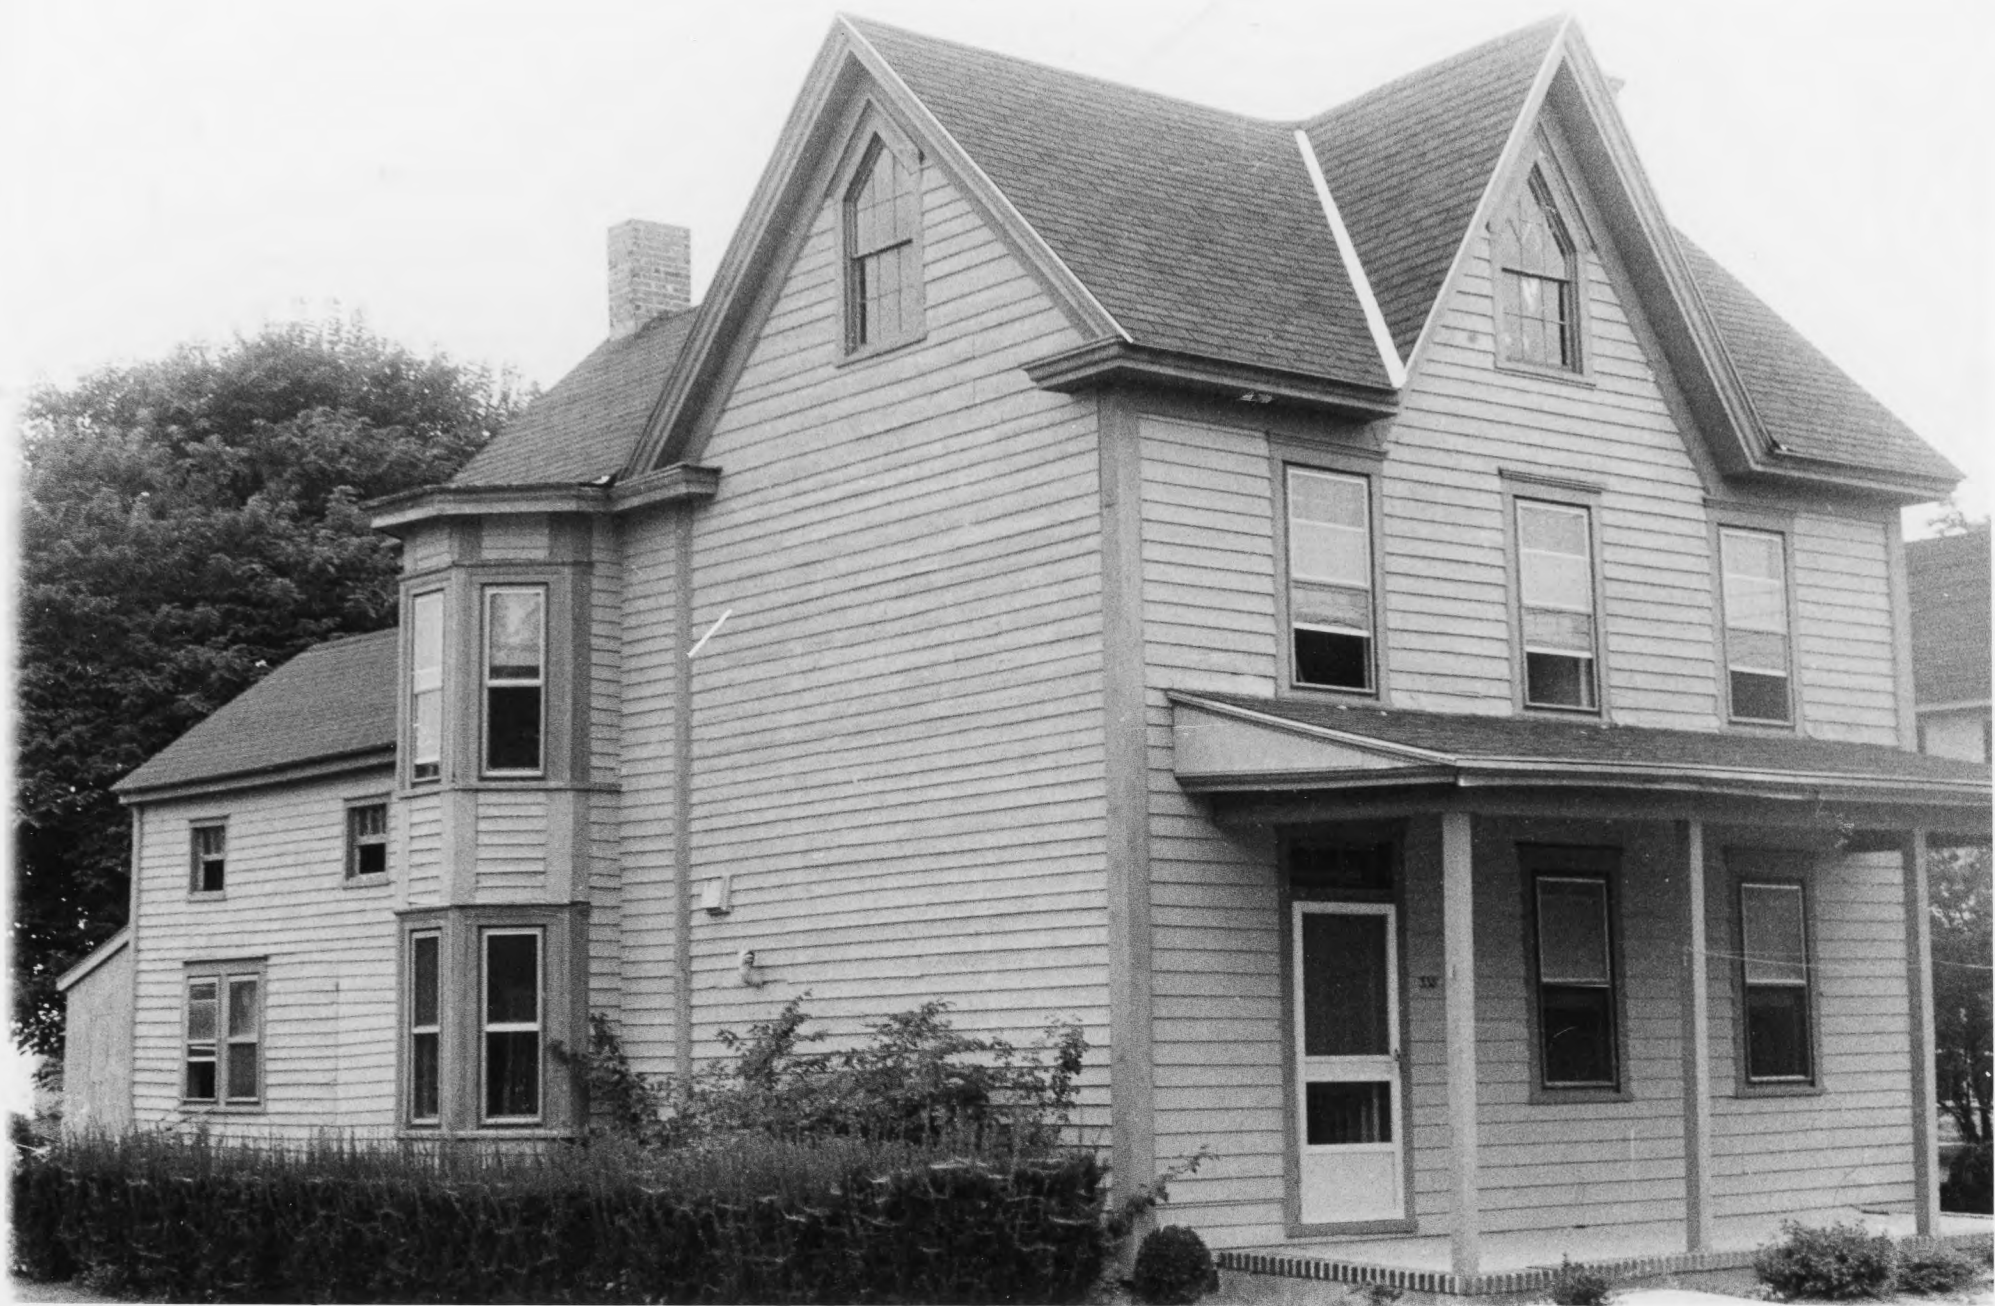
Photograph Number: 8 of 38

Name: Milton Historic District (Clendaniel house, site
#9)

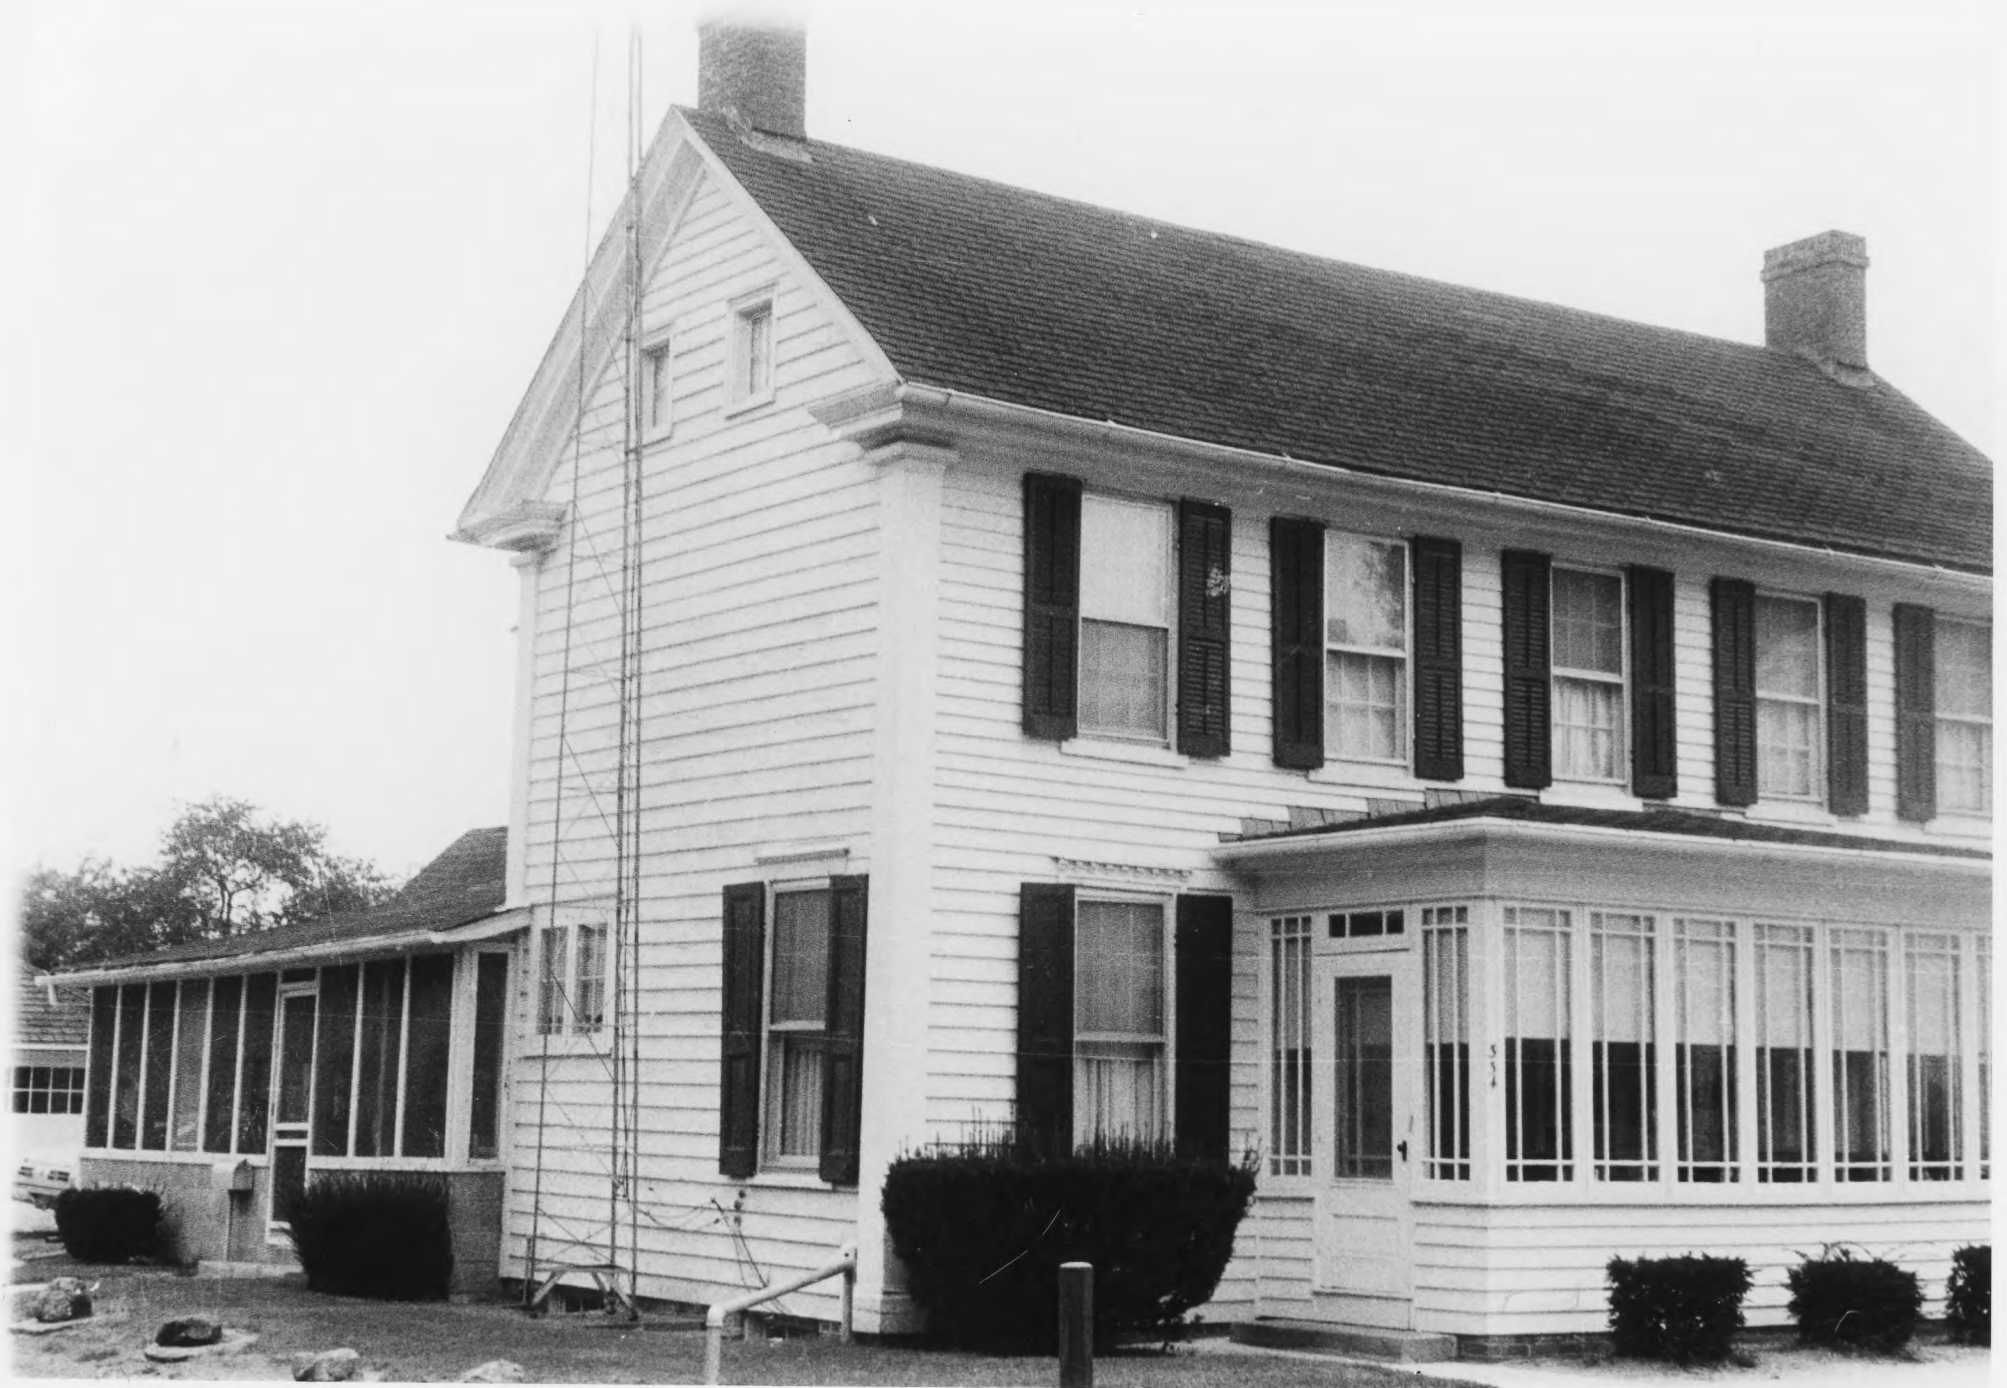
Photograph Number: 10 of 38

Name: Milton Historic District (Lingo house, site
site #10)

Description: view from northeast
