**National Register of Historic Places
Inventory—Nomination Form**

historic Milton Historic District

Milton

Delaware

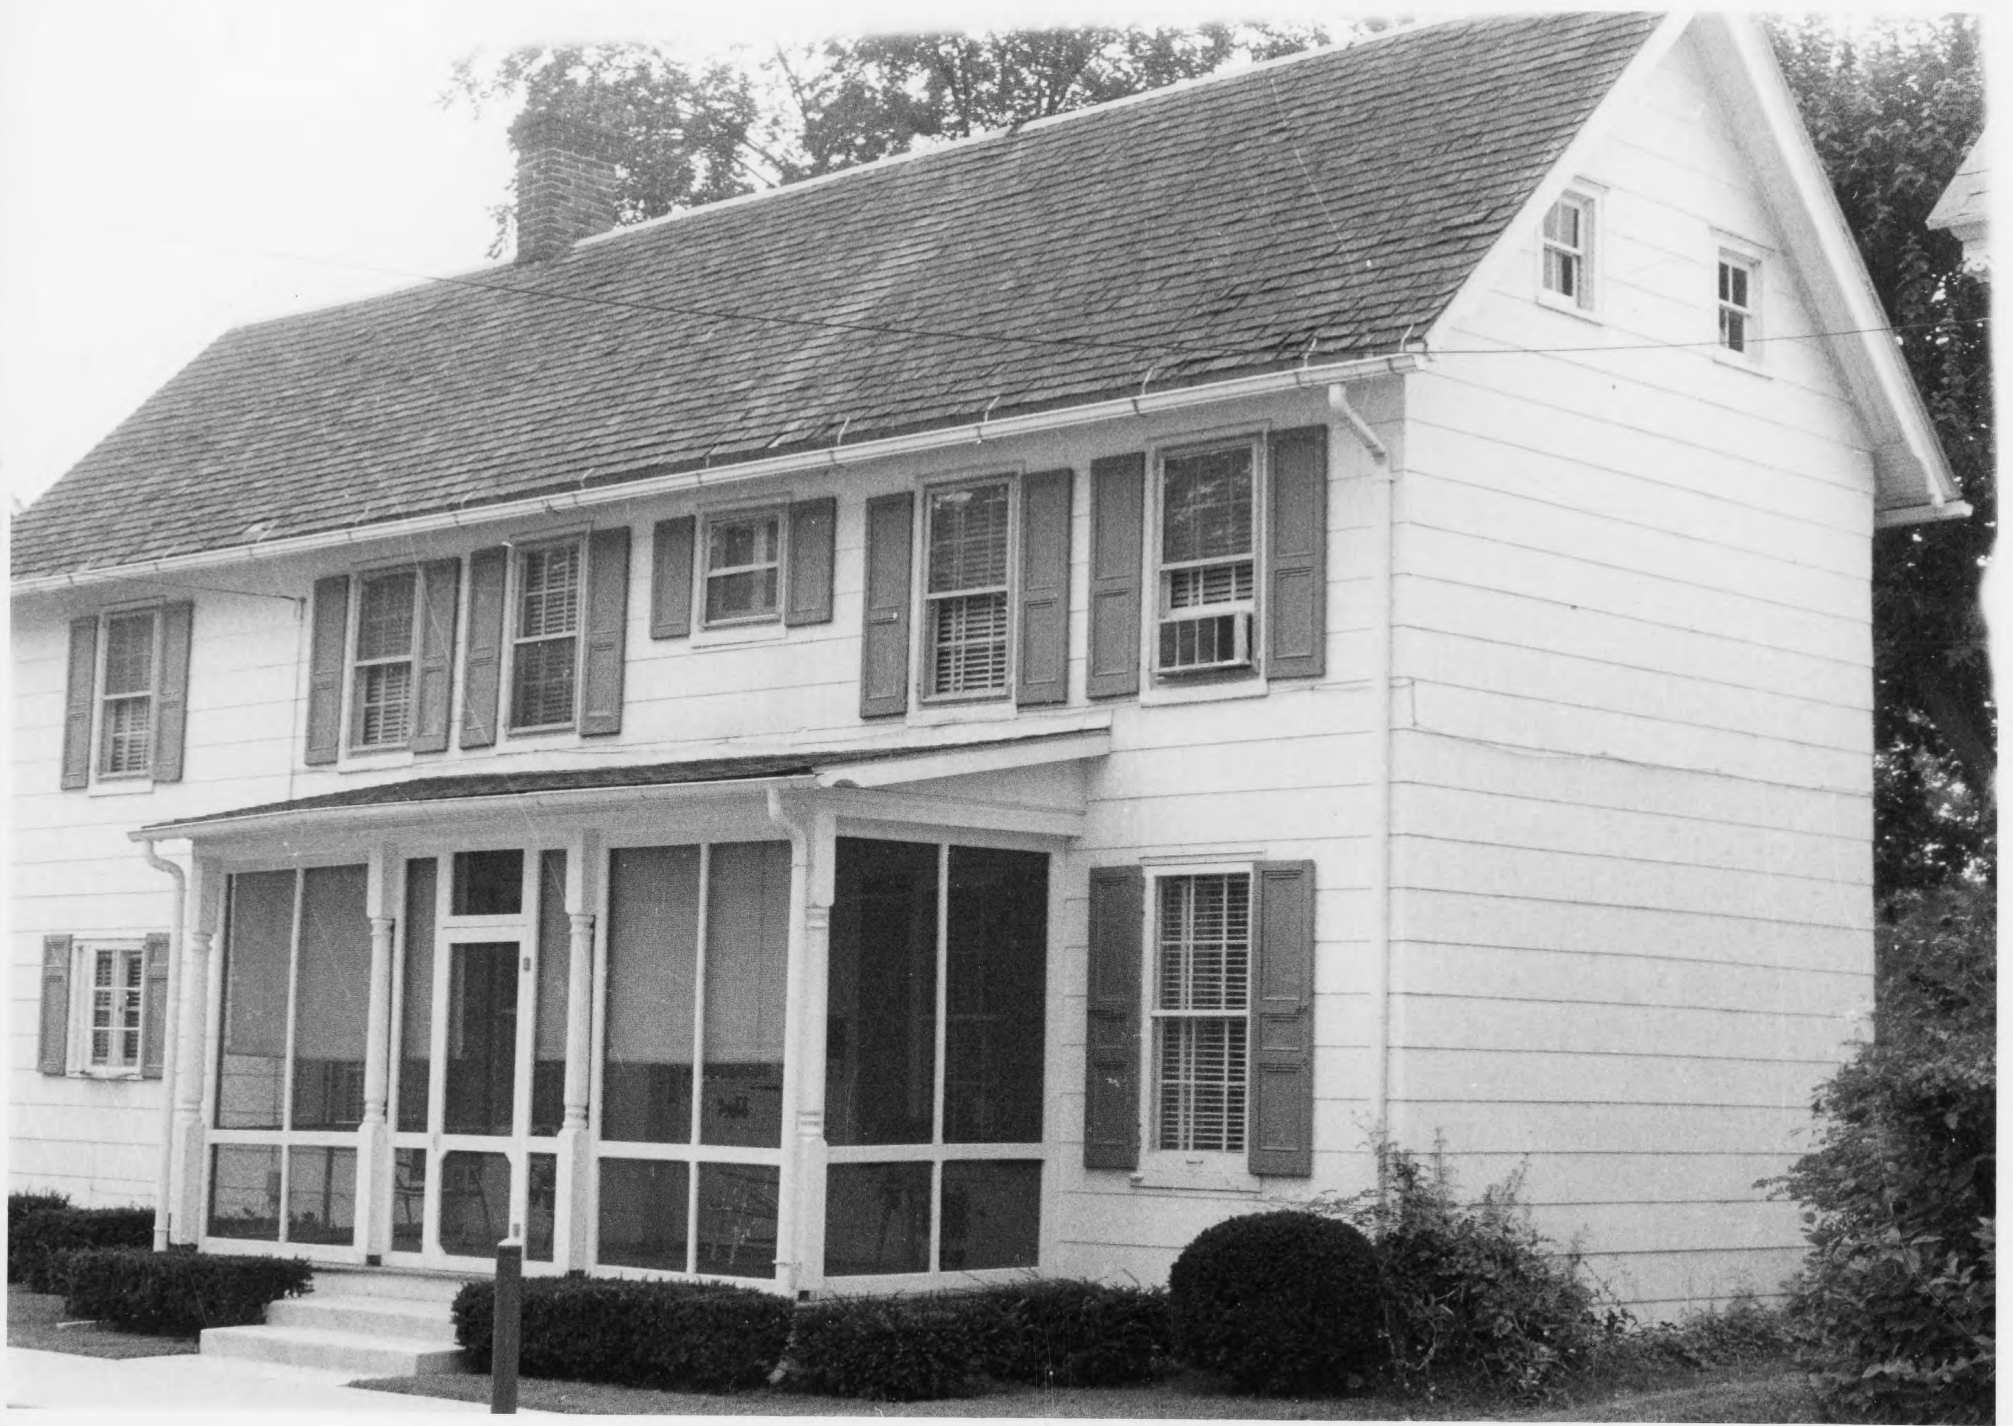
Photograph Number: 10 of 38

Name: Milton Historic District (Joseph Betts house,
site #14)

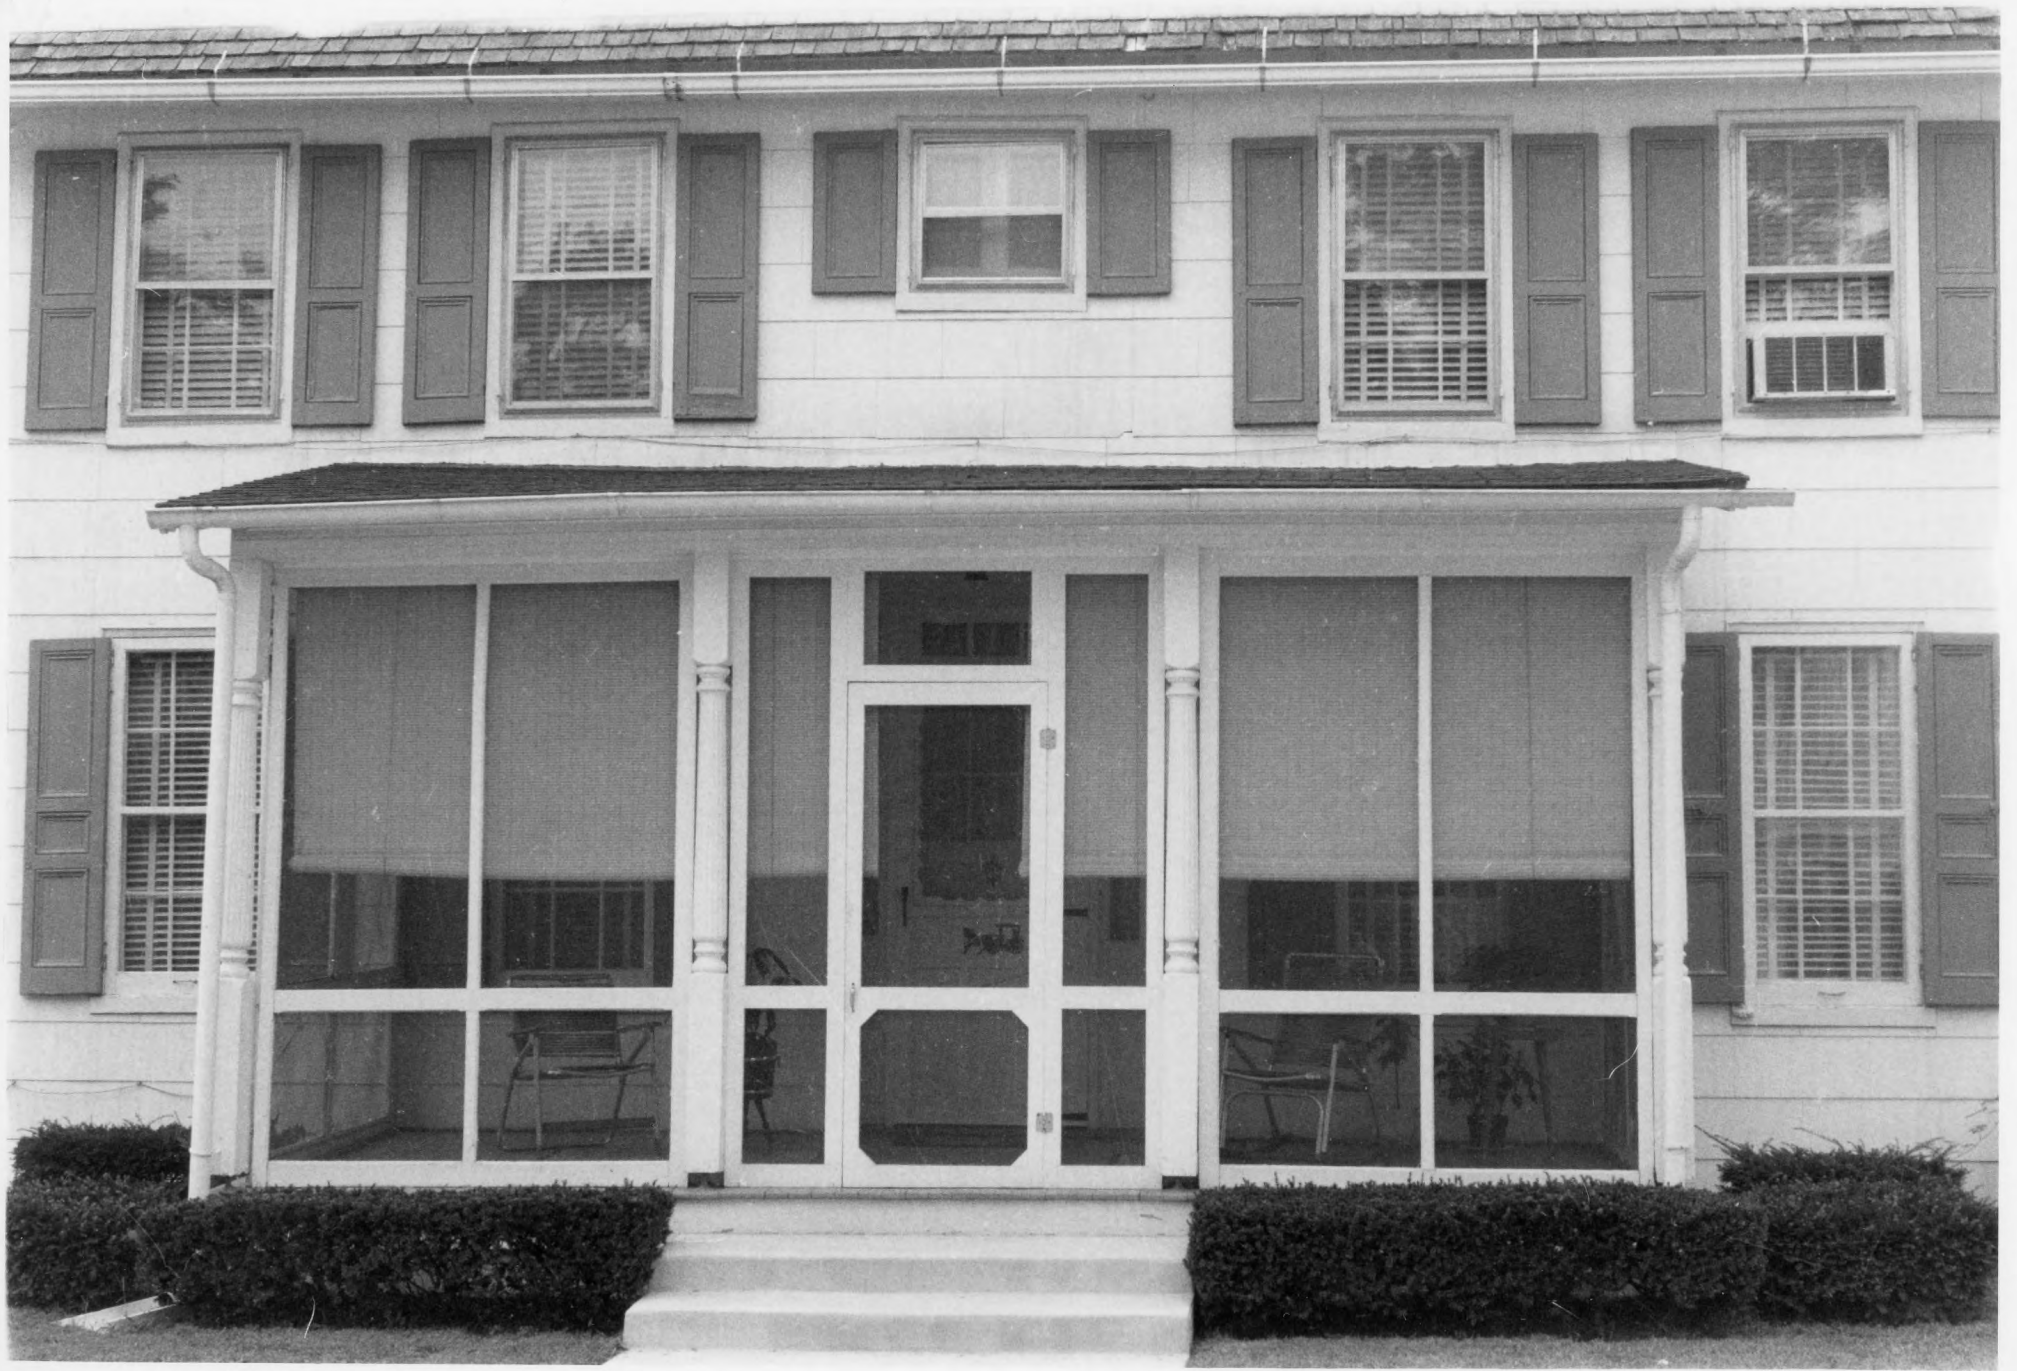
Photograph Number: 11 of 38

Name: Milton Historic District (Betts house, site #14)

Description: detail view from east-northeast

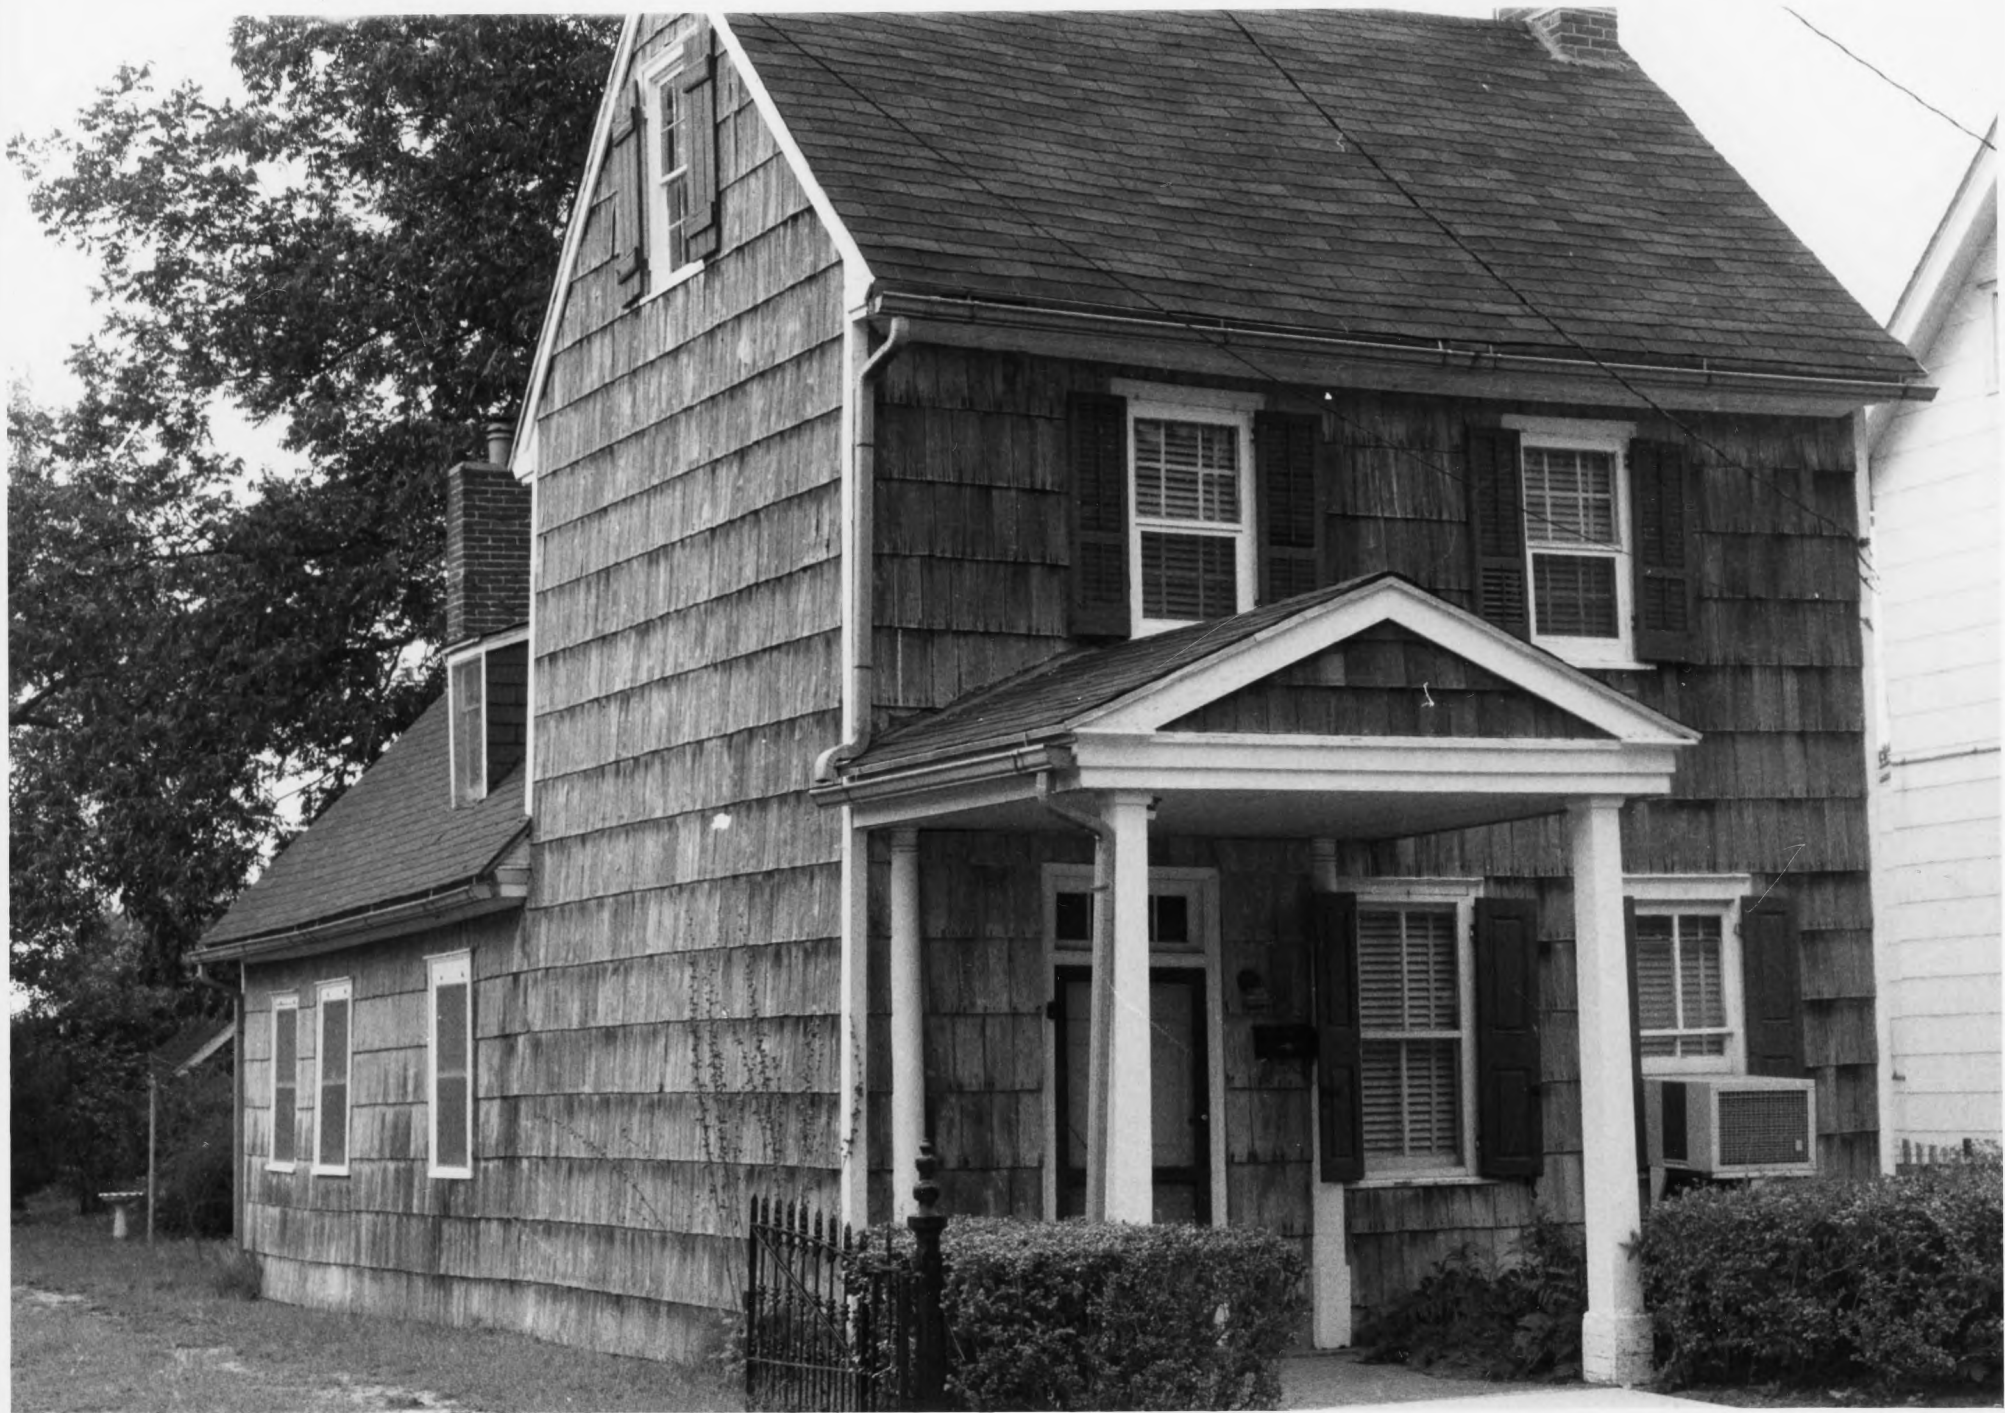
Photograph Number: 12 of 38

Name: Milton Historic District (Capt. Russell house,
site #15)

Description: view from west

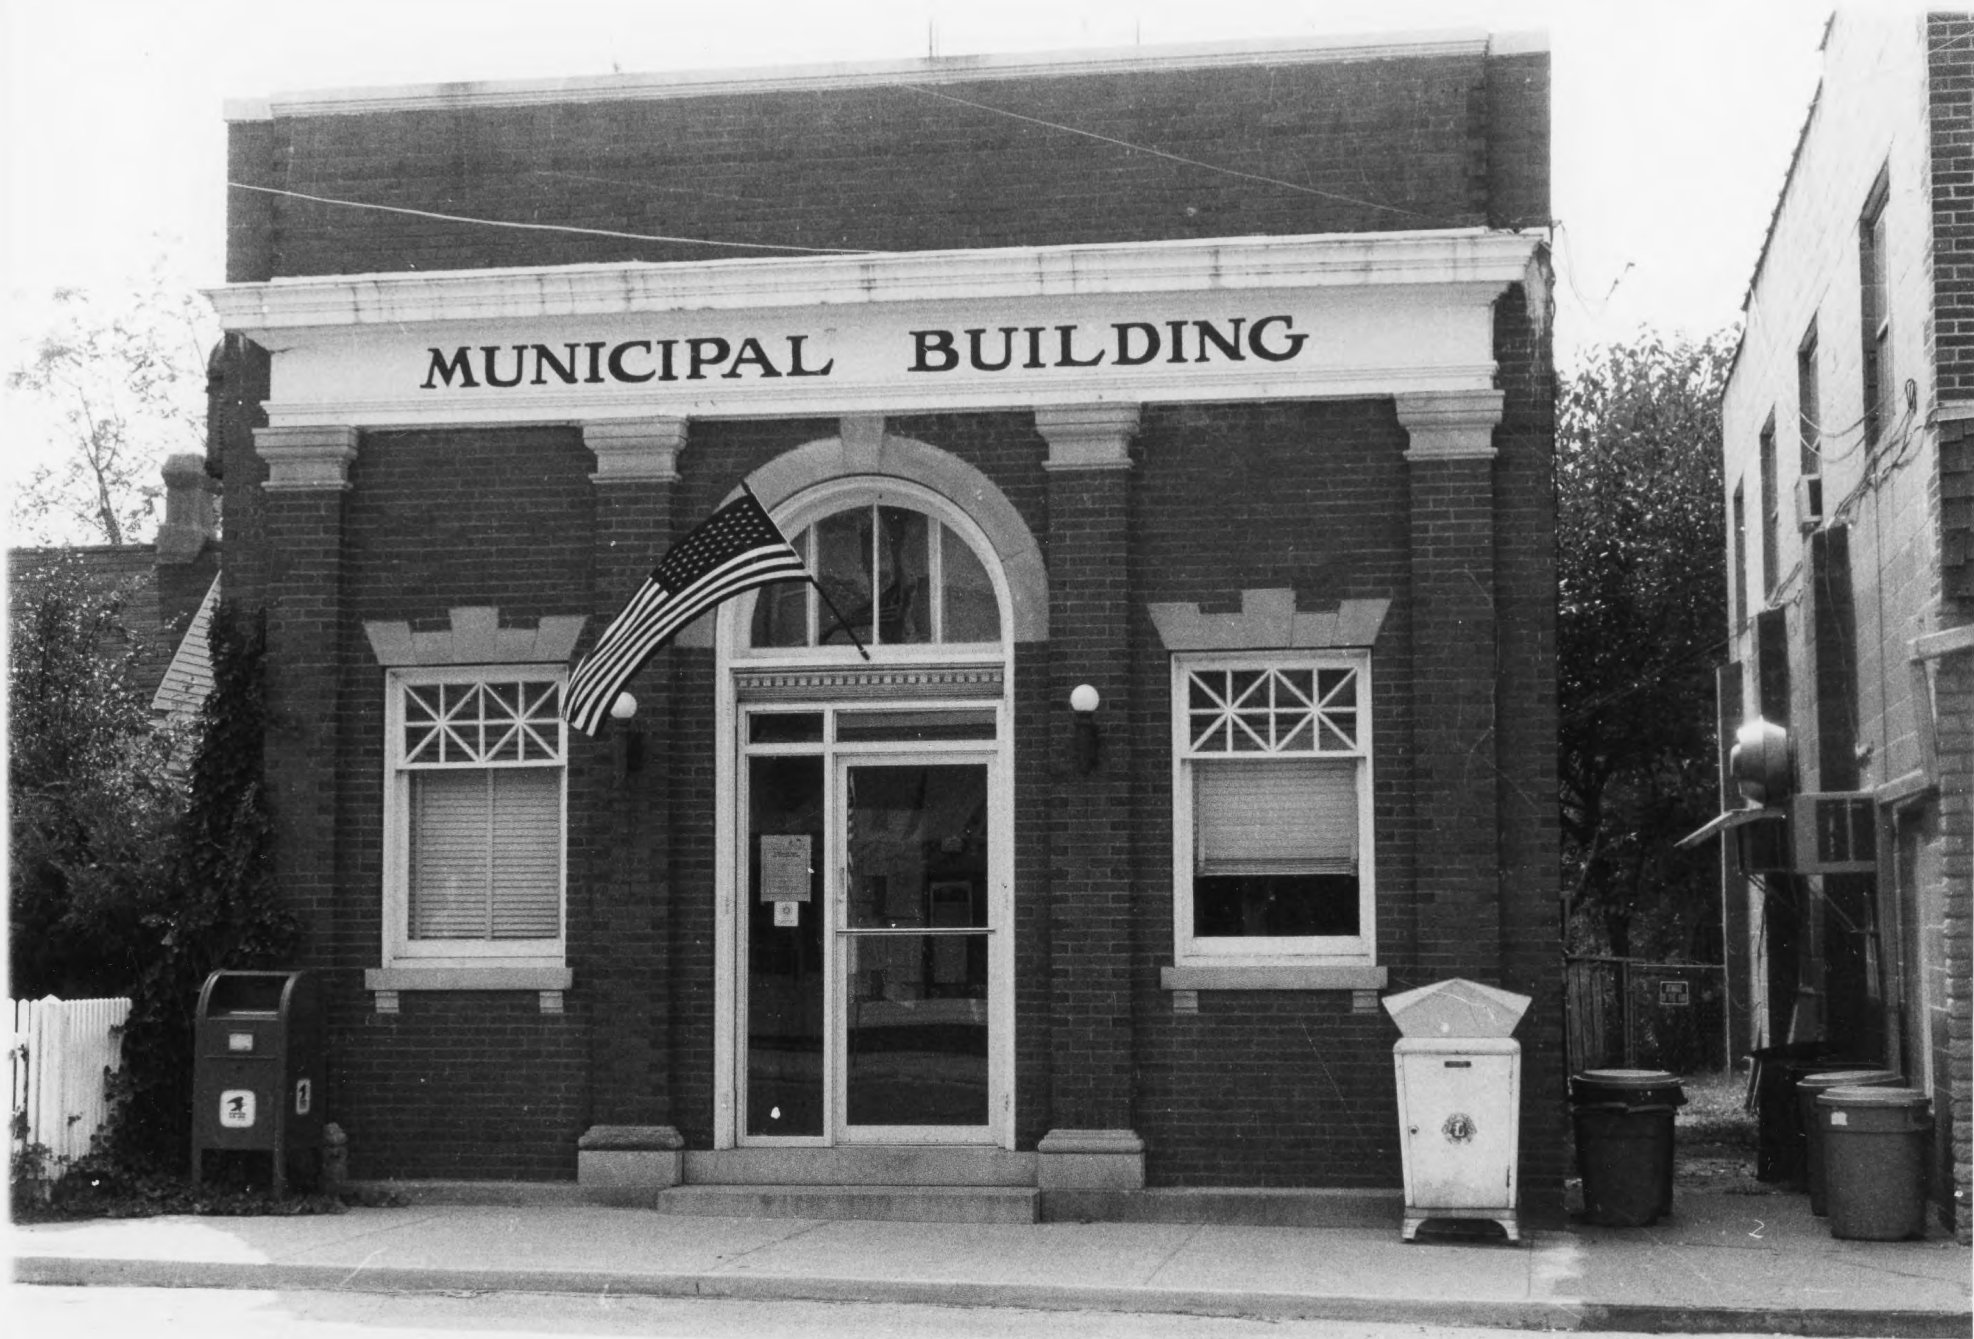
Photograph Number: 15 of 38

Name: Milton Historic District (Municipal Building,
site #31)

Description: view from northeast

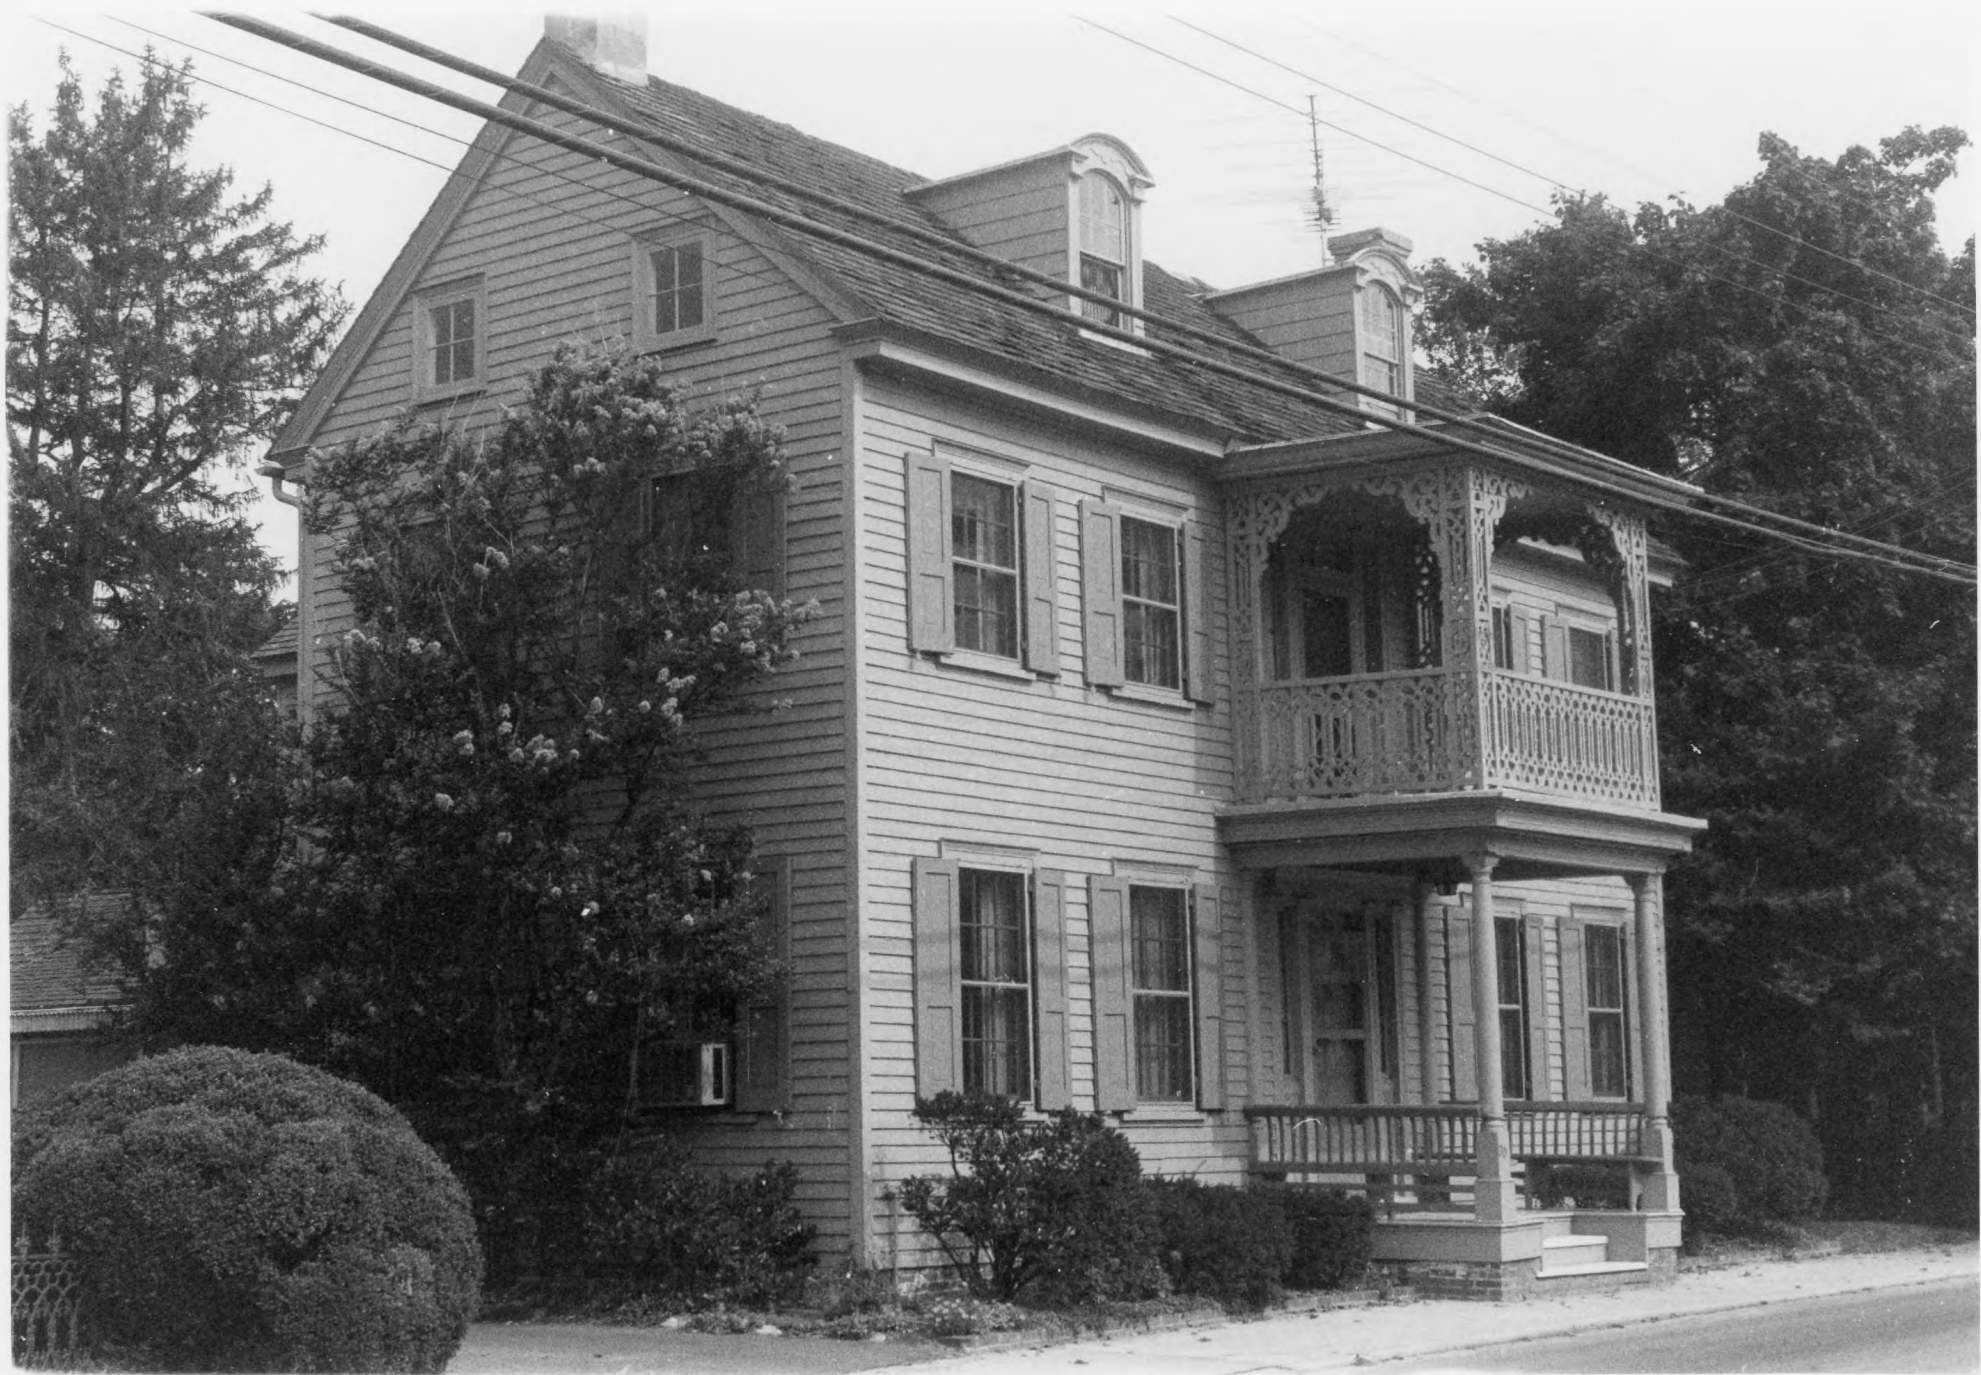
Photograph Number: 17 of 38

Name: Milton Historic District (Draper-Atkins house,
site #39)

→ The area along Federal Street between Mill Street and the Mulberry Street intersection contains many of the town's finest mid-to-late nineteenth century homes. The Draper-Atkins House at 206 Federal Street (No. 39 in the inventory) is earlier, dating from the Federal period. As previously noted it is one of three structures in town already listed in the National Register. Next door at 208 Federal Street is a modern, non-conforming one-story home built in 1957. At 308 Federal Street (No. 44 in the inventory) is one of the town's better examples of Victorian Gothic architecture. This house incorporates double cross gables, a motif which appeared on several Milton homes of this period.

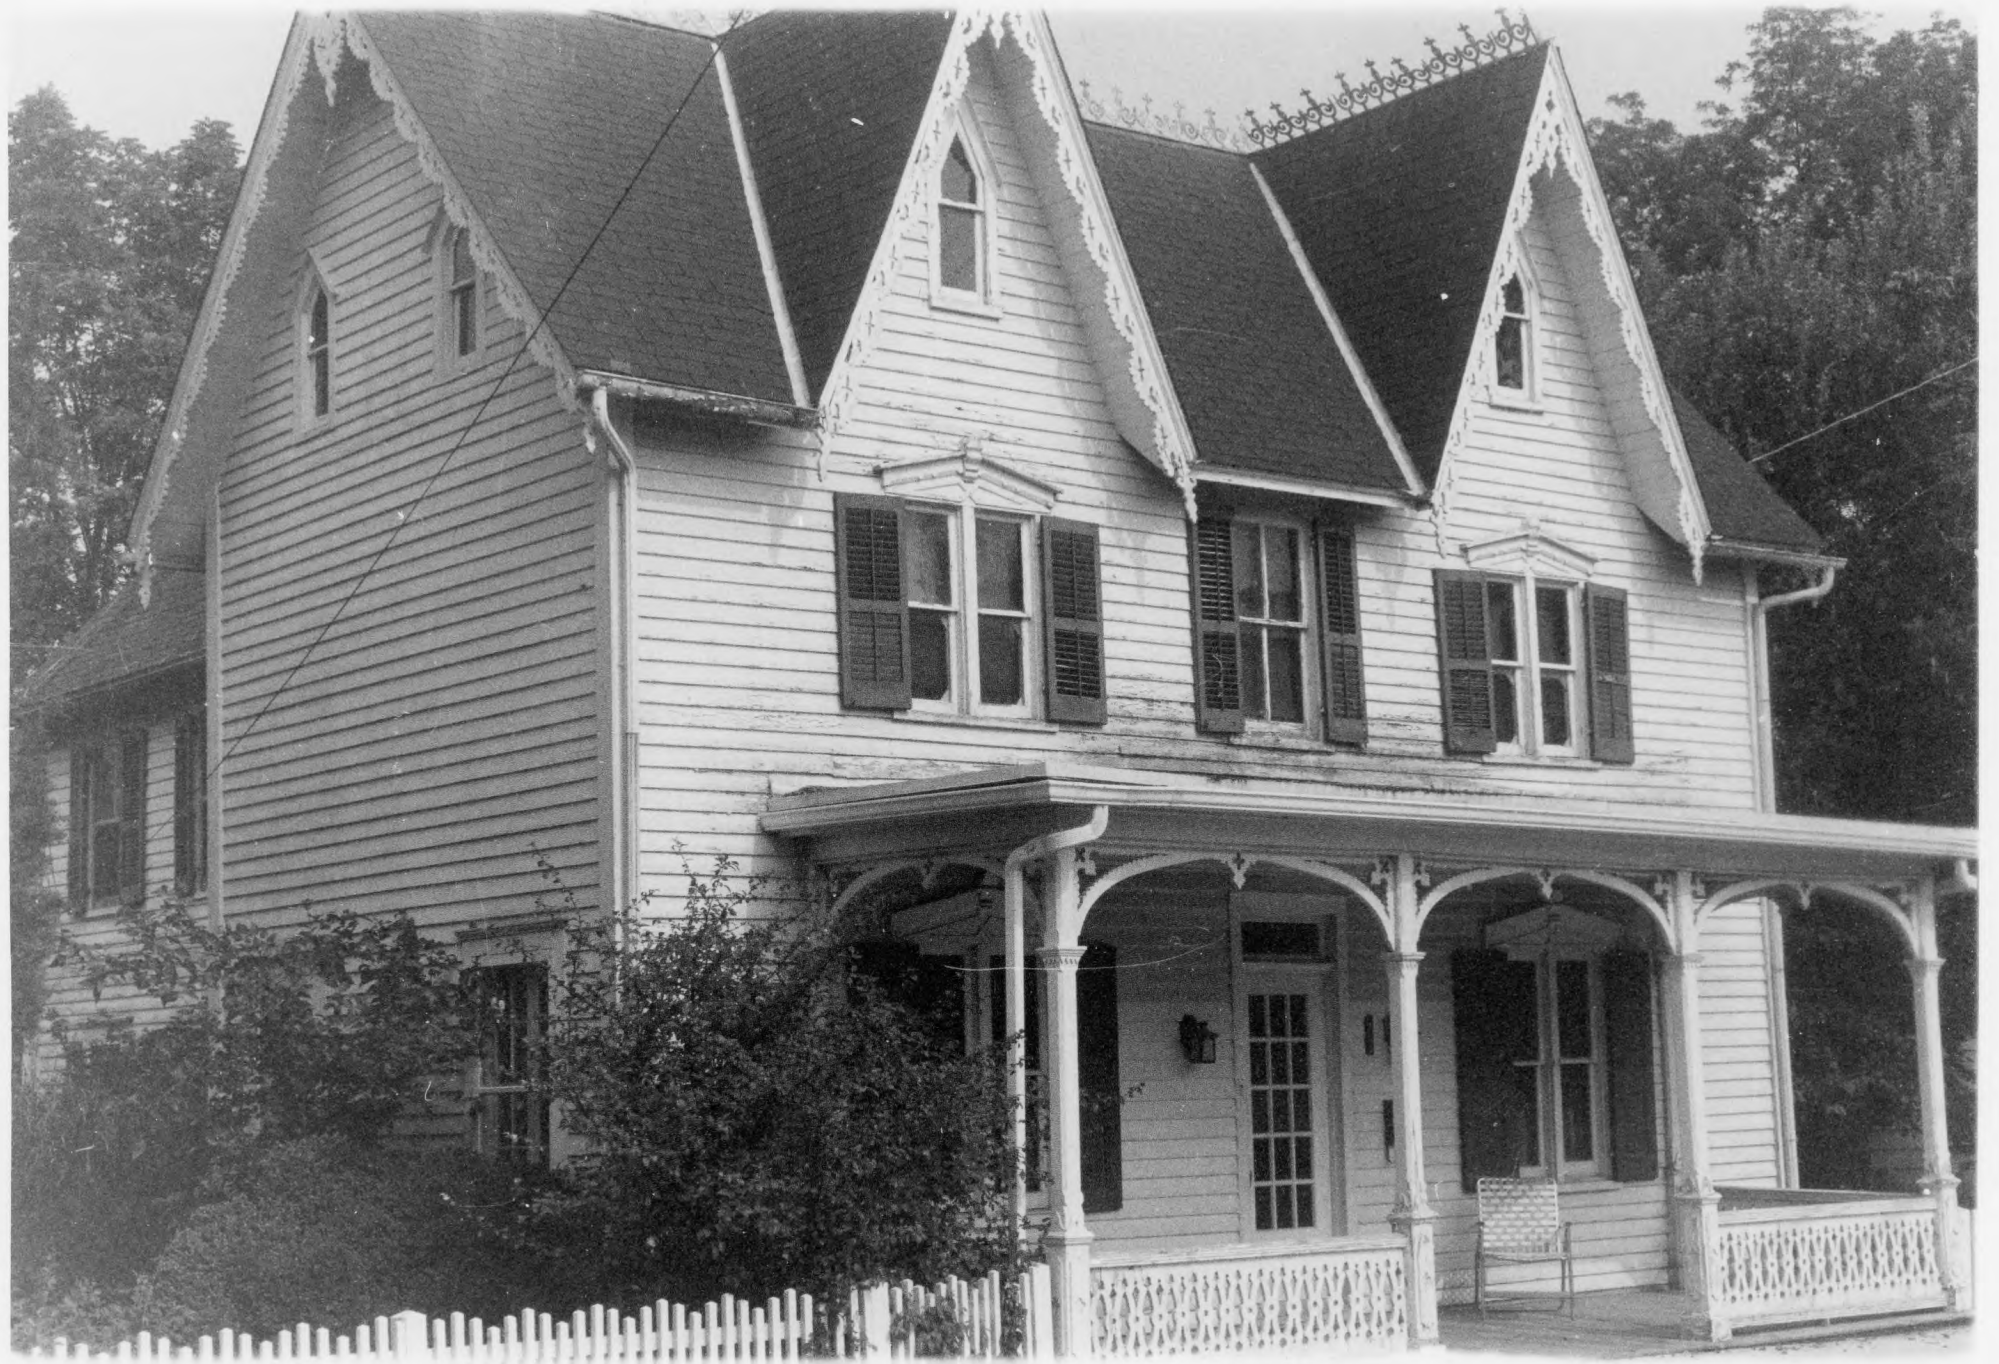
Photograph Number: 18 of 38

Name: Milton Historic District (Ca. 1875 house, site #44)

Description: view from southeast

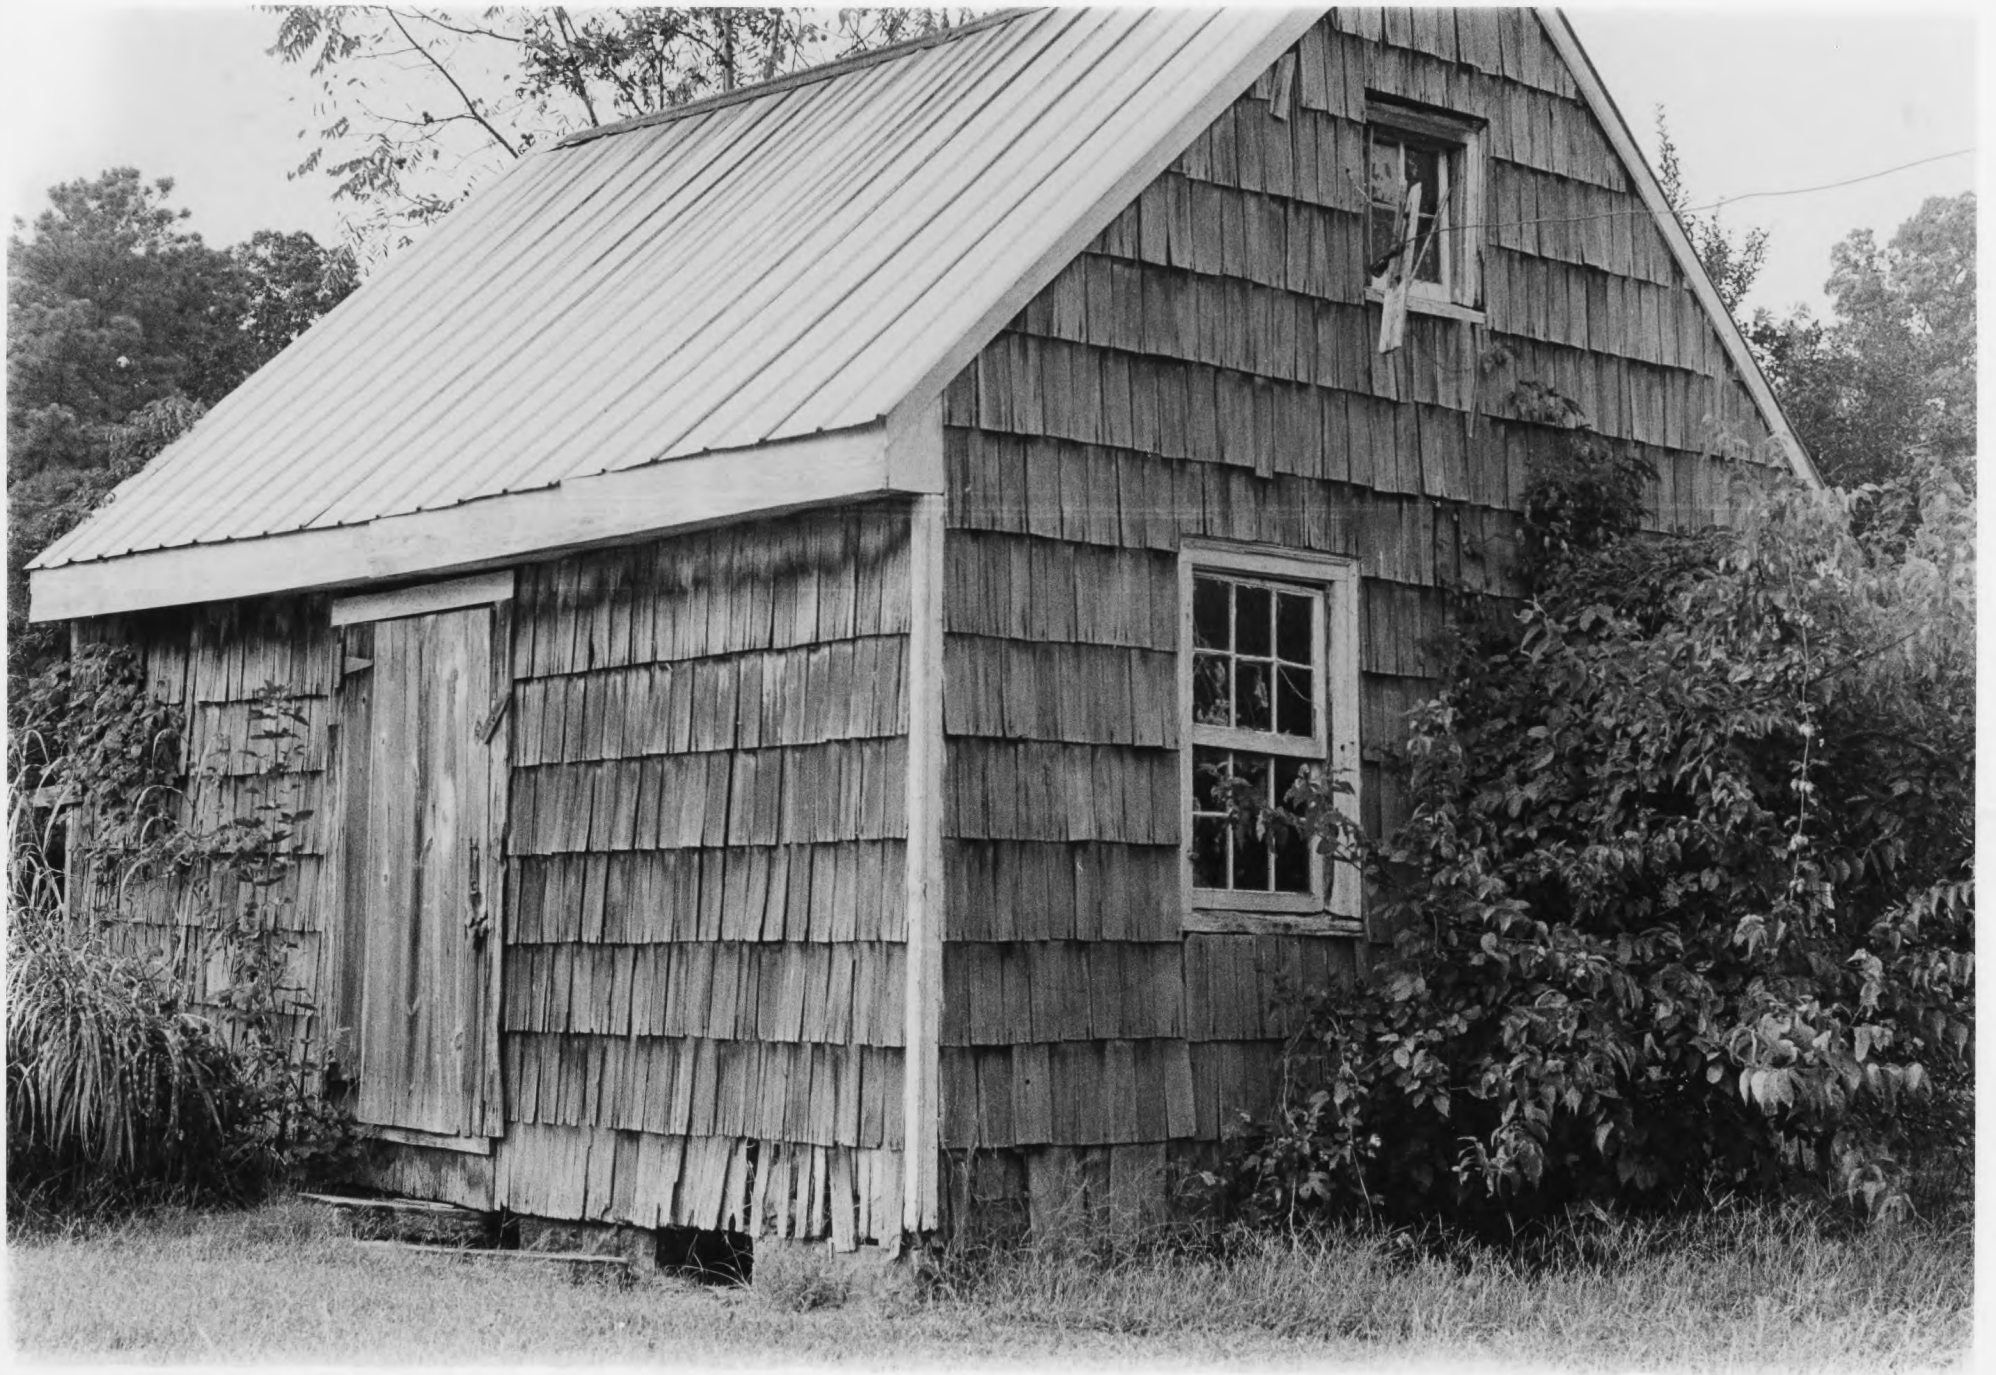
Photograph Number: 19 of 38

Name: Milton Historic District (Gov. Hazzard office)
site #52)

Description: view from south-southeast

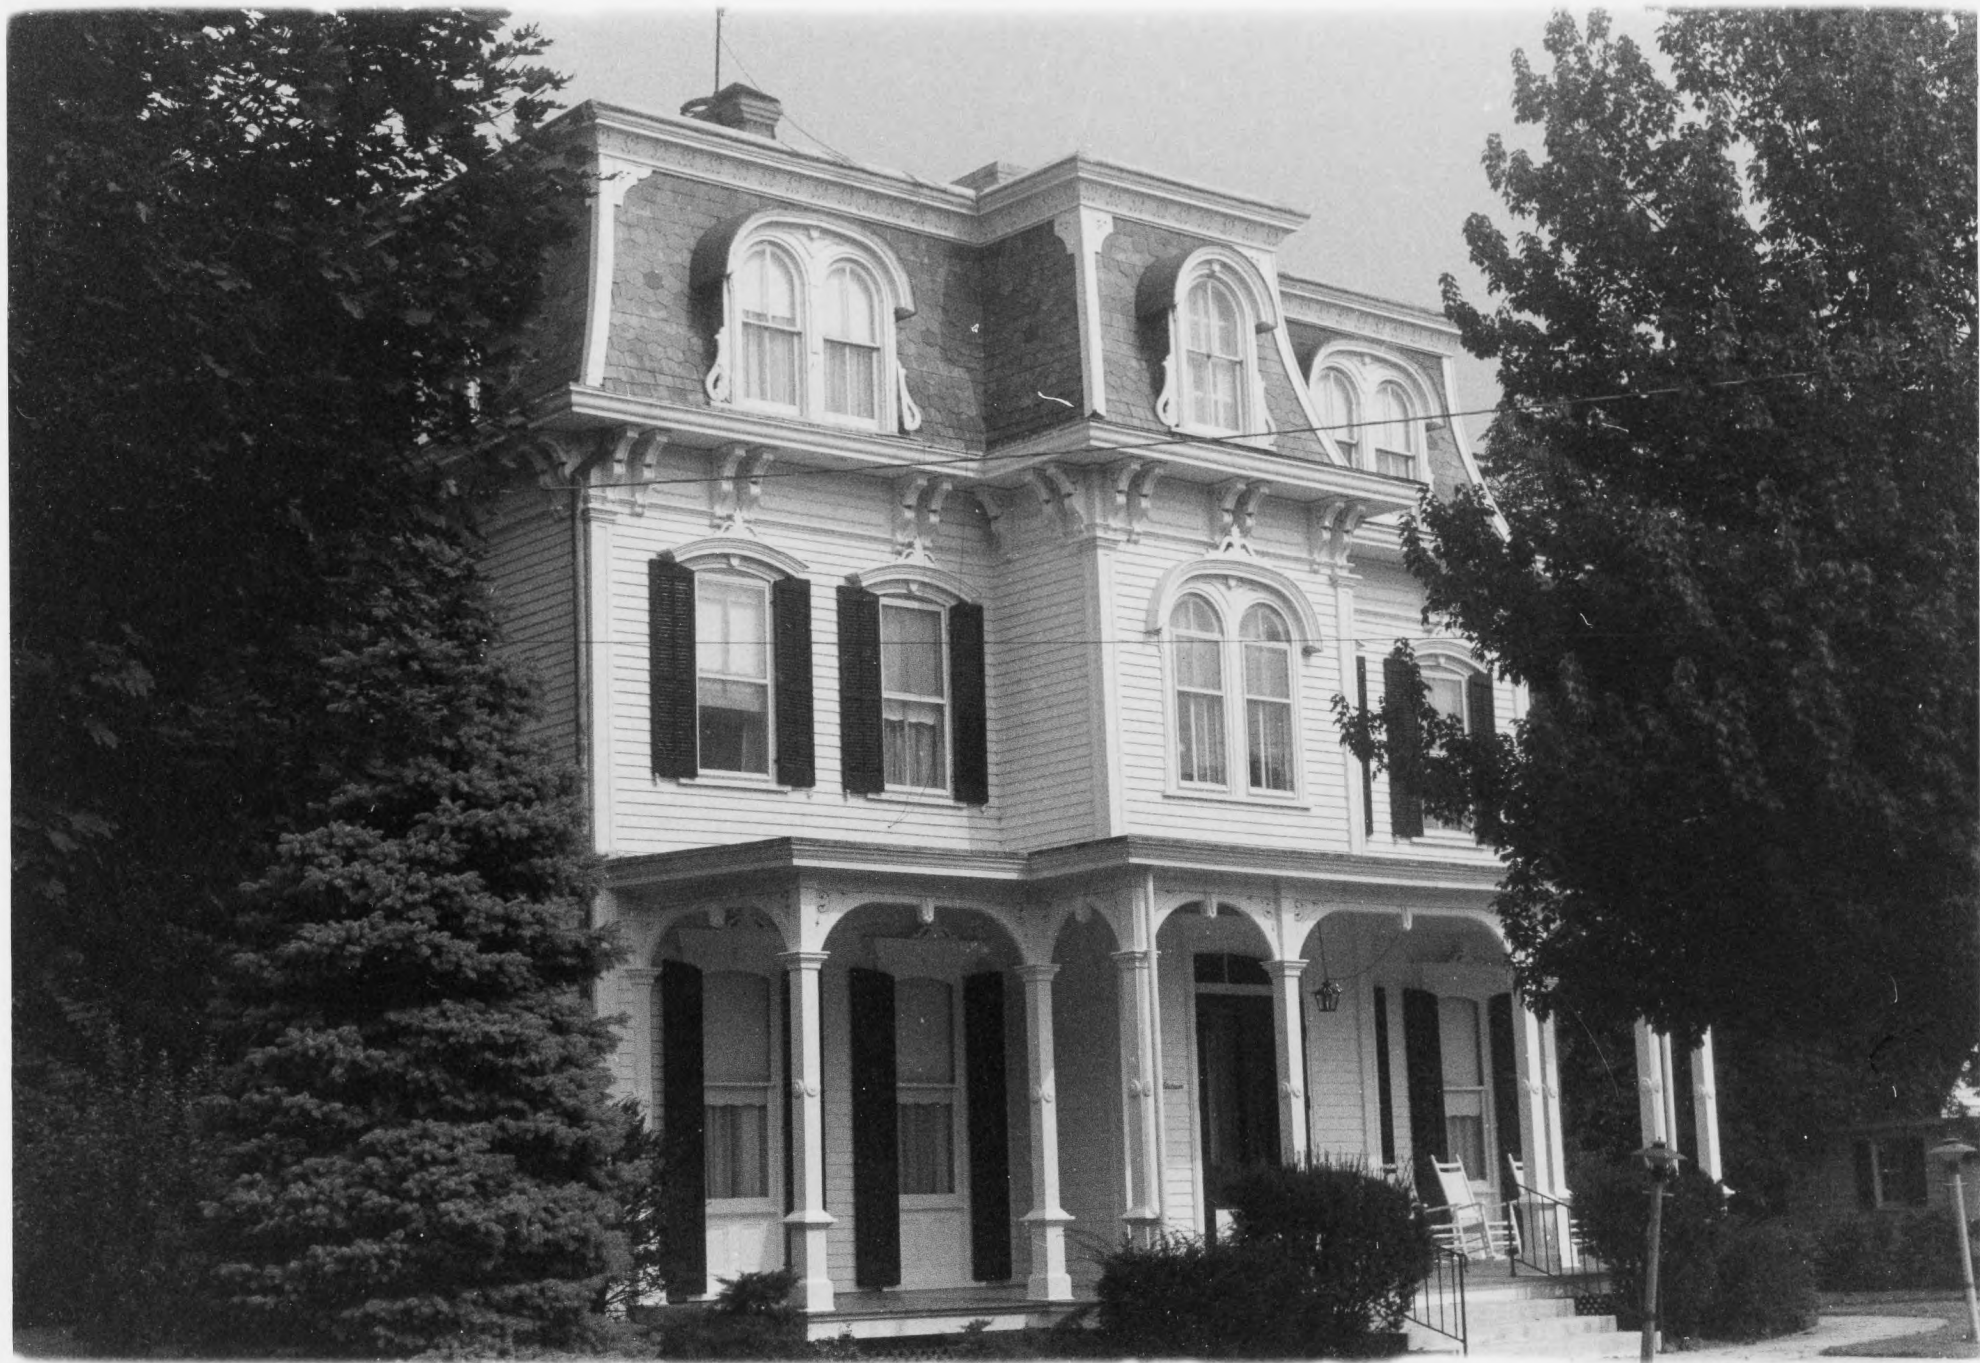
Photograph Number: 20 of 38

Name: Milton Historic District (Gov. Ponder mansion,
site #54)

Description: view from southeast
