**National Register of Historic Places
Inventory—Nomination Form**

historic Milton Historic District

Milton

Delaware

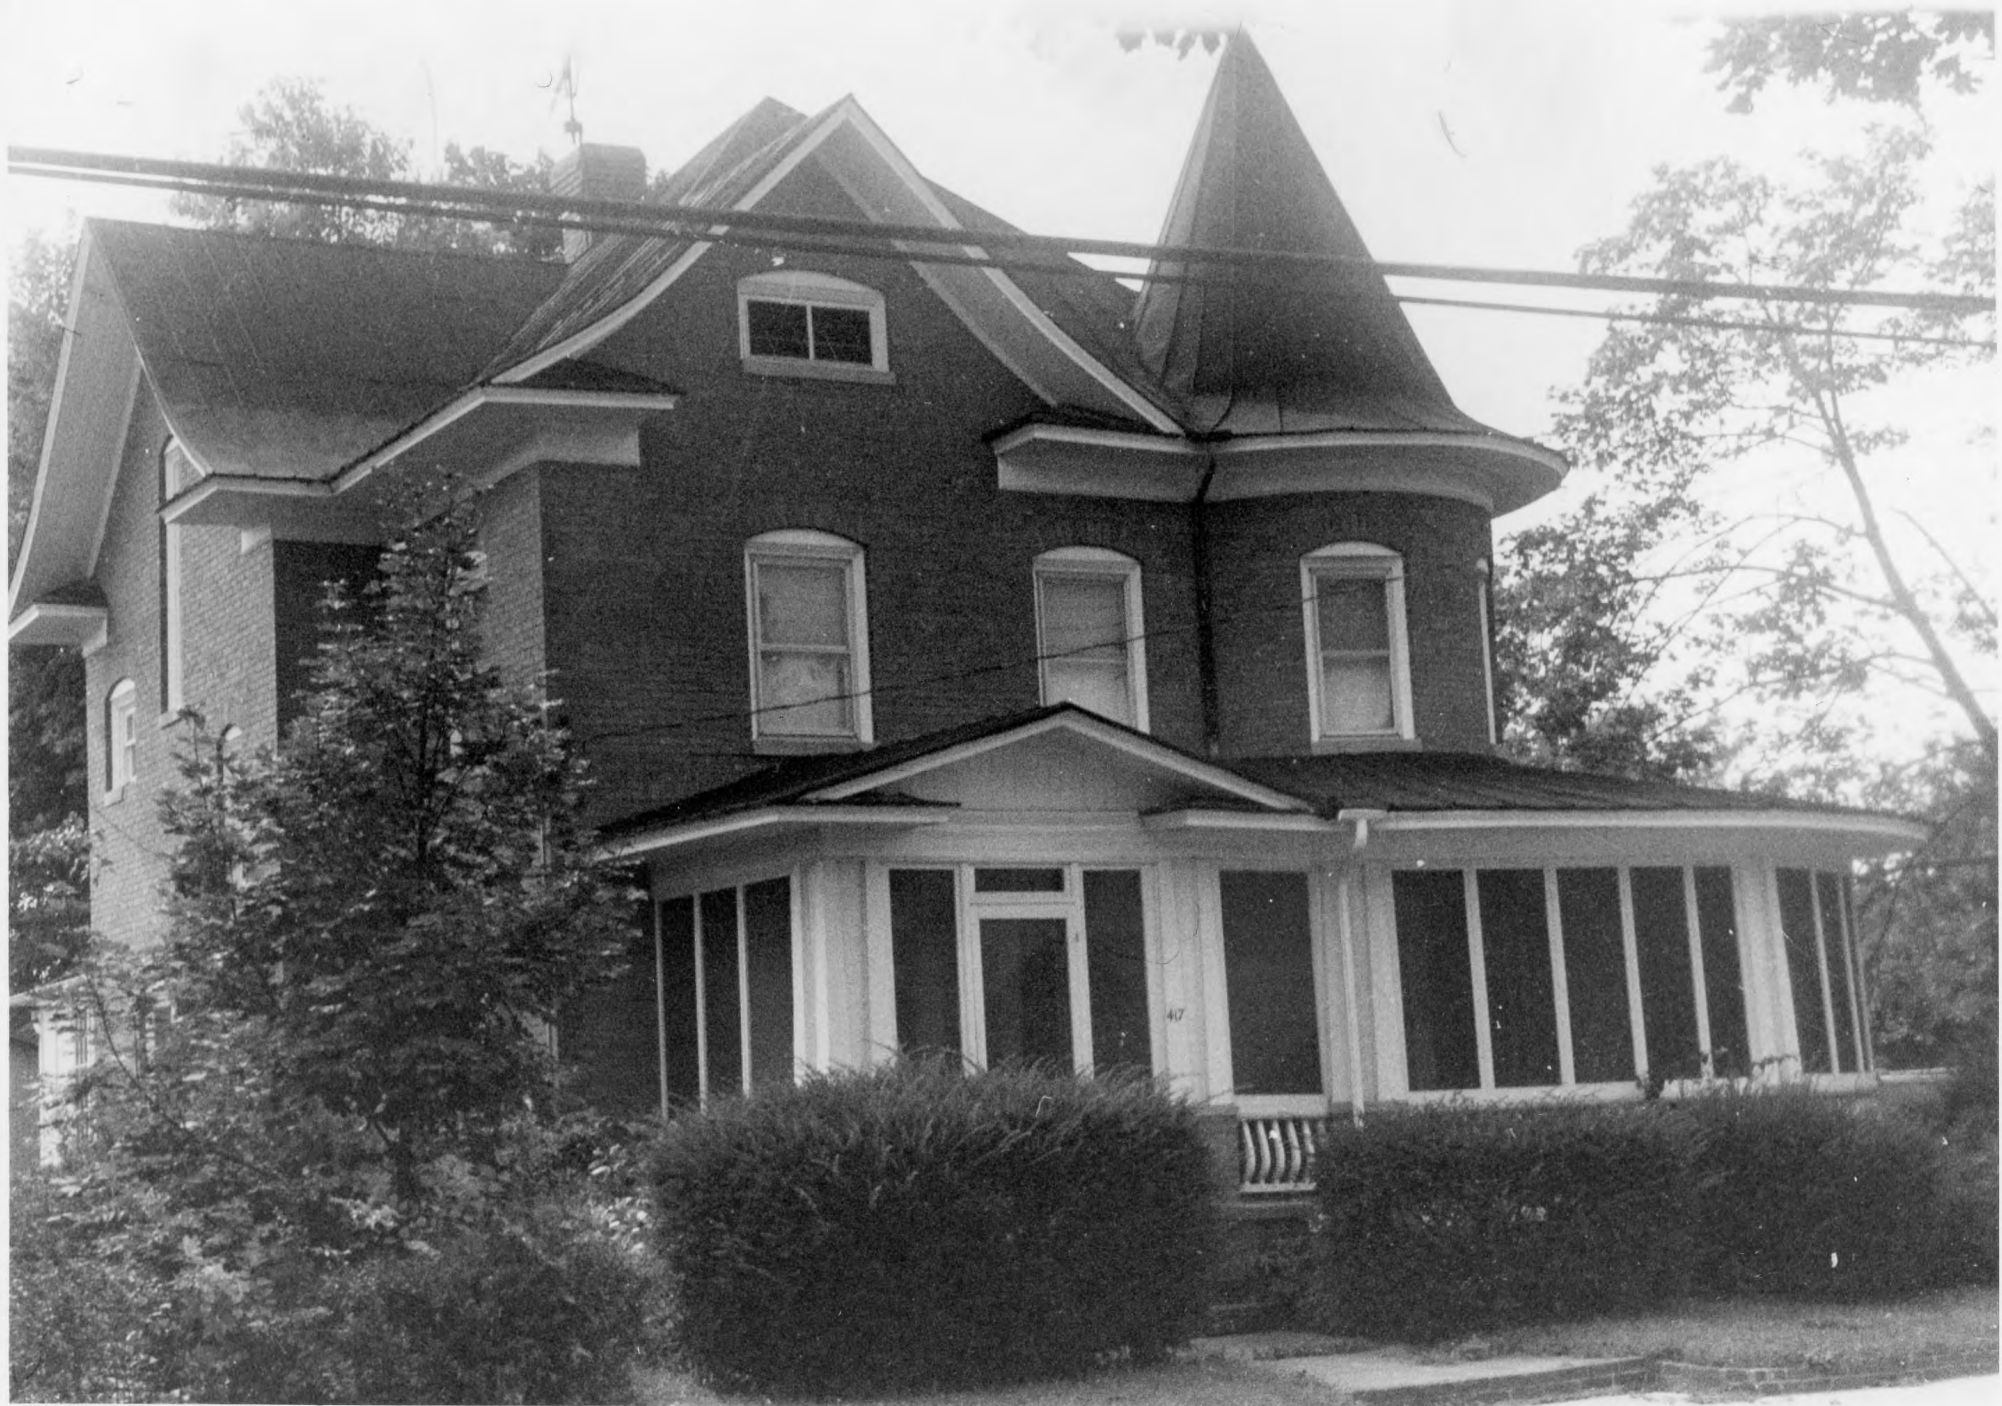
Photograph Number: 22 of 38

Name: Milton Historic District (Ca. 1900 Queen Ann house,
site #63)

63. 417 Federal Street. Ca. 1900. Large Queen Anne style, modified "T"-shape with base of "T" facing street. Turret at front southwest corner. Brick construction. Pedimented entry porch with circular porch extending around turret and leading to side porch. Curved Queen Anne balusters on porch railings. Porch columns on brick pedestals. Soffited cornice with frieze, partial returns roofed, flared eaves. Segmentally-arched window and door openings. Large stained glass window in northeast gable end. Horizontal two-light casements in gable ends, segmentally arched. Two sheds, garage and privy in rear contemporary with house. Structure now vacant.

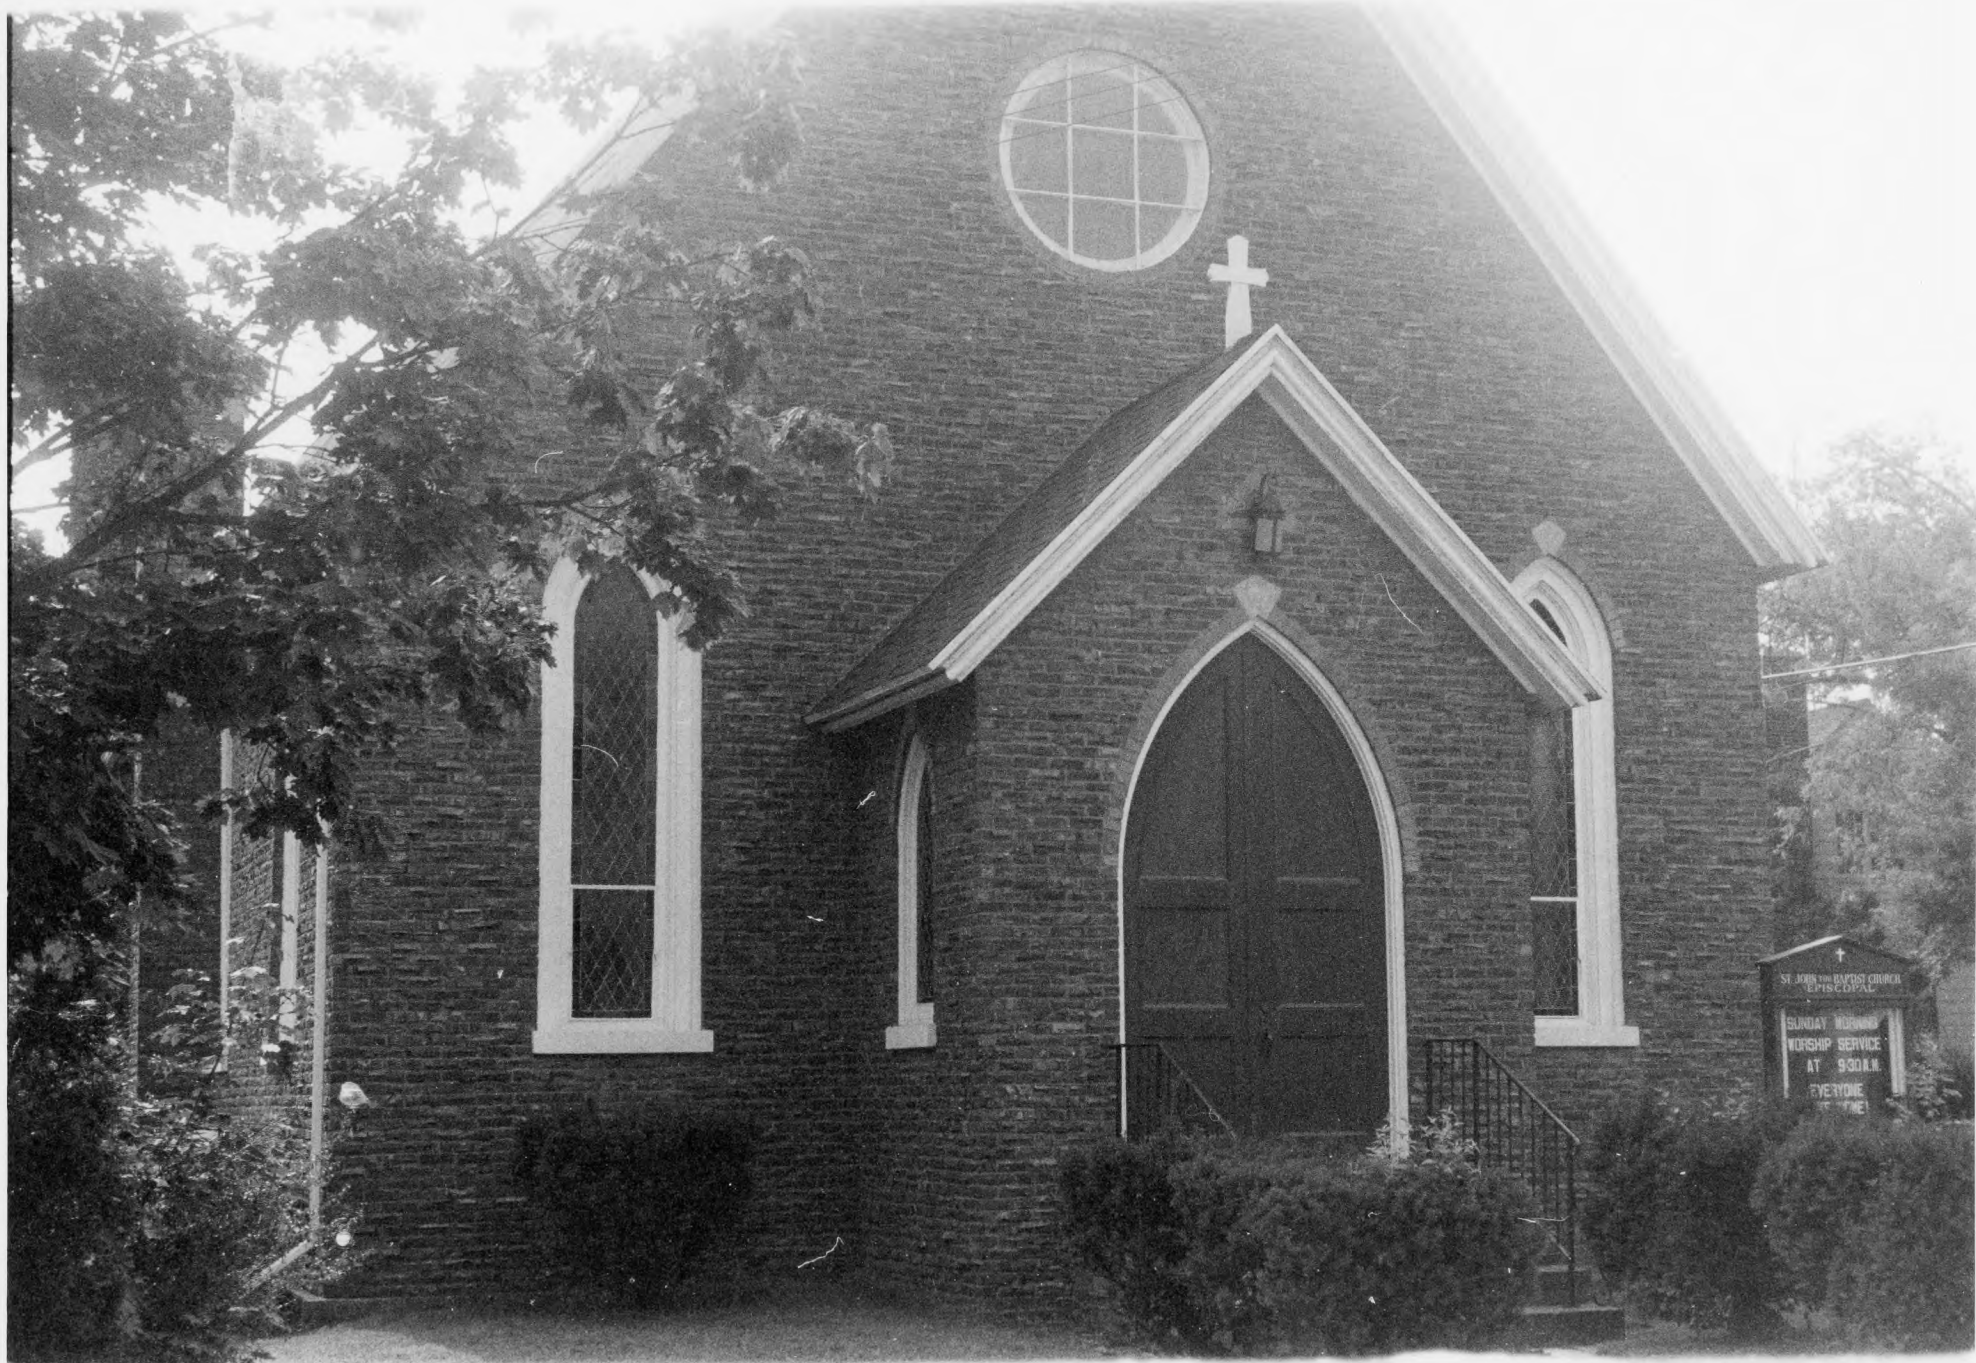
Photograph Number: 23 of 38

Name: Milton Historic District (St. John the Baptist,
site #71)

Across Federal Street is St. John the Baptist Episcopal Church (No. 71 in the inventory) which dates from 1887, though with the later addition of brick veneer (1936) and a rear parish house. In spite of the brick, the church is a very good example of Gothic church architecture with its trefoil lancet windows and other details.

71. 307 Federal Street. Original construction 1877 but much altered. St. John the Baptist Episcopal Church. Main core is rectangular gable-roofed Gothic church structure with gable end facing street. Frame structure with brick veneer added in 1936. Gable-roofed frame and shingle parish hall in rear connected by gable-roofed covered wing to church added in 1941. On each side of church building are four double trefoil arched windows with diamond panes in lower section. Chancel window is rose pattern over twelve-light stained glass window. Front facade has diamond-paned lancet window on either side with diamond keystones. Gable-roofed vestibule with lancet doorway and small lancet windows on each side. Structure is latest in a succession of buildings dating back to early-eighteenth century.

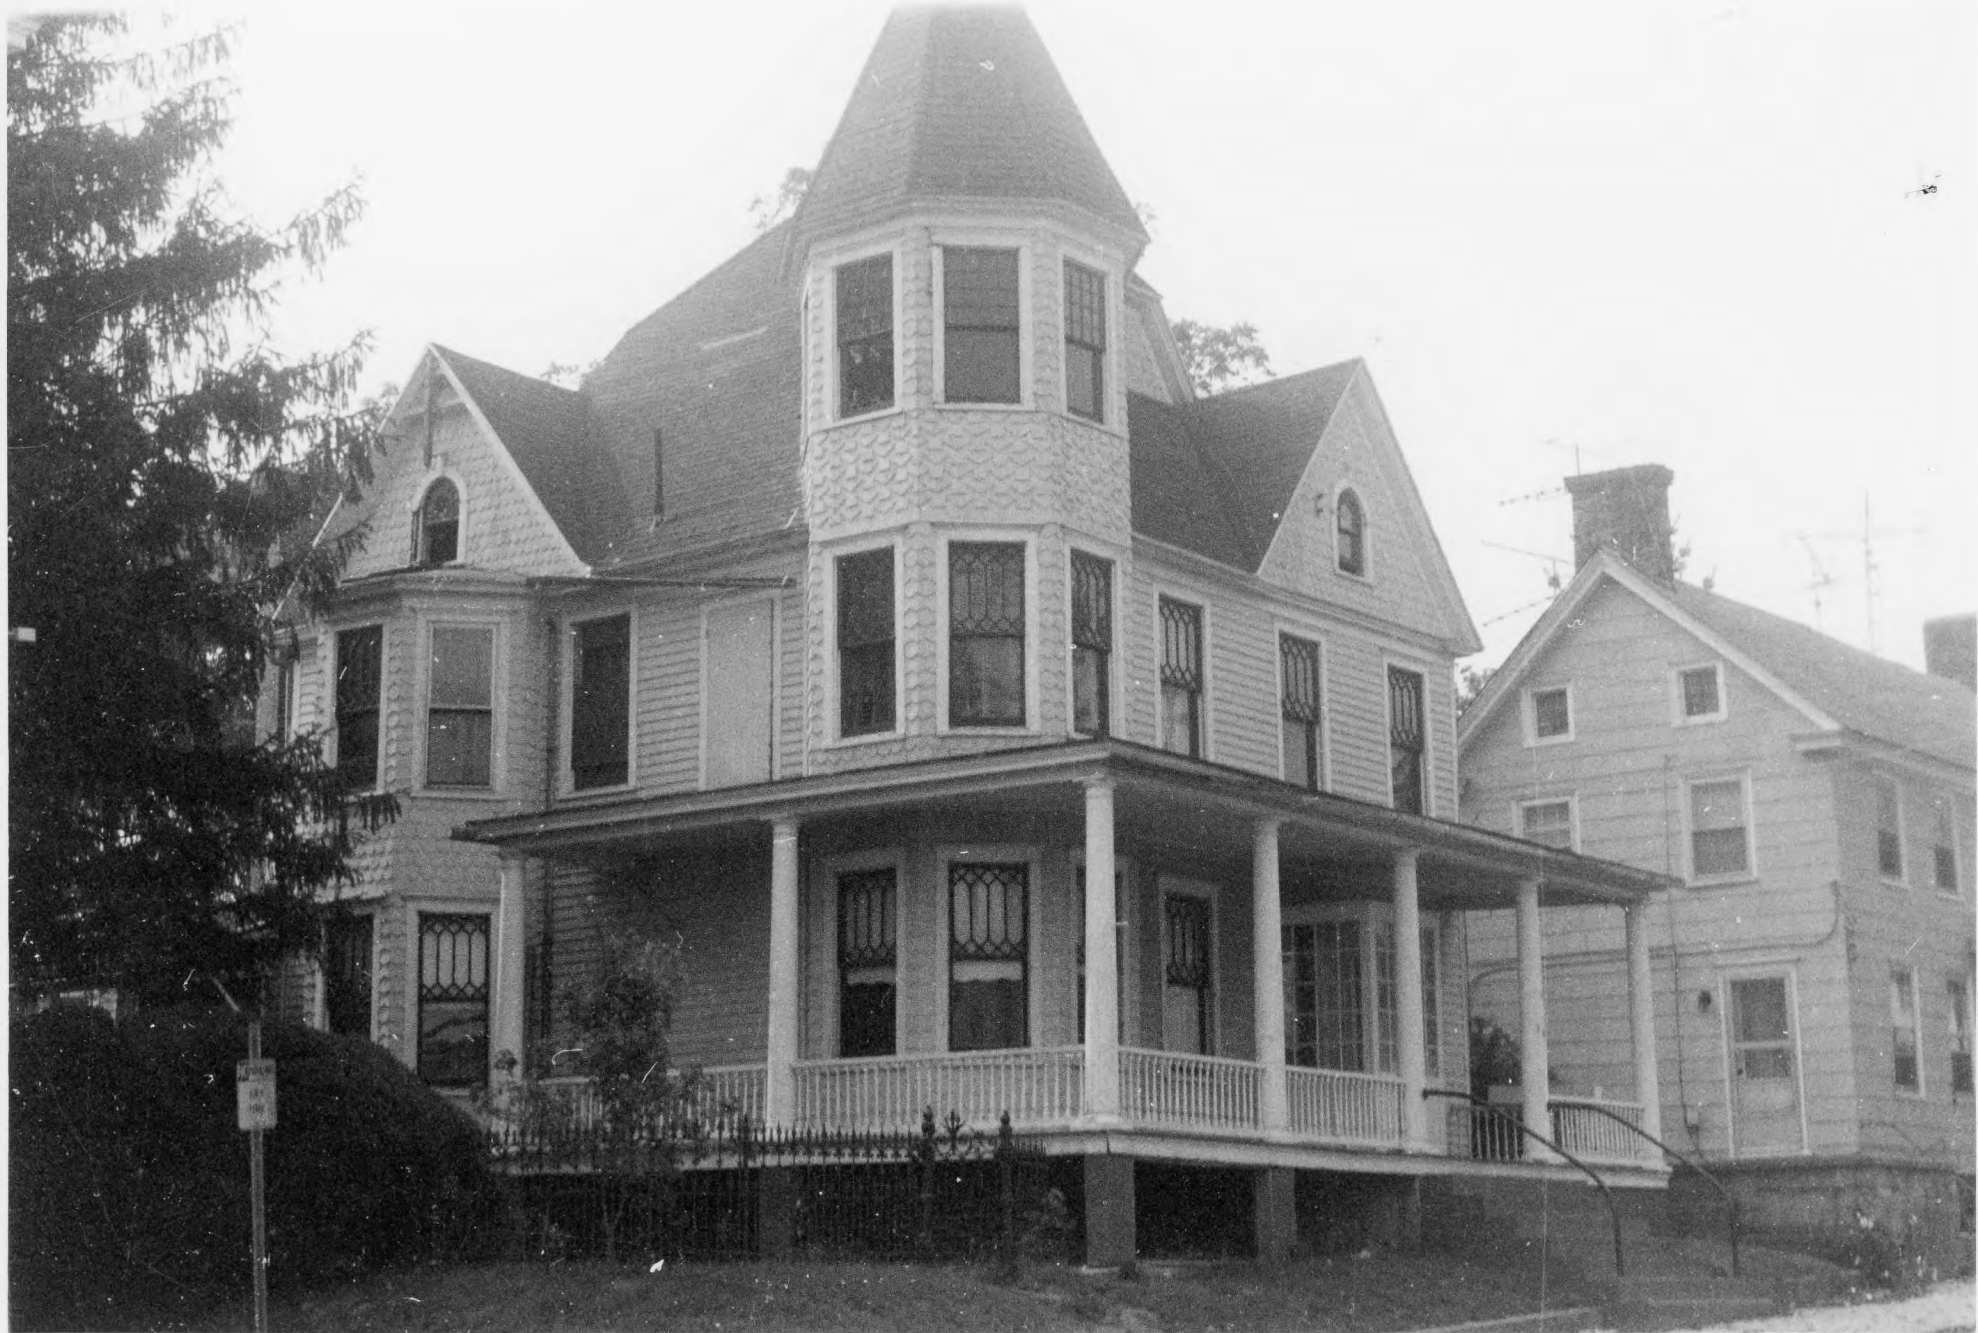
Photograph Number: 25 of 38

Name: Milton Historic District (Prettyman house,
site #77)

Several of Milton's late-nineteenth-century houses are among the finest and most imaginative Victorian structures in lower Delaware. The Second Empire-style Dr. James A. Hopkins House is one example. The 1845 W. C. Prettyman House is one of the best classic Greek Revival homes in the county. The Robert Hood Carey carriage house, as noted previously, is unique in Sussex County, and the D. W. Burton House on Federal Street with its gable on hip-on-hip roof and triangular bay window is extremely unusual, not to say odd, by any standard of measurement.

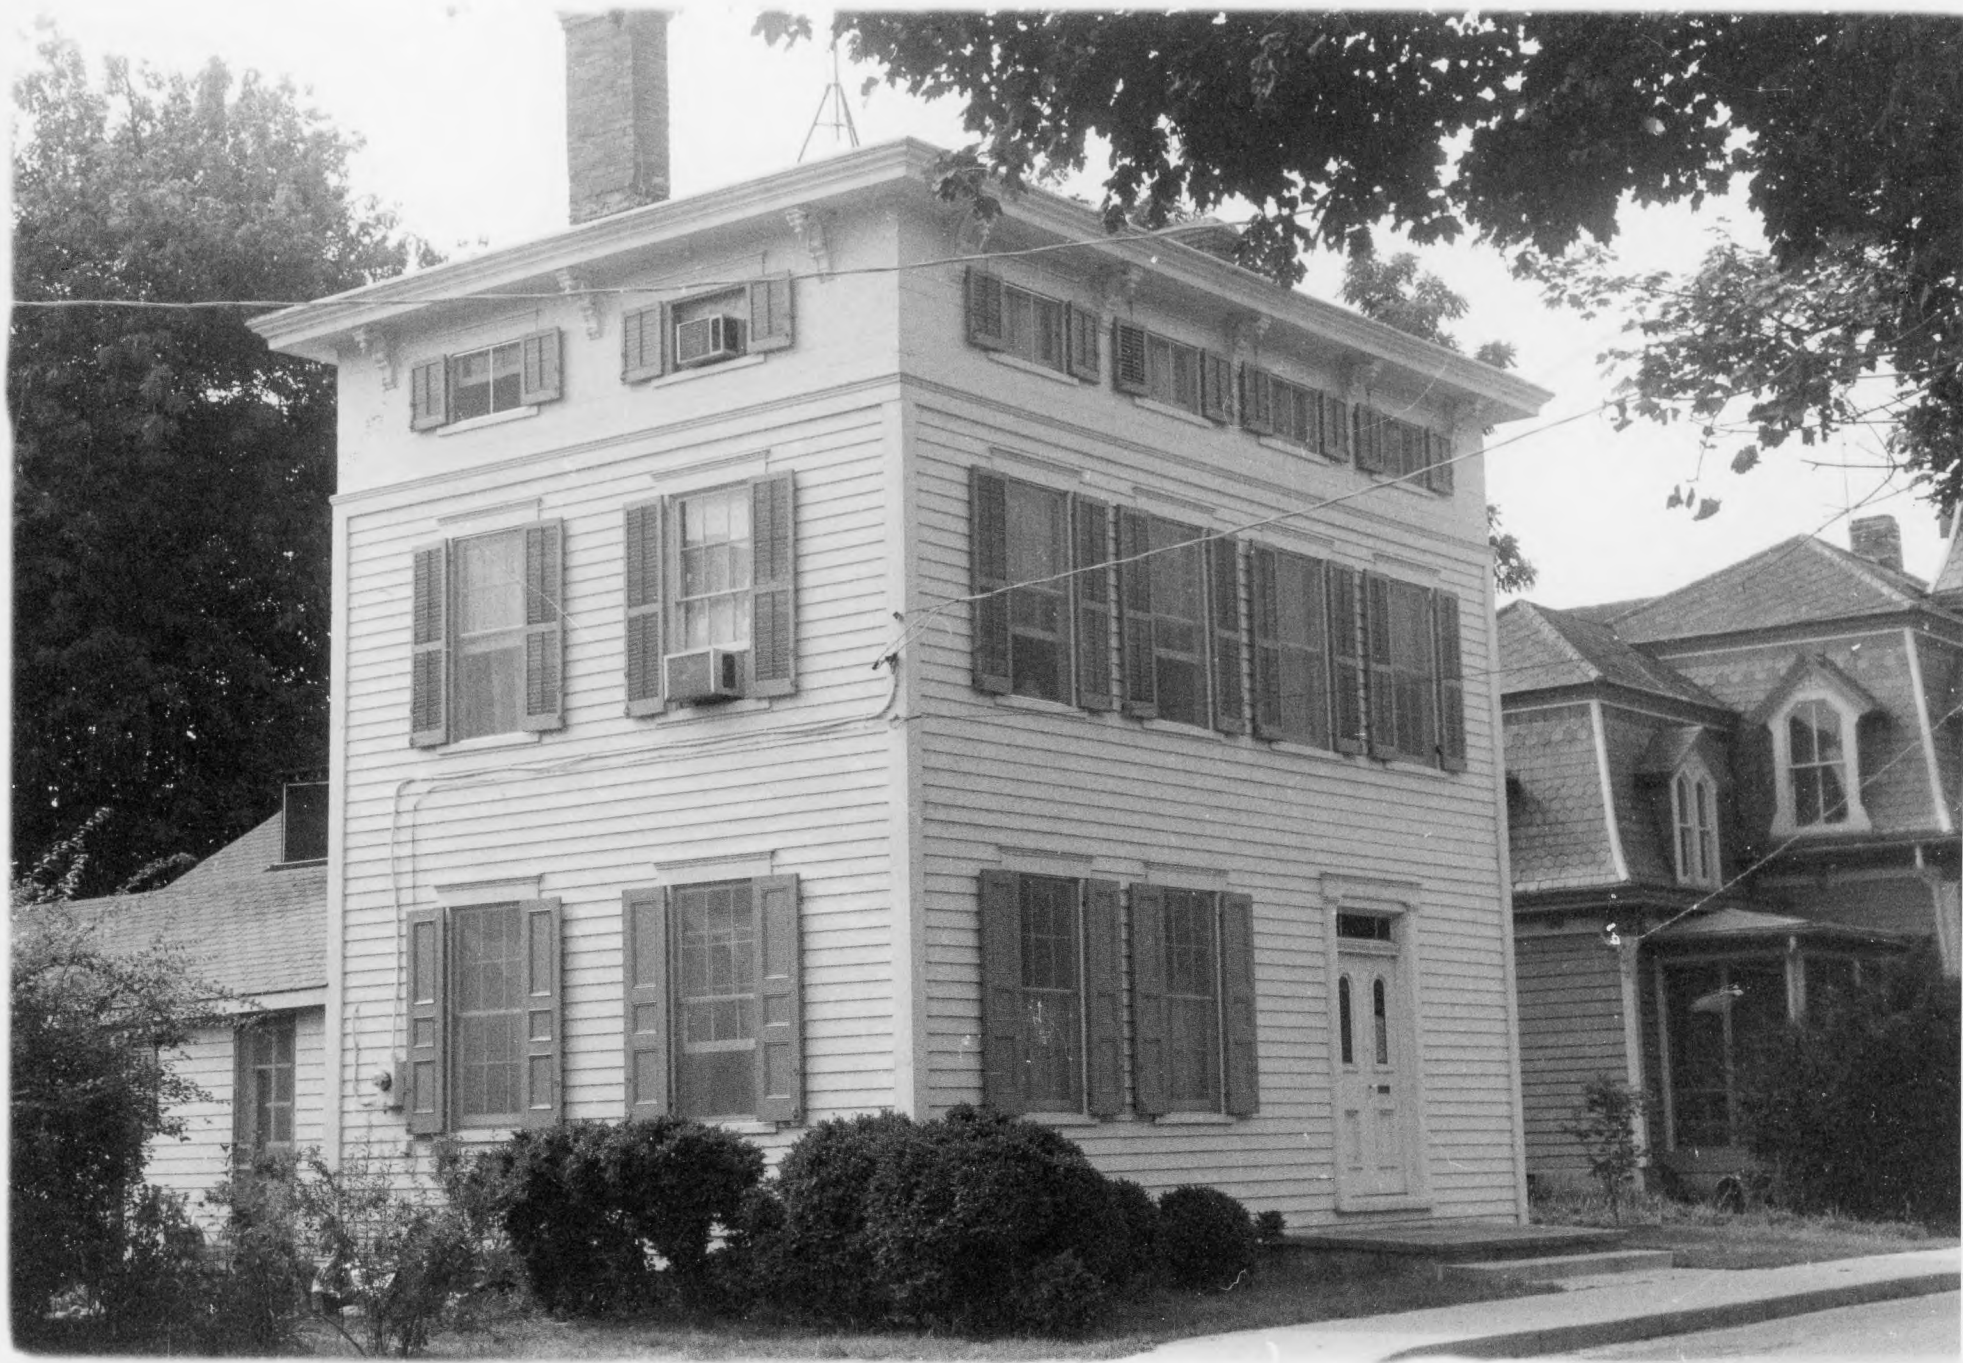
Photograph Number: 26 of 38

Name: Milton Historic District (Dr. Hopkins house
site #78)

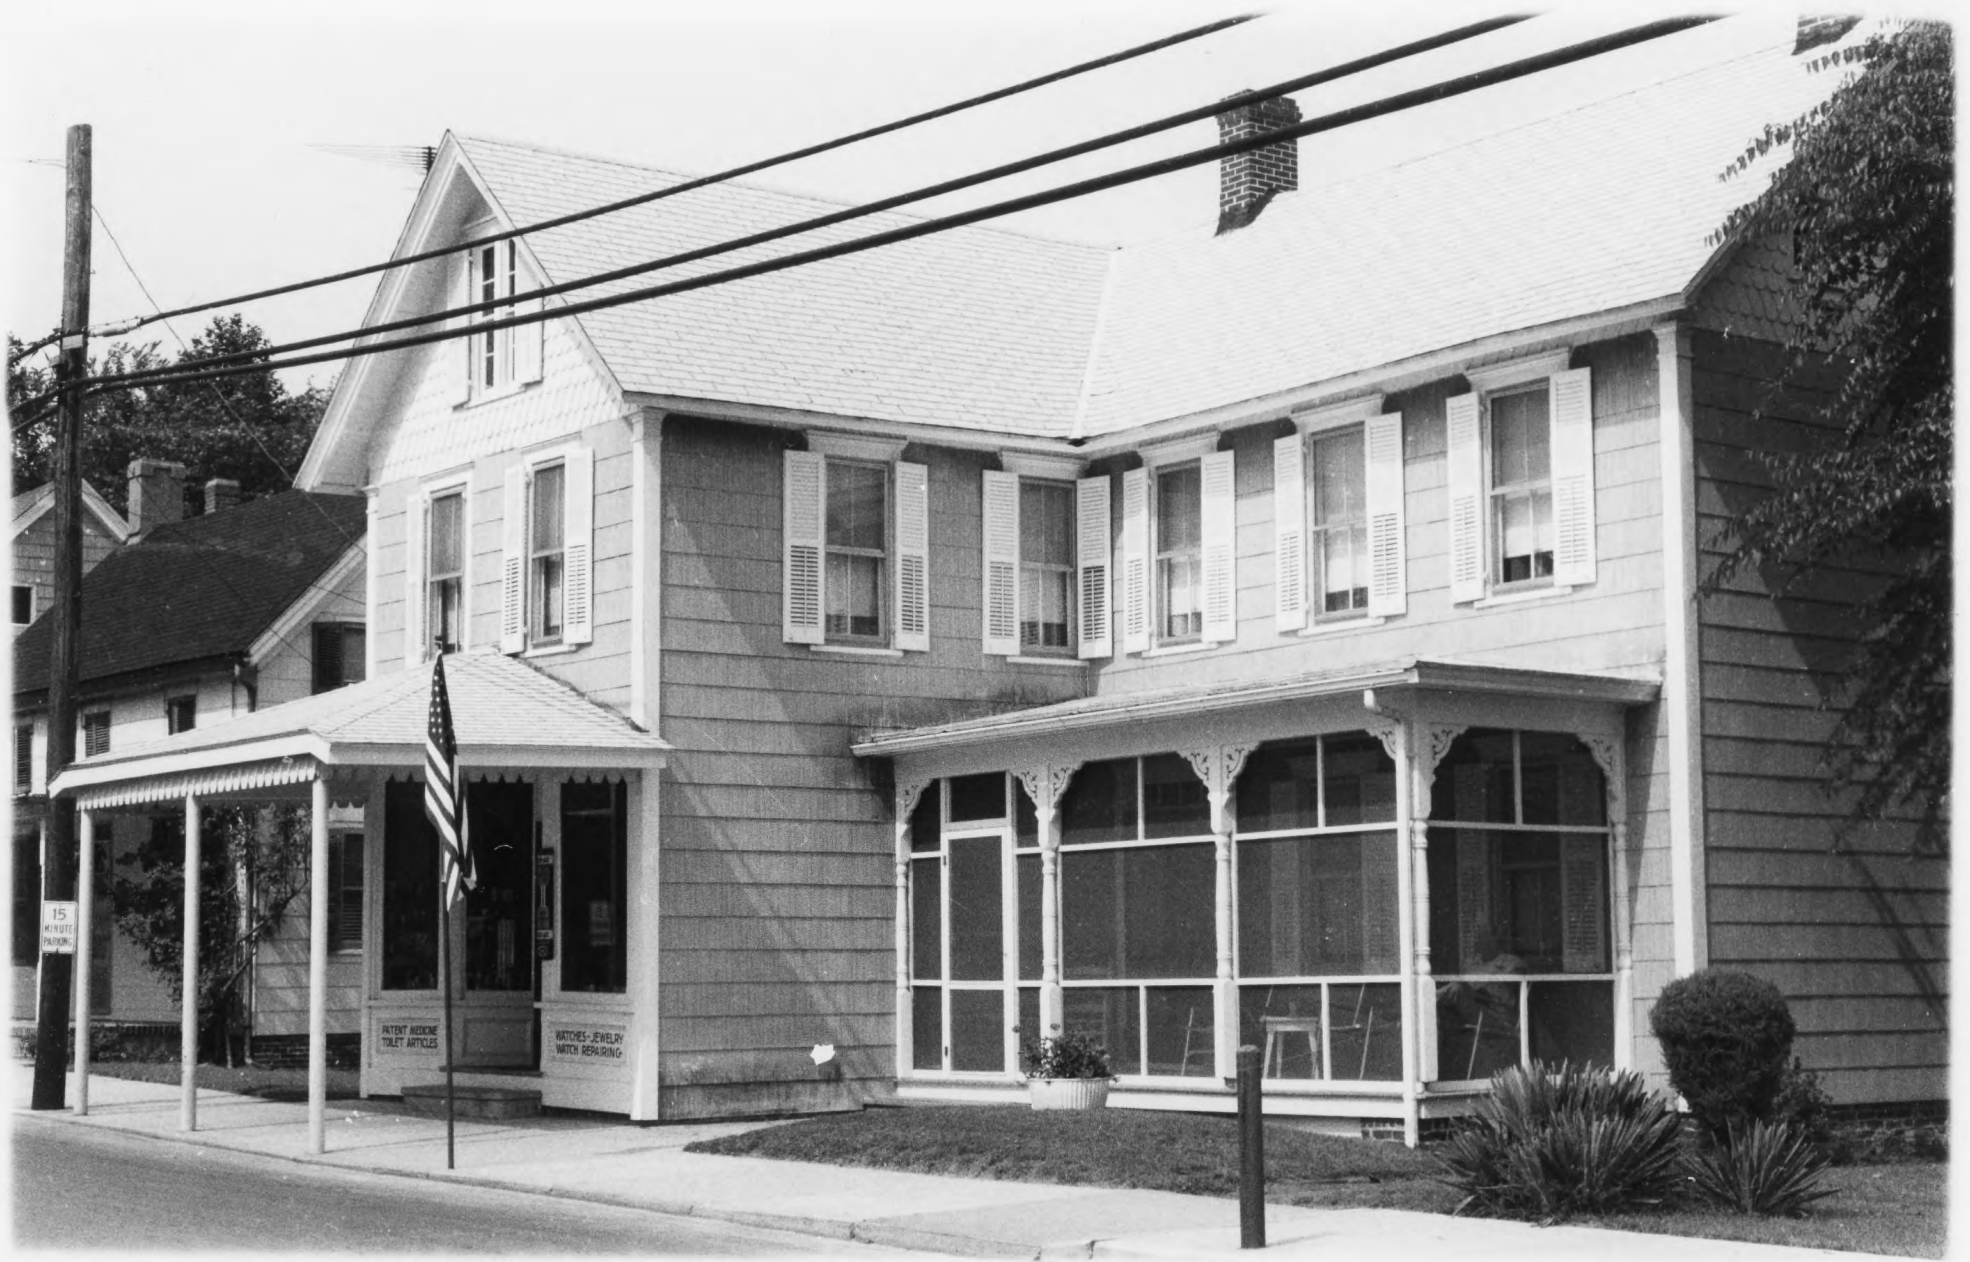
Photograph Number: 30 of 38

Name: Milton Historic District (Welch Home & Drug,
site #94)

Description: view from south

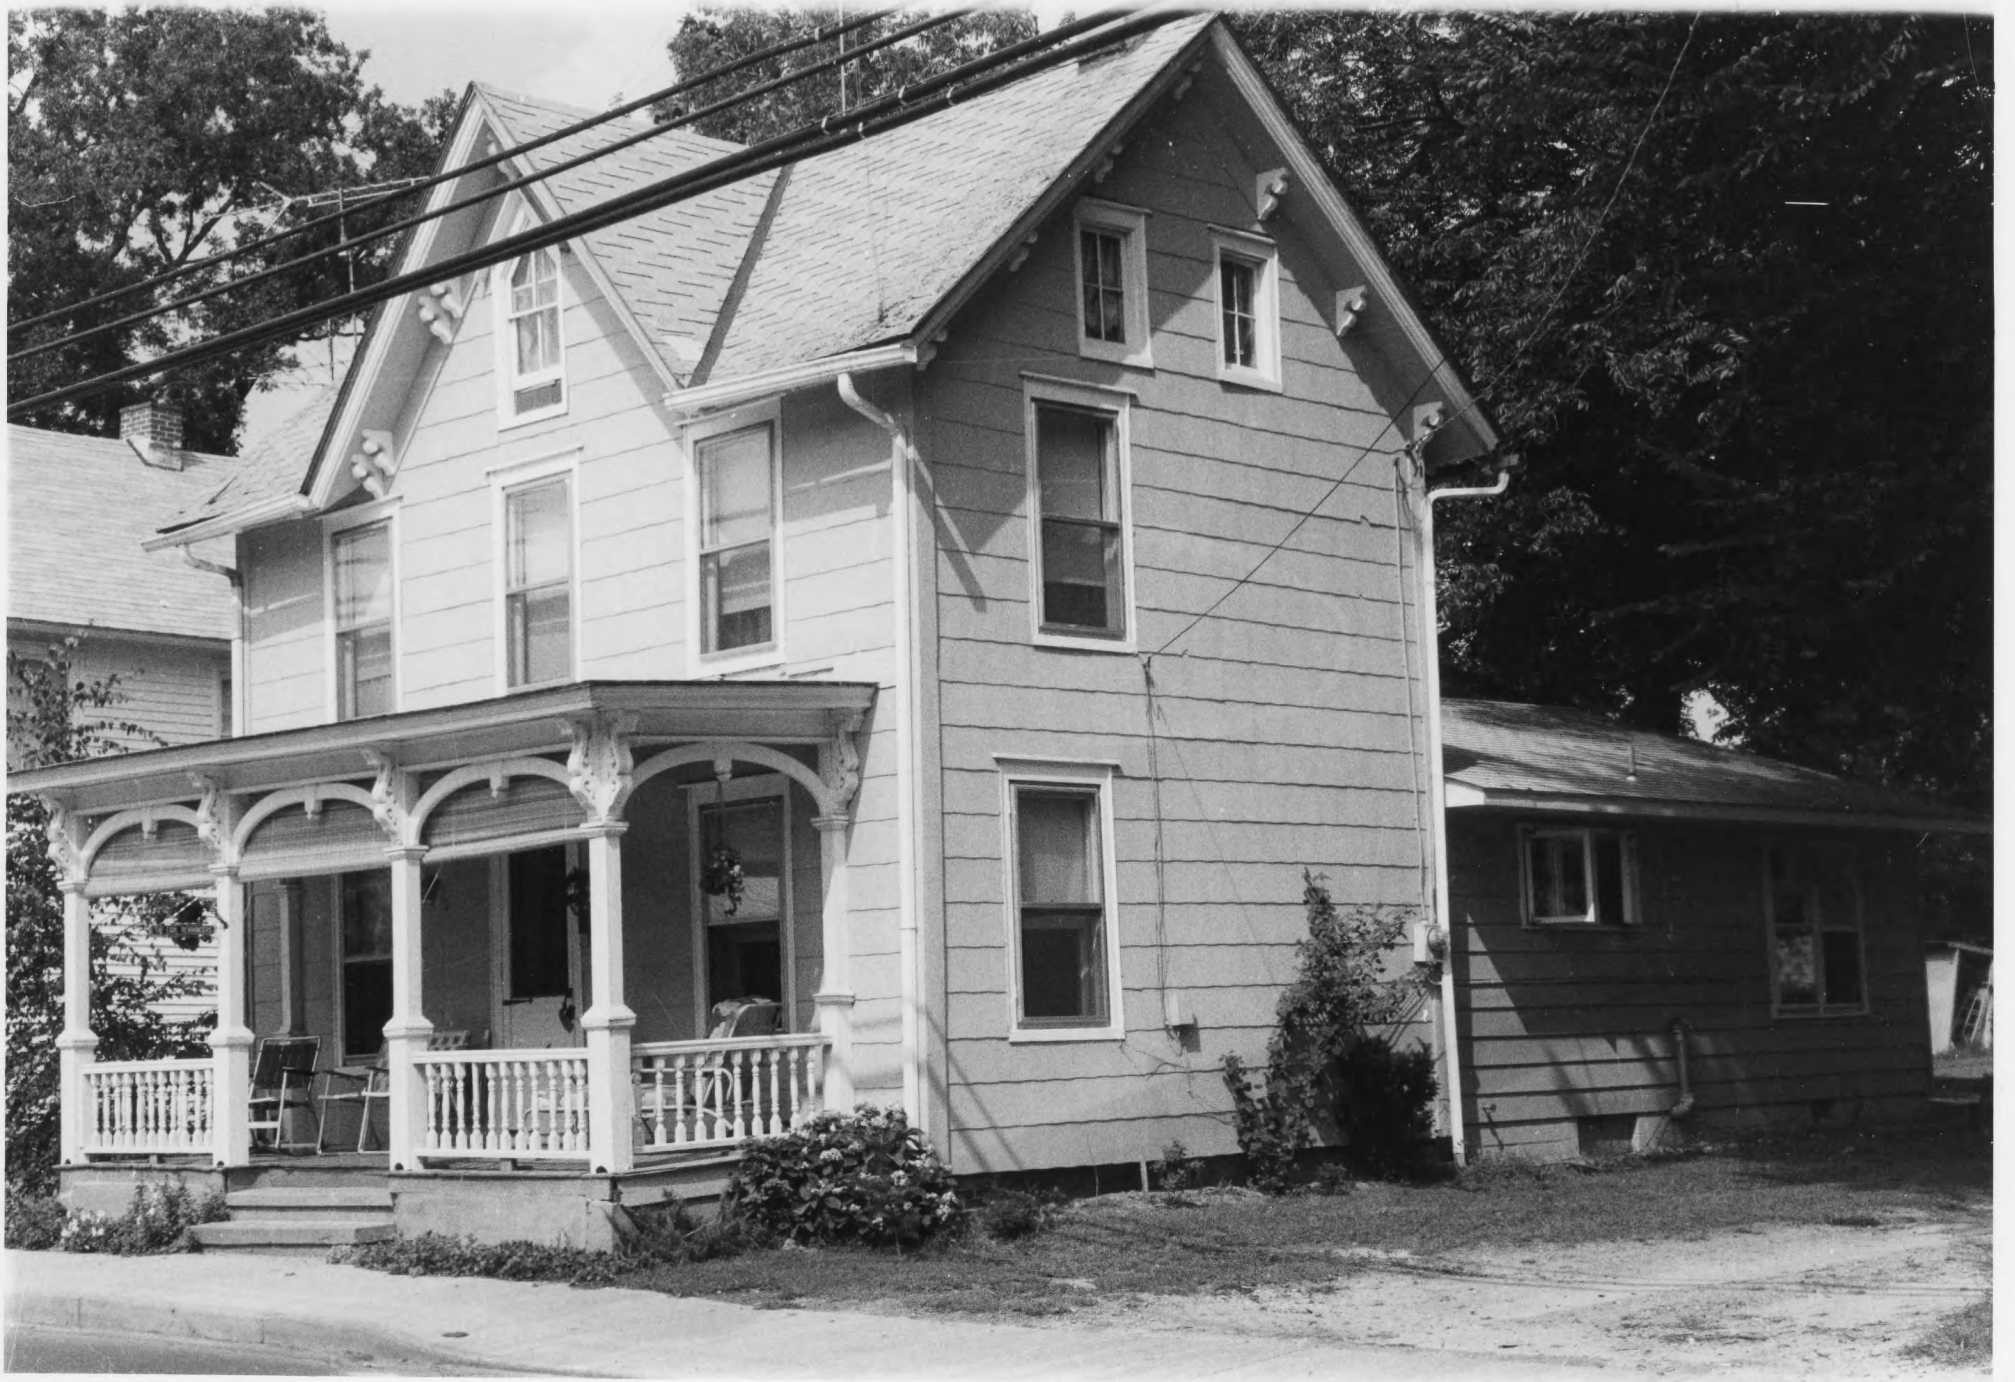
Photograph Number: 32 of 38

Name: Milton Historic District (Warren house, site #102)

Description: view from south

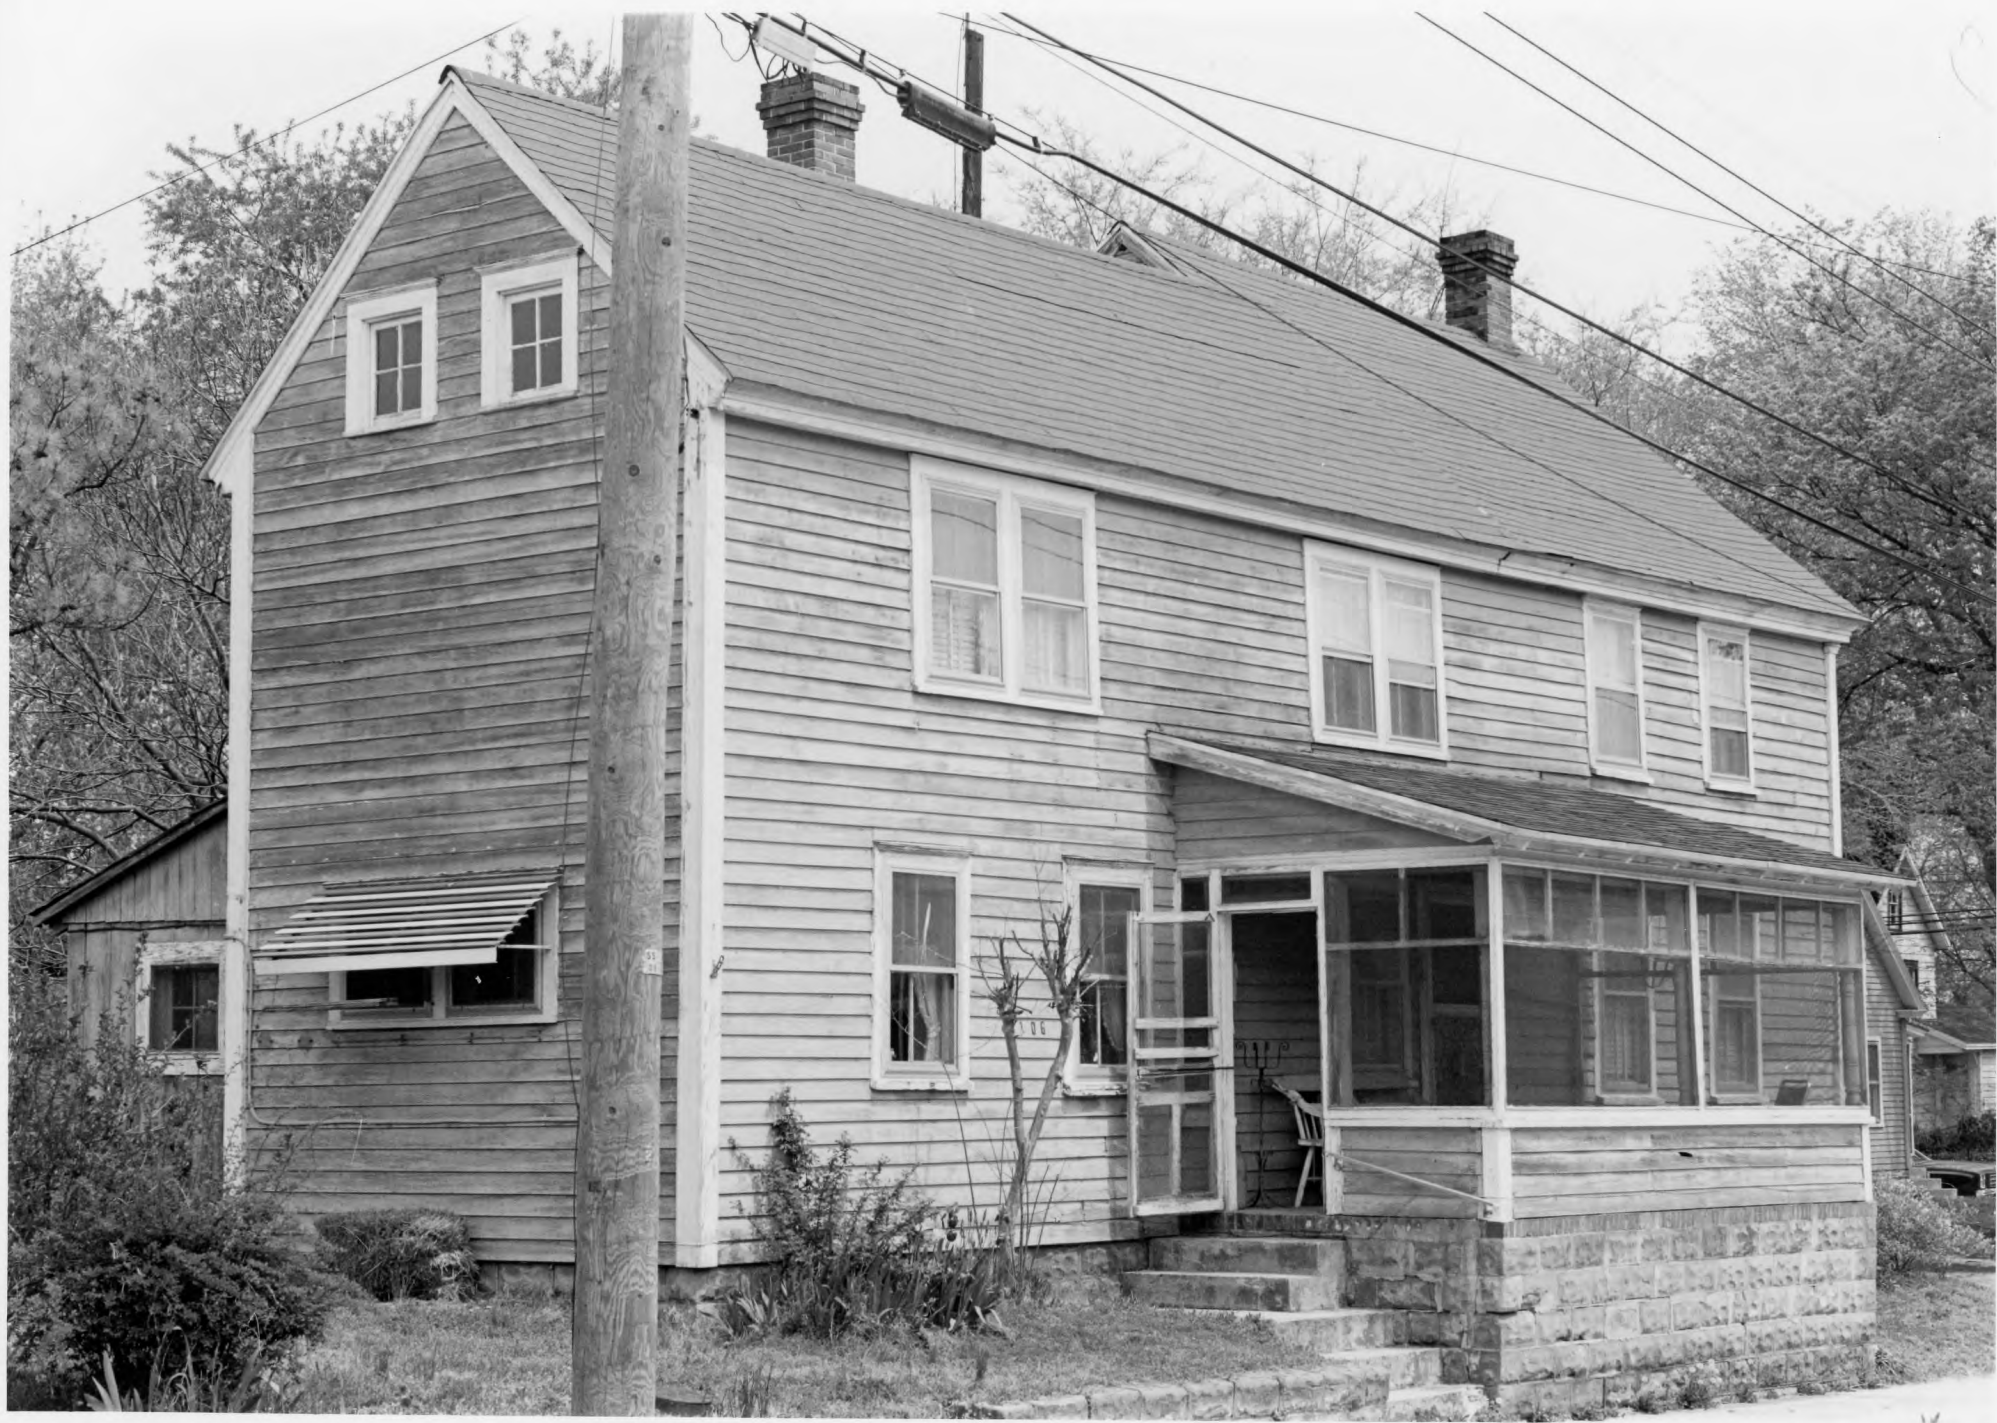
Photograph Number: 34 of 38

Name: Milton Historic District (Ca. 1870 house,
site #114)

Description: view from southwest

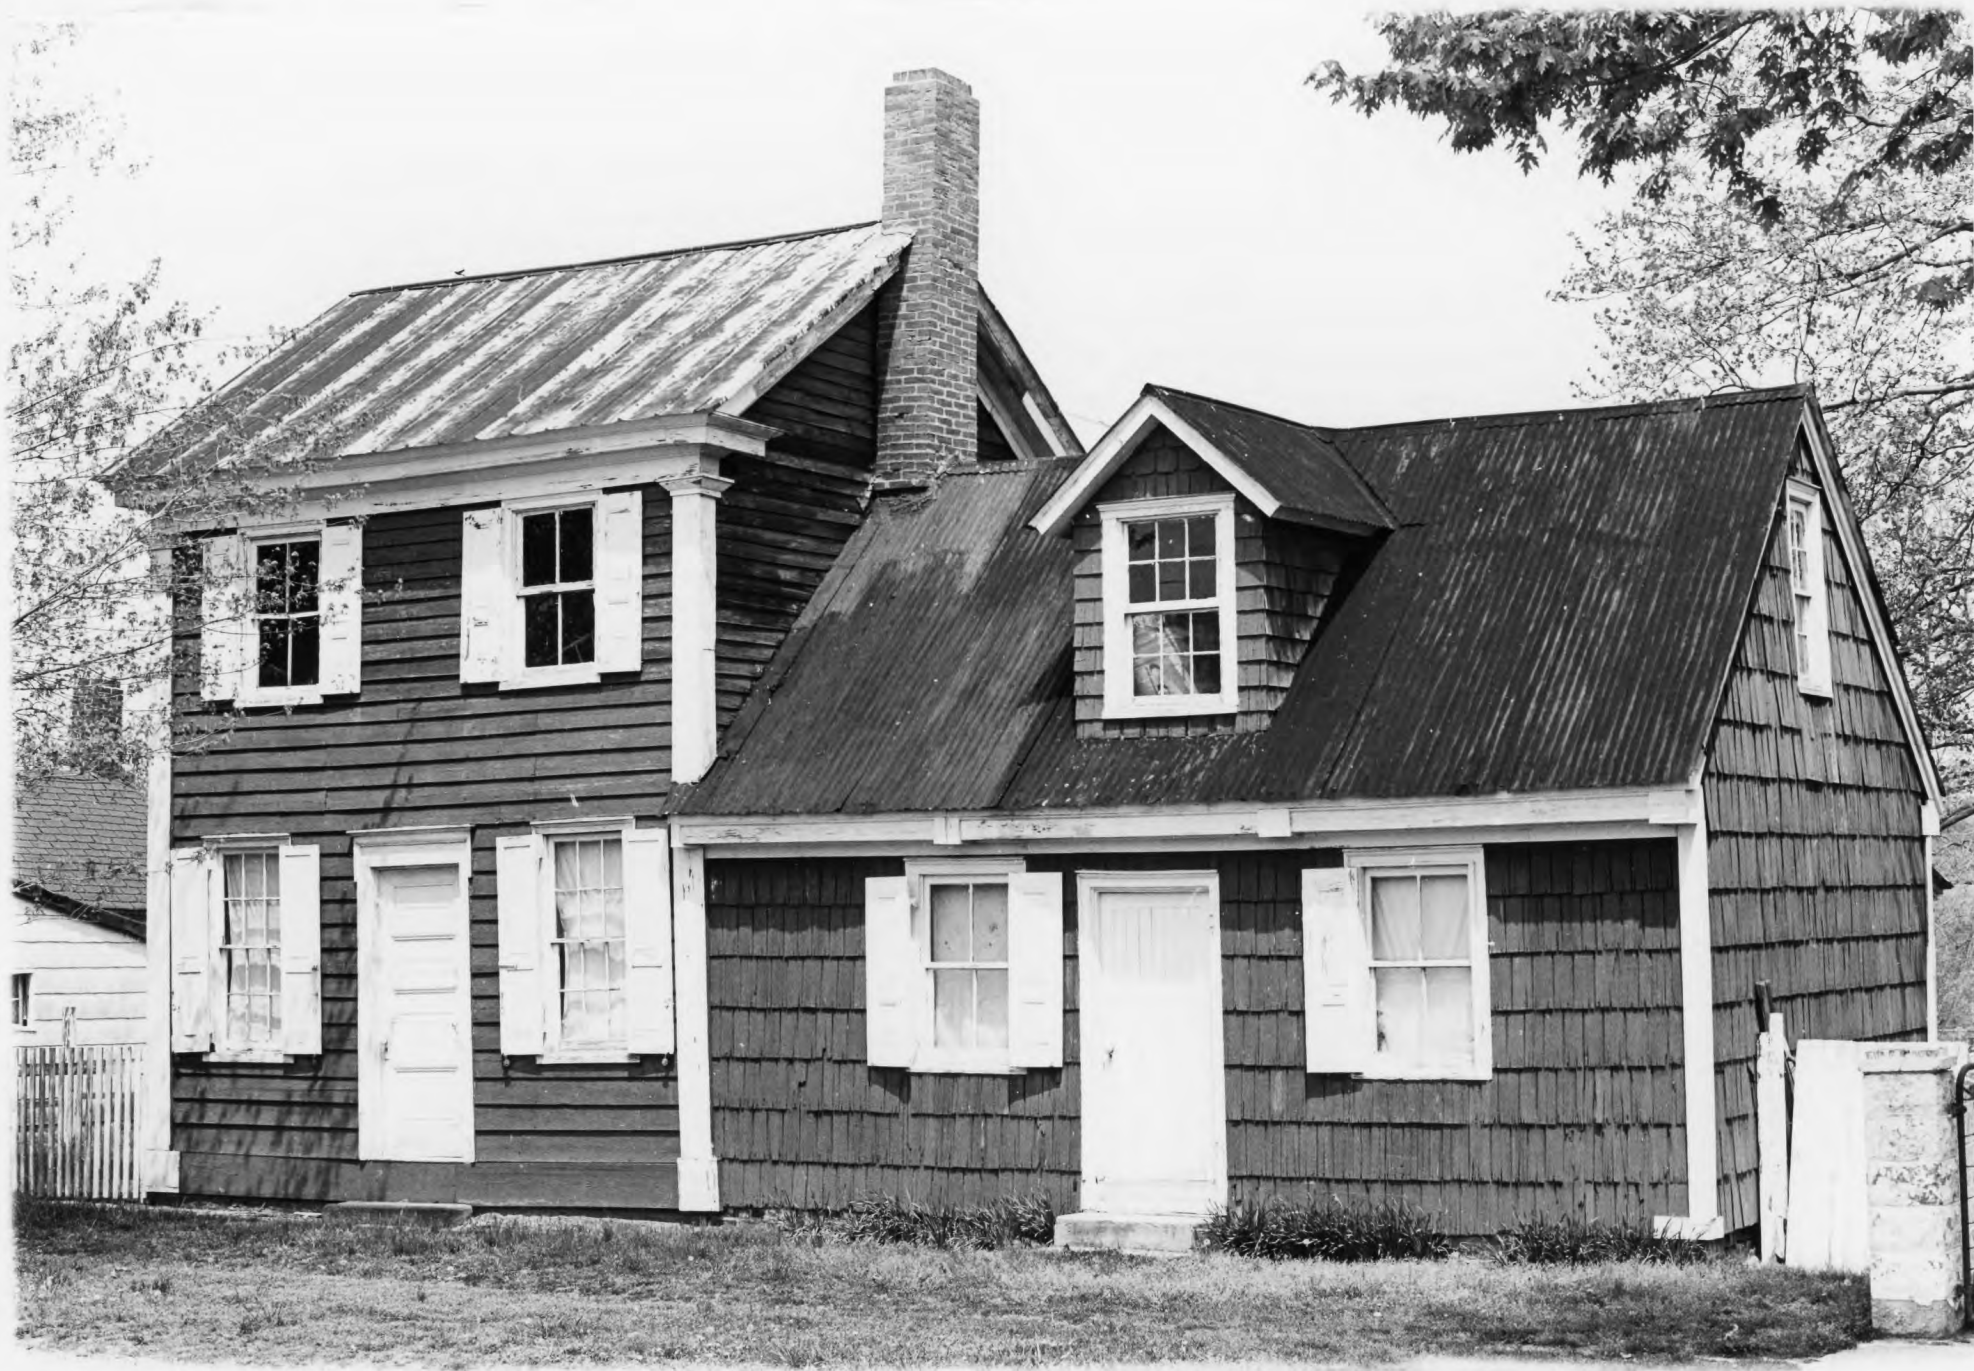
Photograph Number: 37 of 38

Name: Milton Historic District (Ca. 1830 house, site
#146)

Description: view from south-southeast
