National Register of Historic Places Inventory—Nomination Form

historic New Century Club

street & number 1014 Delaware Avenue not for publication

NEW CENTURY CLUB DESCRIPTION

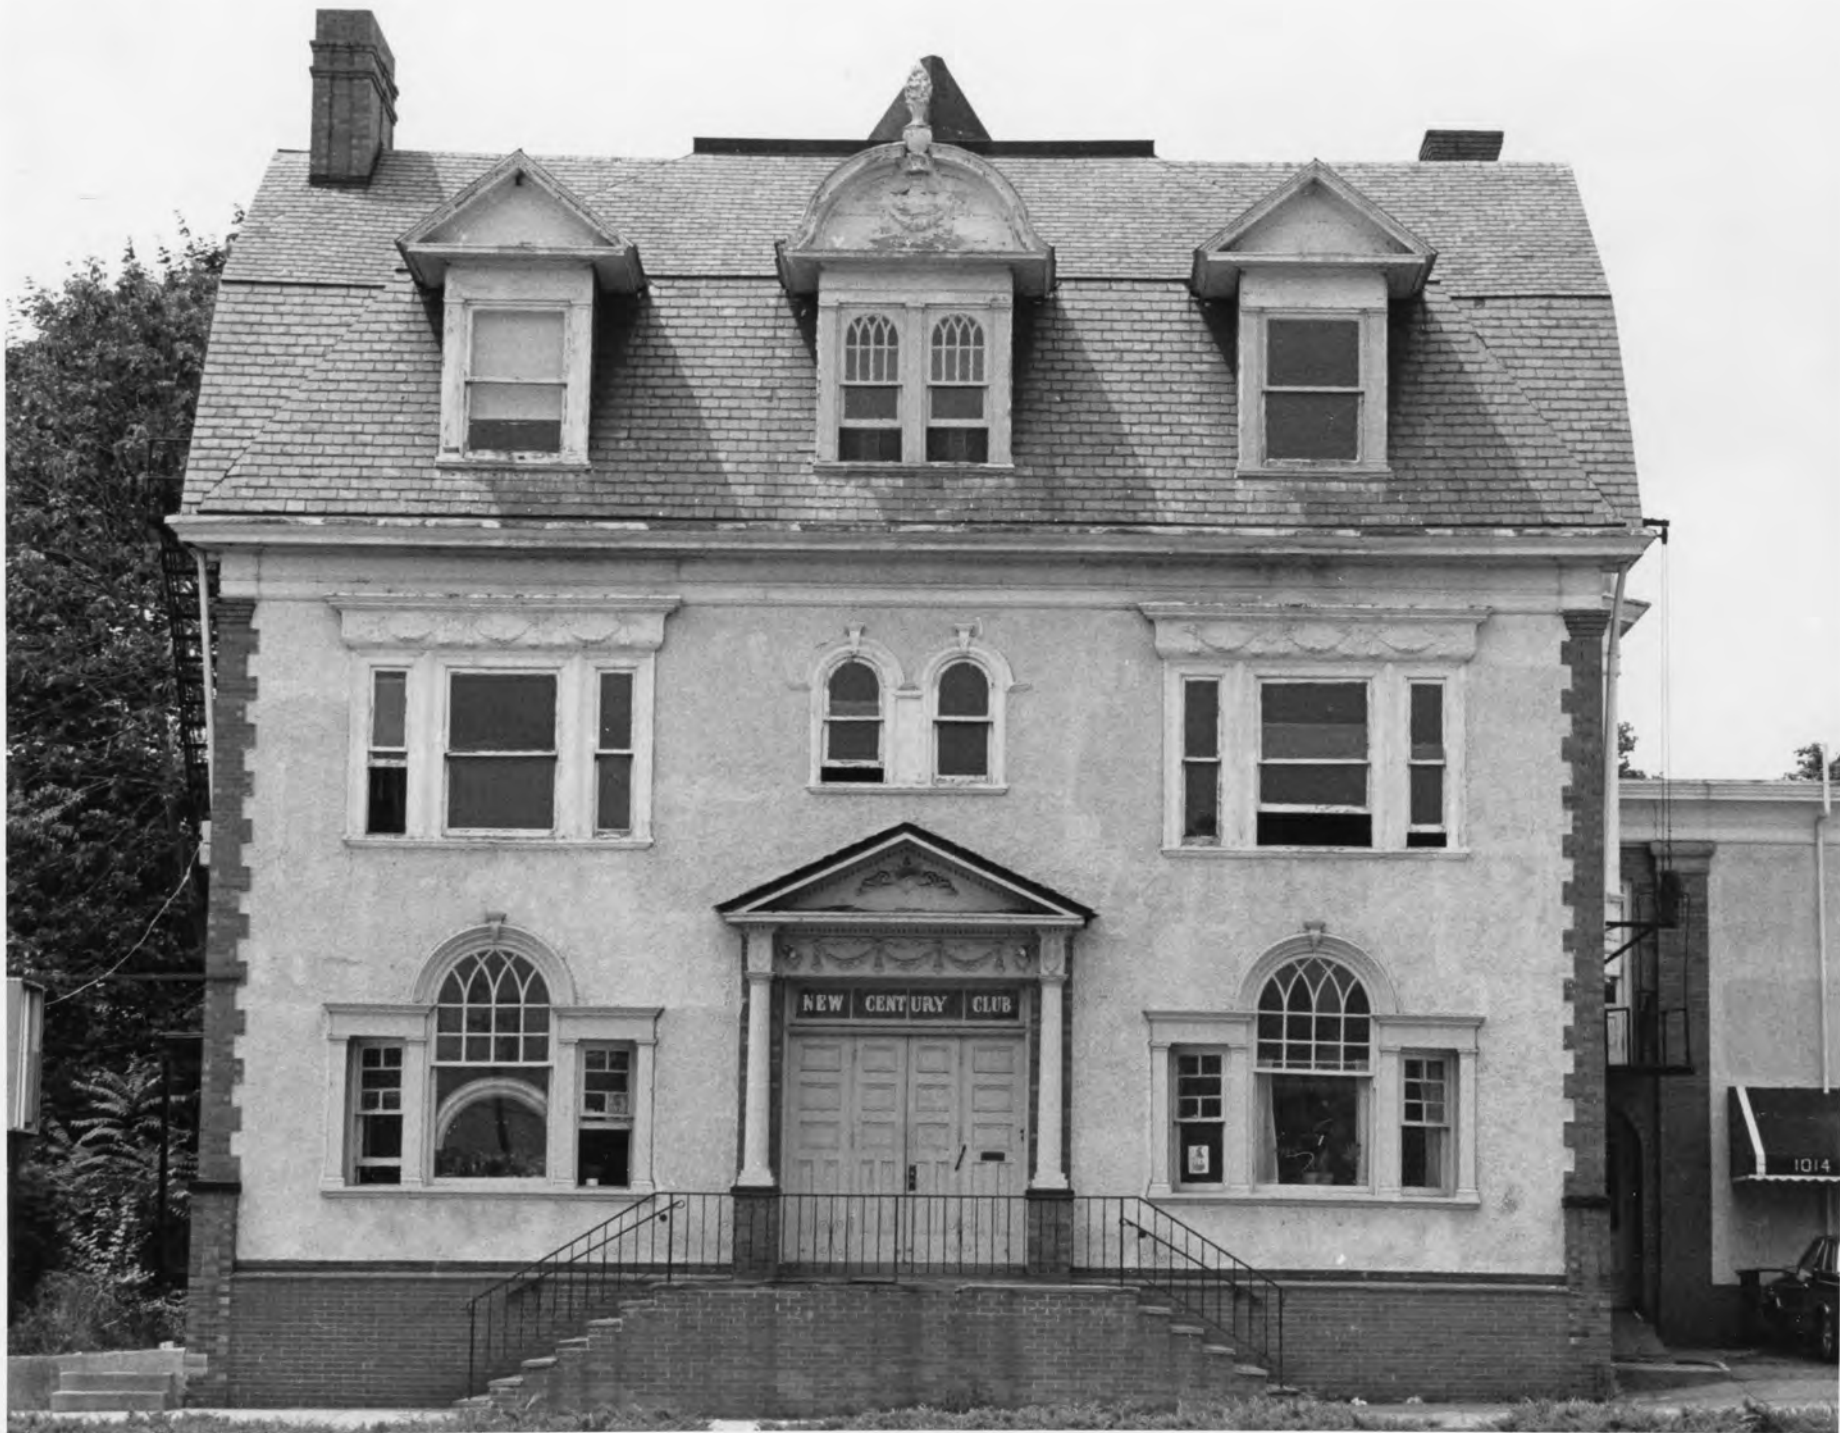
Photograph Number: 1

Description: DELAWARE AVE. FACADE
NORTH WALL

The 2 1/2 story Colonial Revival building has a gambrel slate roof (photo #1, exterior). The building's symmetrical 3-bay northern facade--its front facade--faces Delaware Avenue. A rear wing with a cross-gambrel roof sits perpendicular to Delaware Avenue making the building appear "T"-shaped. The facade is white pebbledash, and according to the architect's drawings, is the original facade surface. Brick quoins accent the building's corners. The exposed foundation wall is also brick. The structural system combines masonry, wood joists, and some steel I-beams.

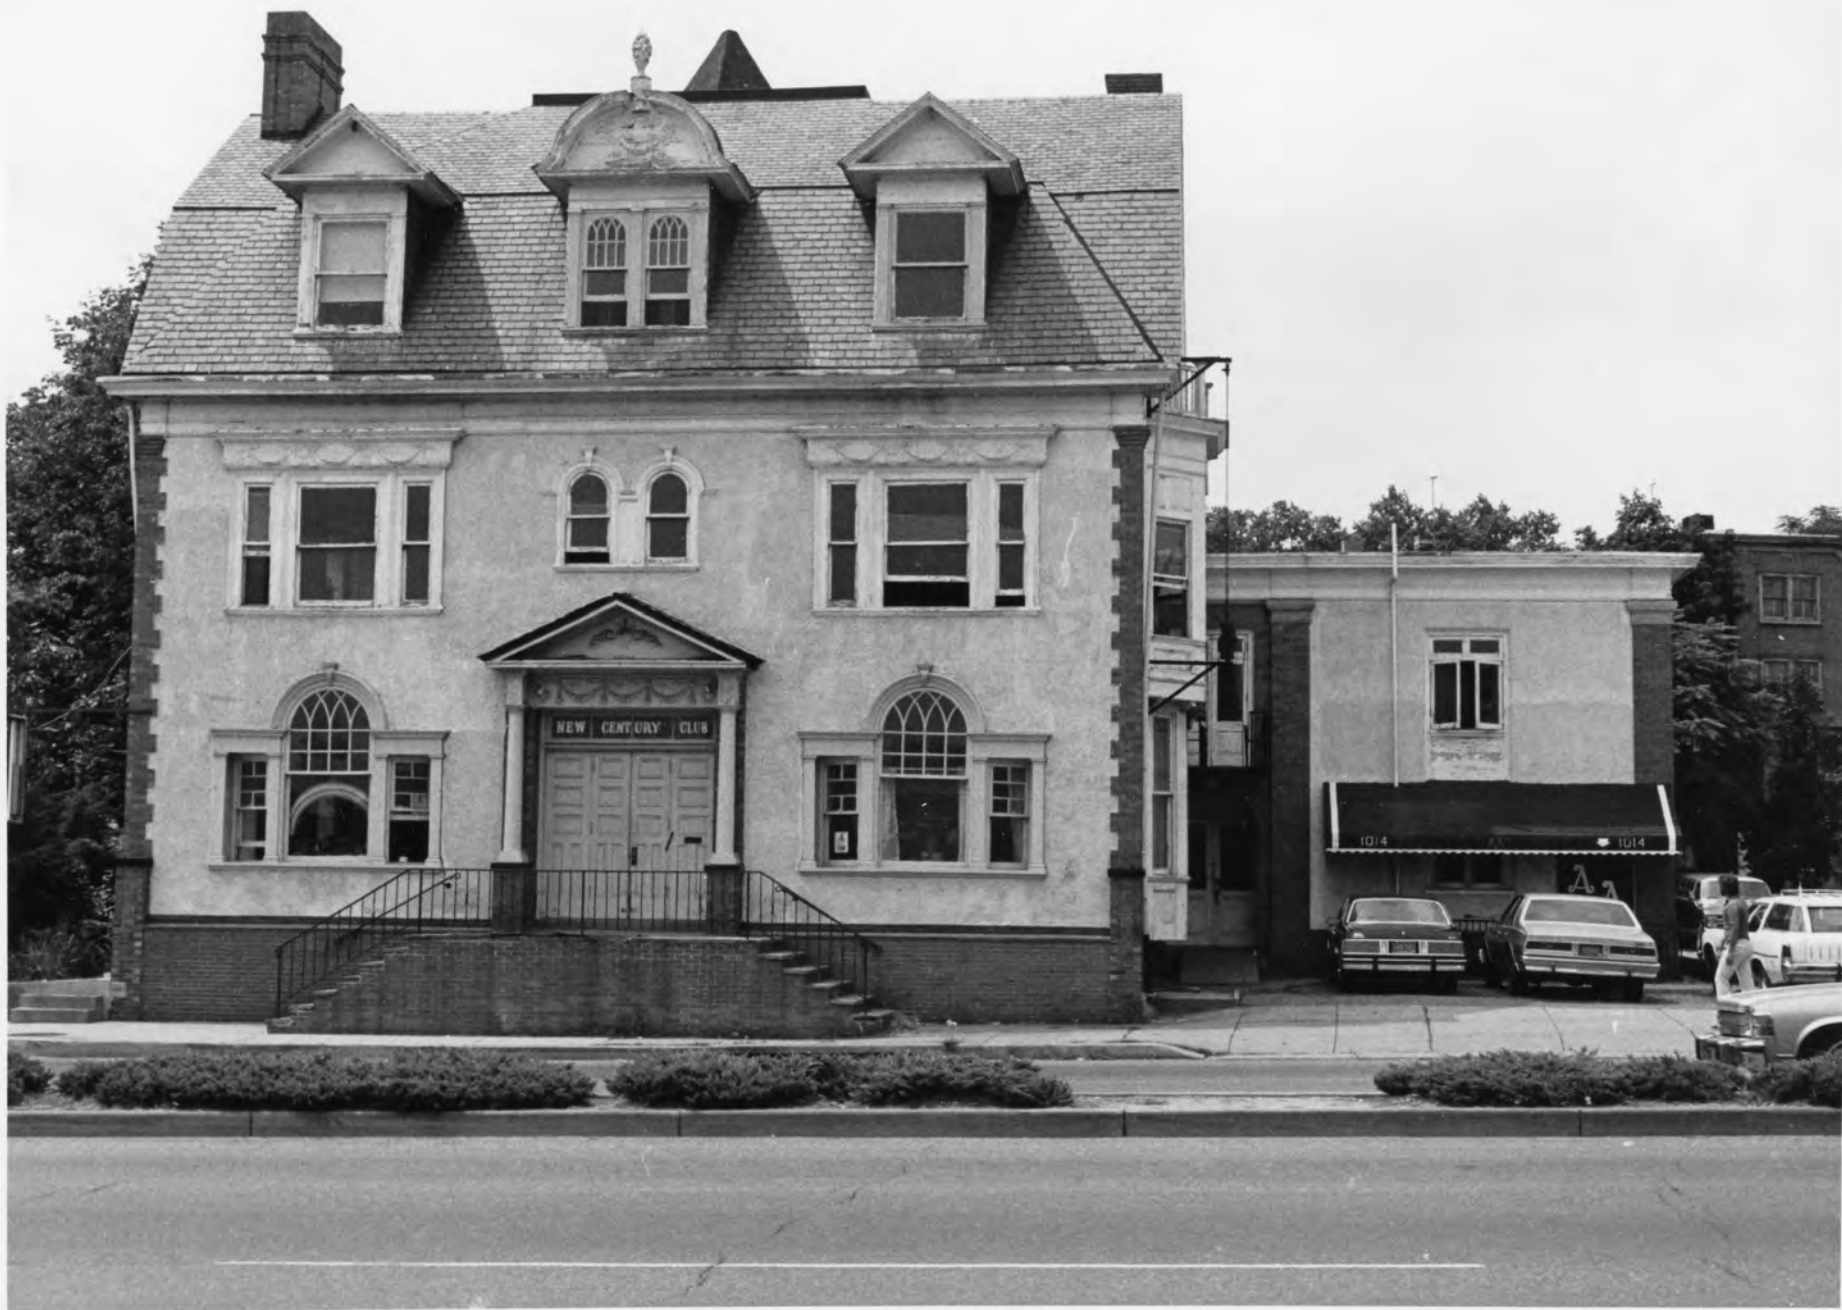
Photograph Number: 2

Description: DELAWARE AVE. FACADE, including annex
NORTH WALL

The gambrel roof has a further slight roof projection into which three dormers are set. The two outside dormers have a gable roof with a pediment and are one over one. The center dormer has a double window with round arch upper sashes, a bell-shaped hood with a broken pediment, and a tall urn-like finial rising from the center. Below the pediment break is a garland decoration. The building's west side has a one-story addition which houses a kitchen, large serving room, and bathrooms (photo #2, exterior). The western wall of this addition has five double sash windows with transoms and intersecting tracery in the upper sash. These windows were apparently removed from a five-window bay on the building's original western wall and reinstalled in the new addition.

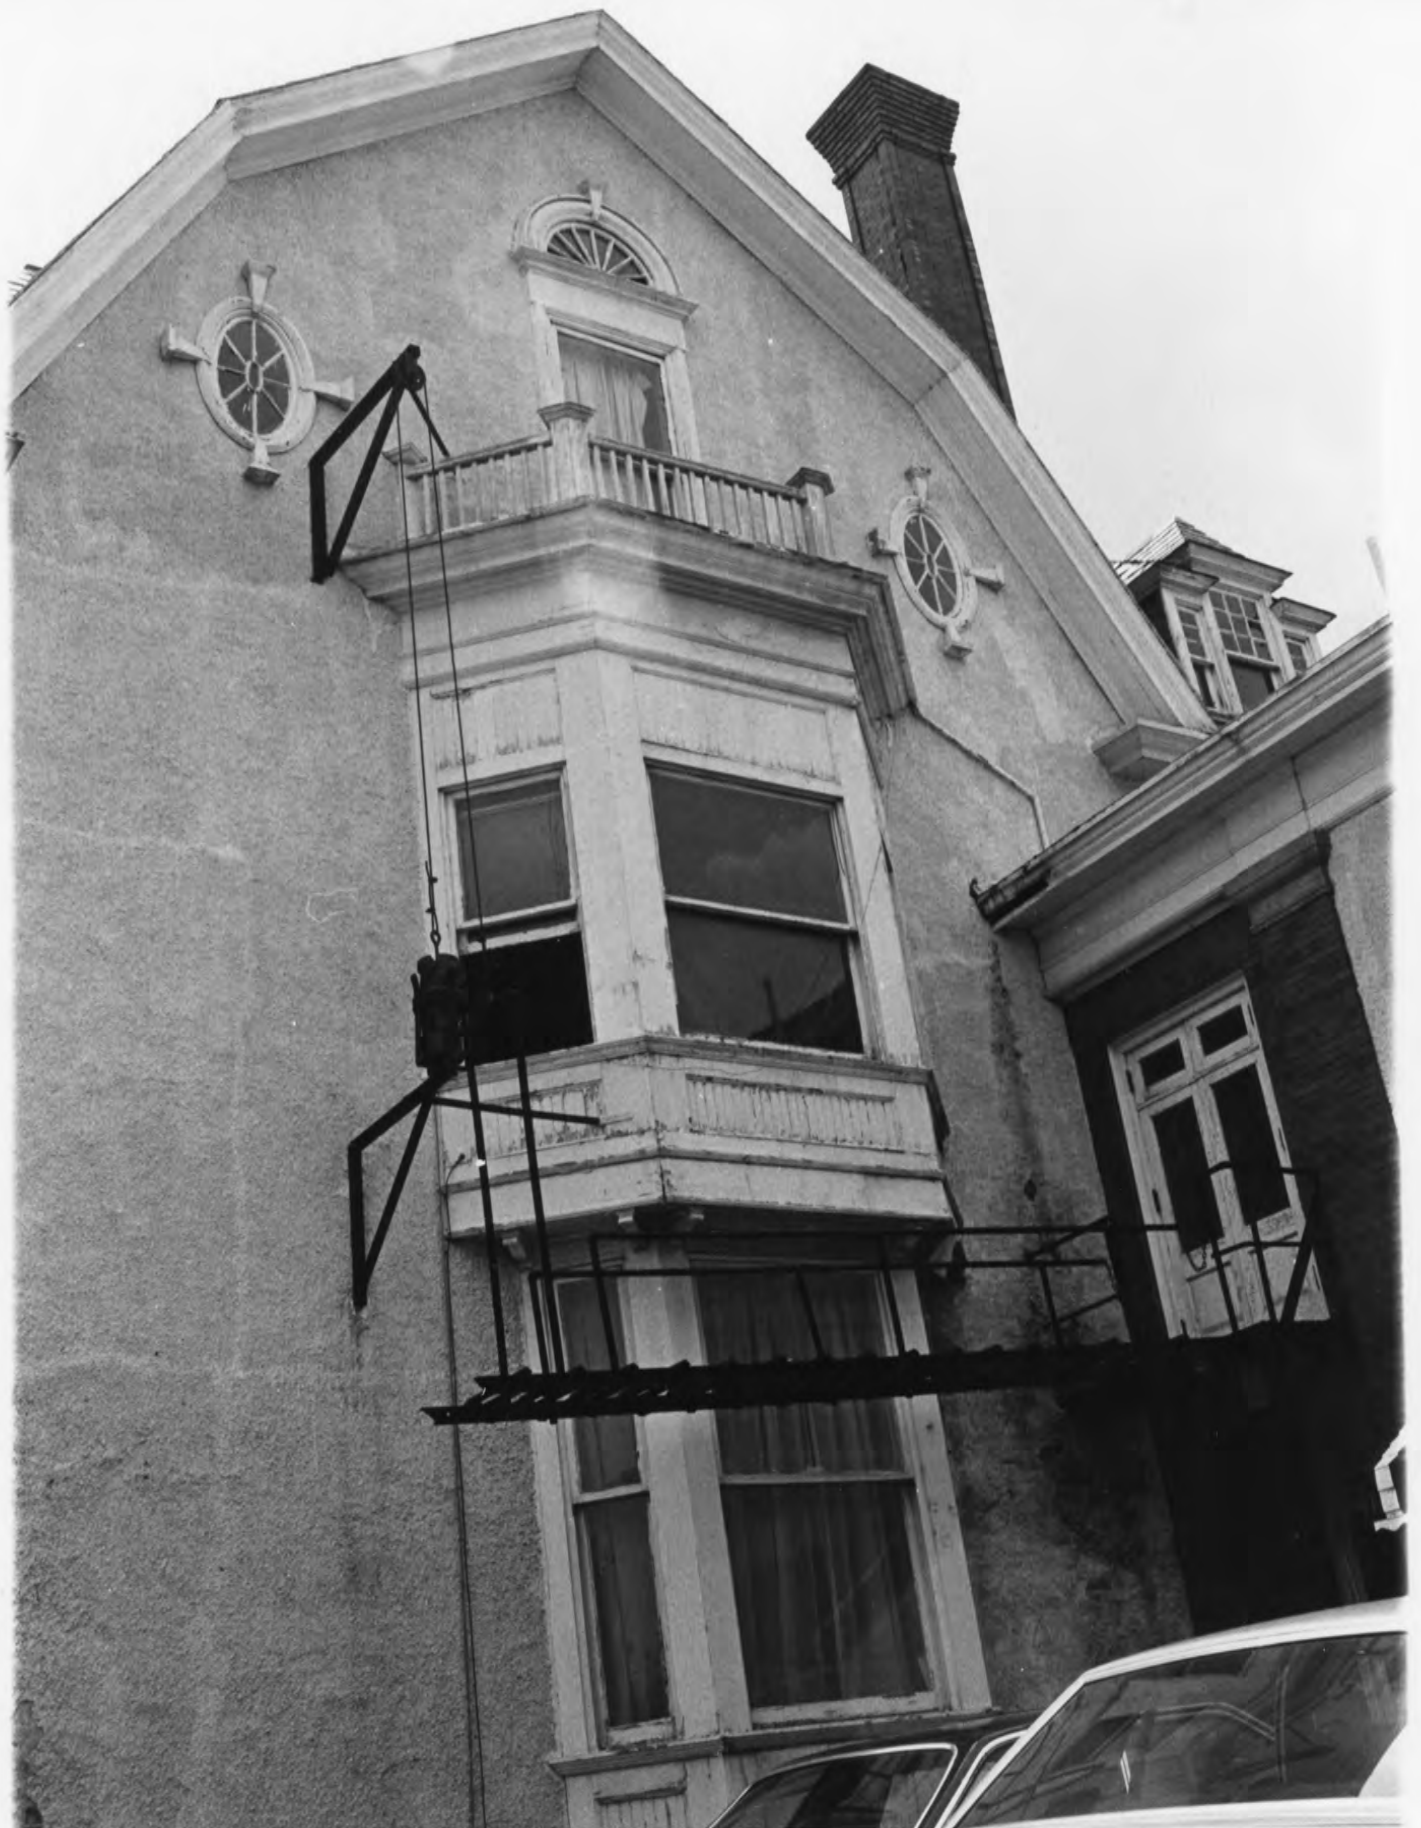
Photograph Number: 3

Description: WEST Wall, original building

The remaining west wall of the original front section of the building (photo #3, exterior) has a shallow, three-window bay on the first floor, with a wider second floor bay above. The second floor bay has a molded cornice and balustrade. Above the cornice of the third floor center window is a fanlight which features radiating muntins and a small wooden keystone. On either side of the third floor center window are oval windows with a molded surround, radiating muntins and decorative wooden keystones on all four sides.

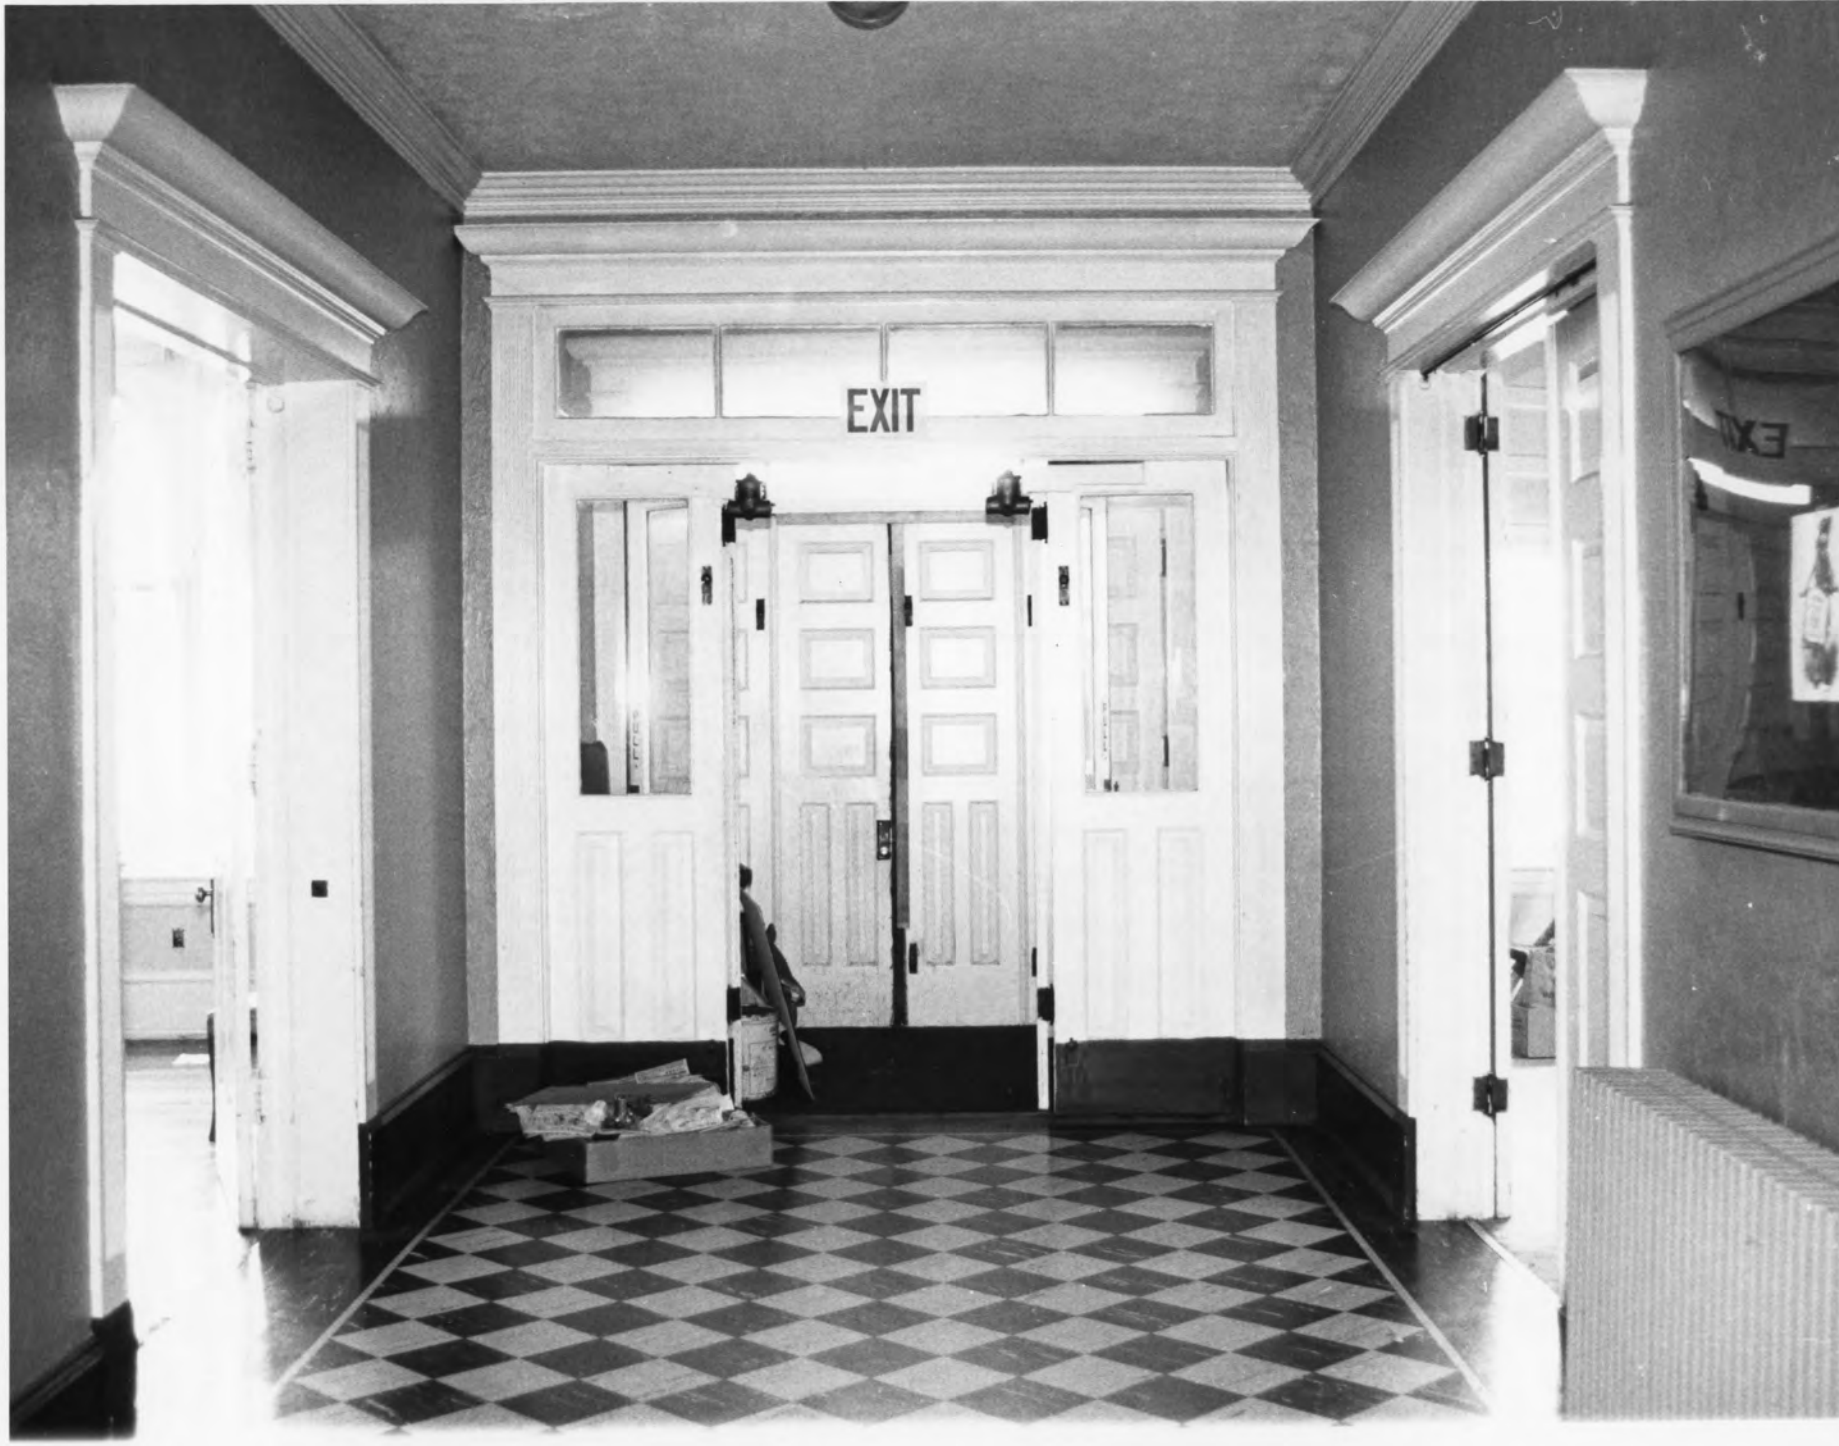
Photograph Number: 4

Description: ENTRANCE VESTIBULE and MAIN HALLWAY,
looking north

The building's exterior symmetry continues in the first floor interior. On entering the Delaware Avenue entrance, one passes through a small vestibule, through an interior set of double doors and into the main hallway. Original doors, molding and pilasters remain intact (photo #4, interior). On either side of the hallway are large airy offices with fireplaces and Palladian windows at their north ends (photo #5, interior).

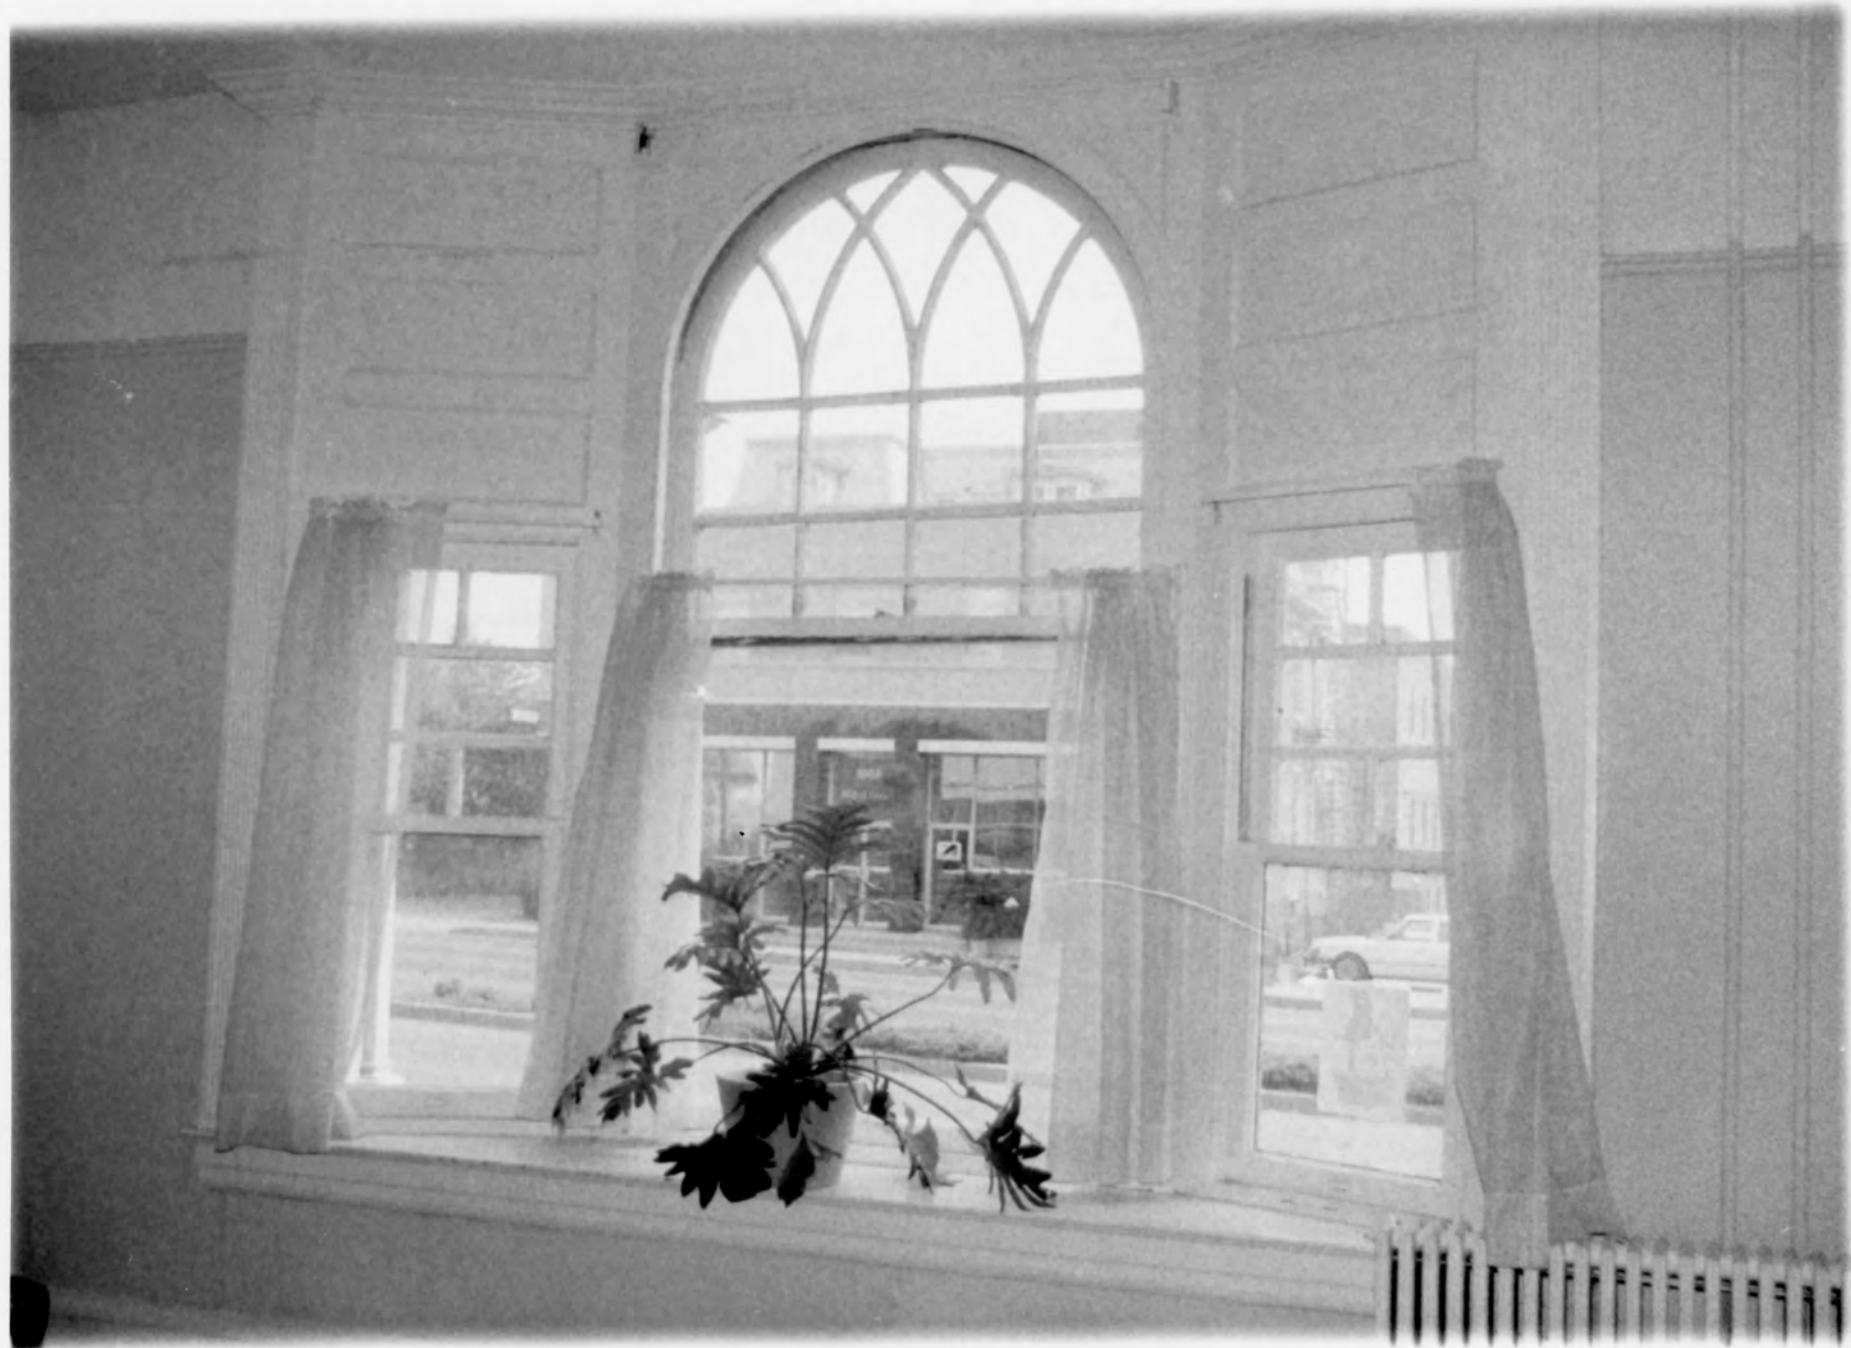
Photograph Number: 5

Description: INTERIOR, FIRST floor front room,
looking north at Del. Ave.

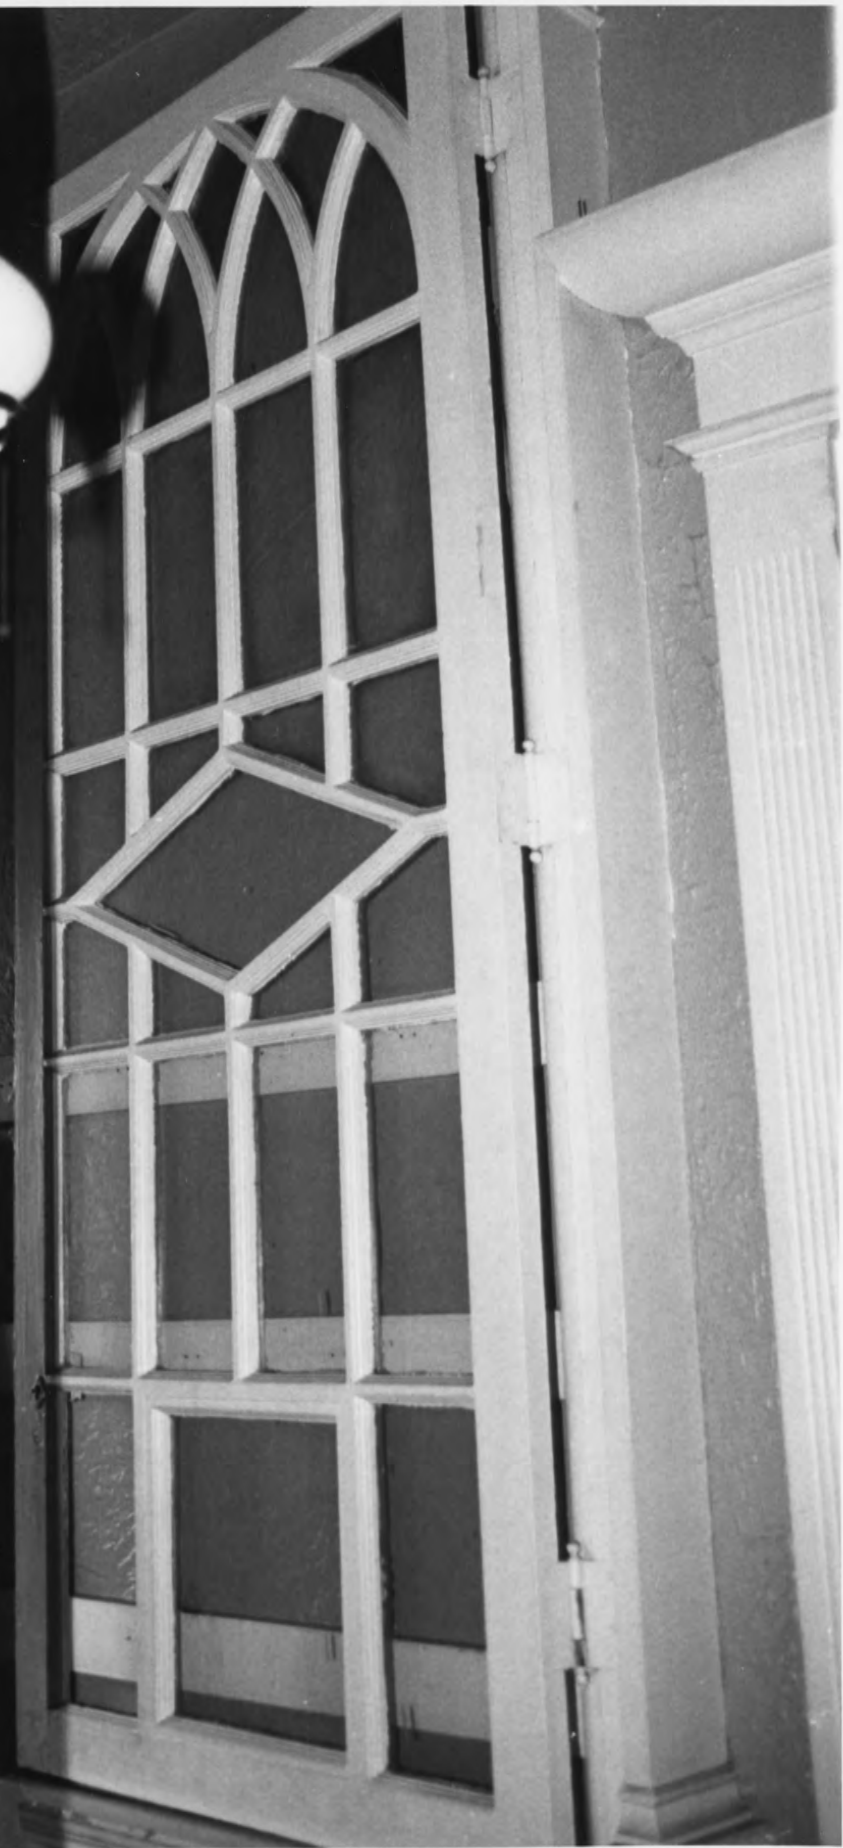
Photograph Number: 6

Description: INTERIOR, DOOR to BAR on east side
of main hall

Further down the black and white, diagonally tiled hallway to the left is a Dutch style doorway on the entry way to the bar, ornamented by an upper door part with a decorative pattern of tracery found on many of the building's windows. An adjacent gas light also remains (photo #6, interior). To the right is a side hallway leading to the men's lounge and rest room. Also to the right are the stairs to the upper floors. The stairs have the original newell post, ballusters, and vitruvian scrollwork (photos #7, #8, interior). The main hall is also graced by a brass early 20th century chandelier (photo #9, interior).

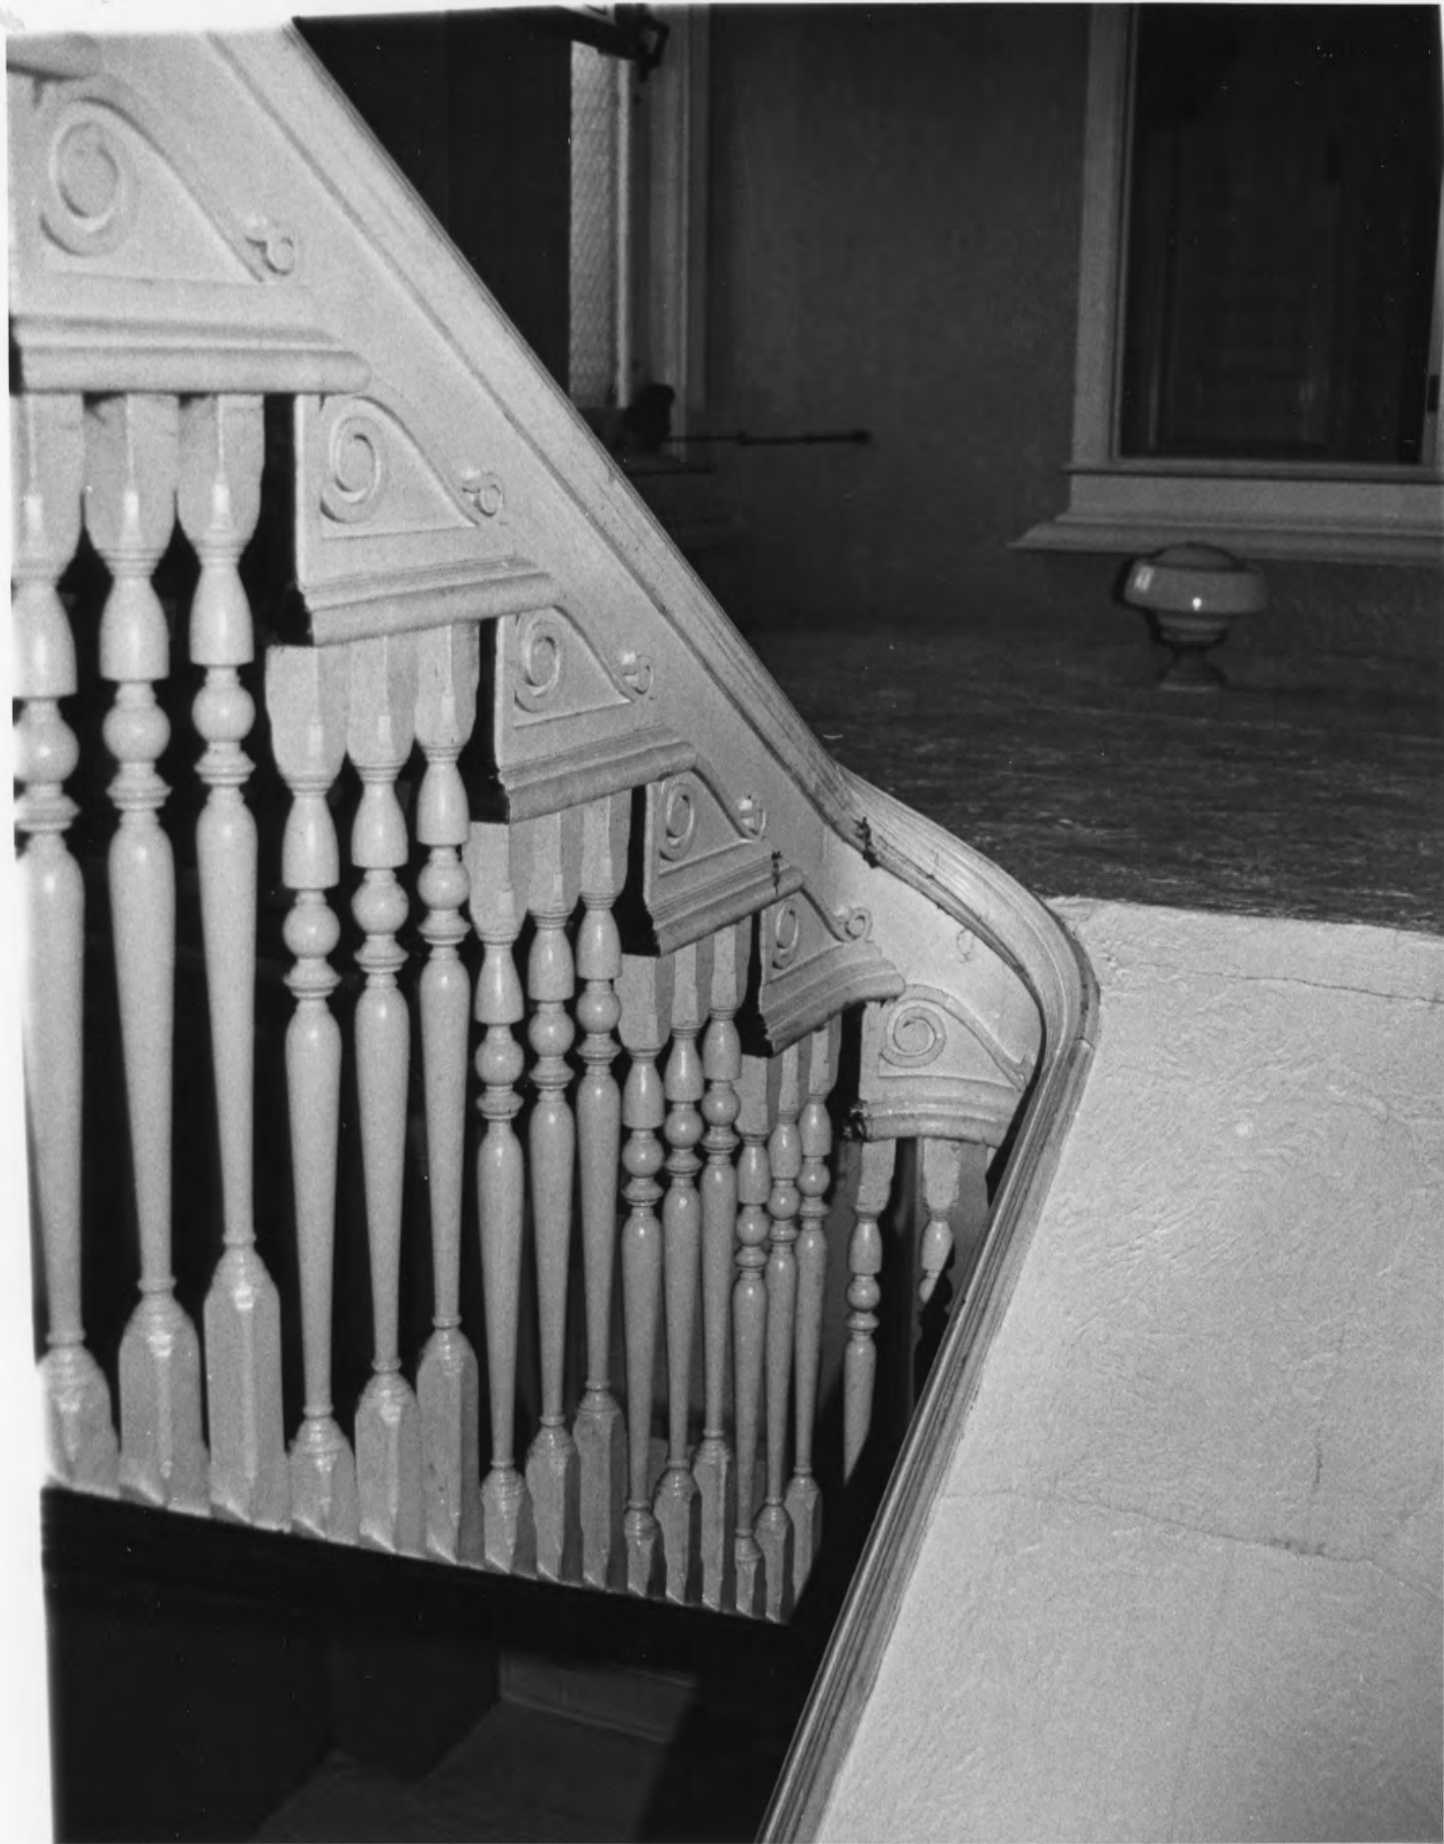
Photograph Number: 7

Description: STAIRWAY balusters and molding ; west side
of main hallway

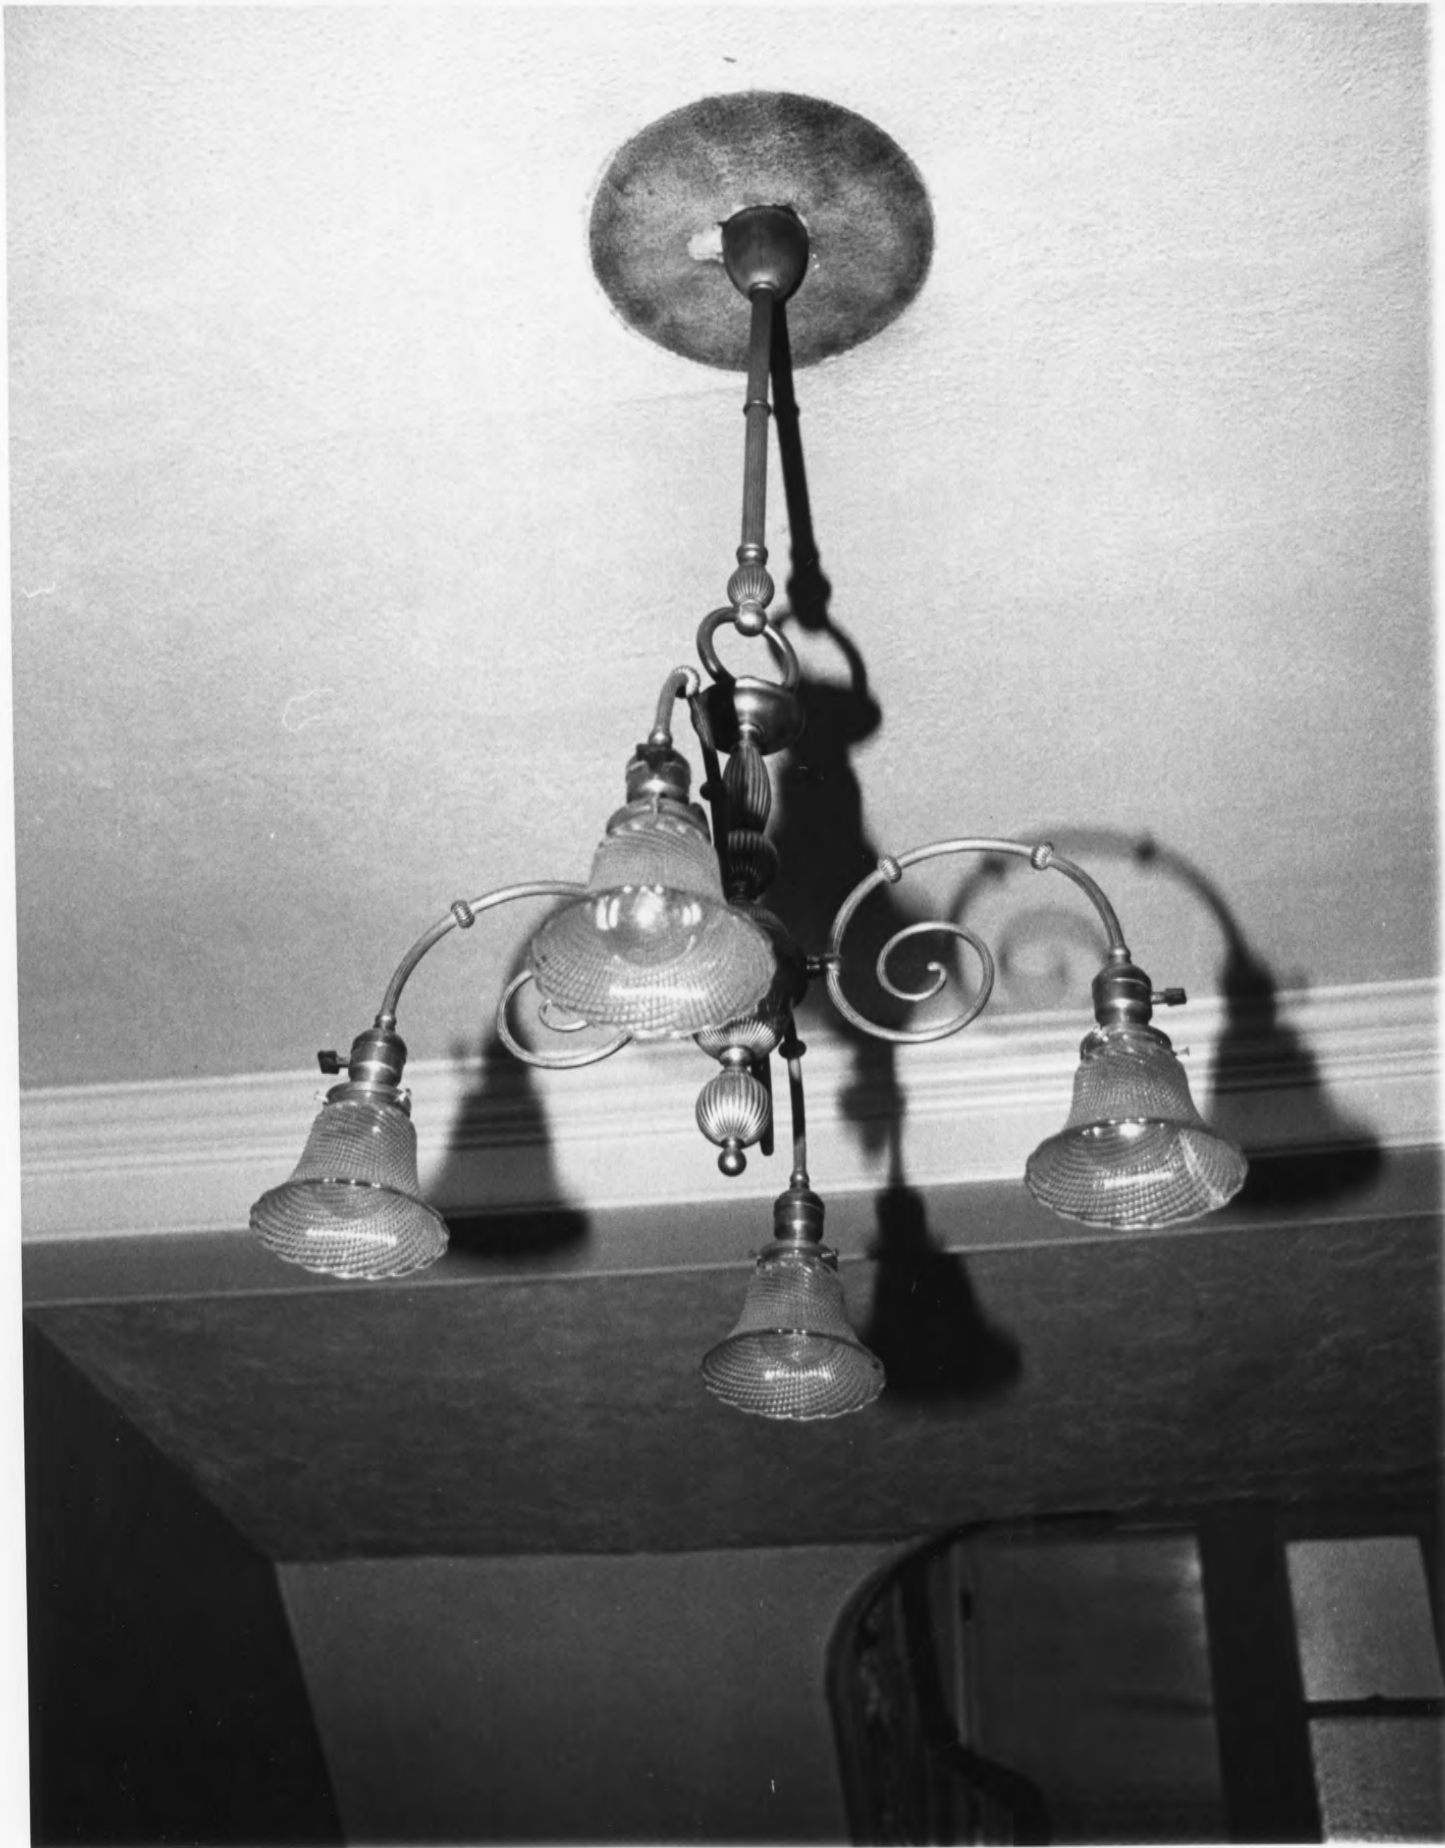
Photograph Number: 9

Description: BRASS Chandelier, MAIN HALLWAY
