National Register of Historic Places Inventory—Nomination Form

historic New Century Club

street & number 1014 Delaware Avenue not for publication

NEW CENTURY CLUB DESCRIPTION

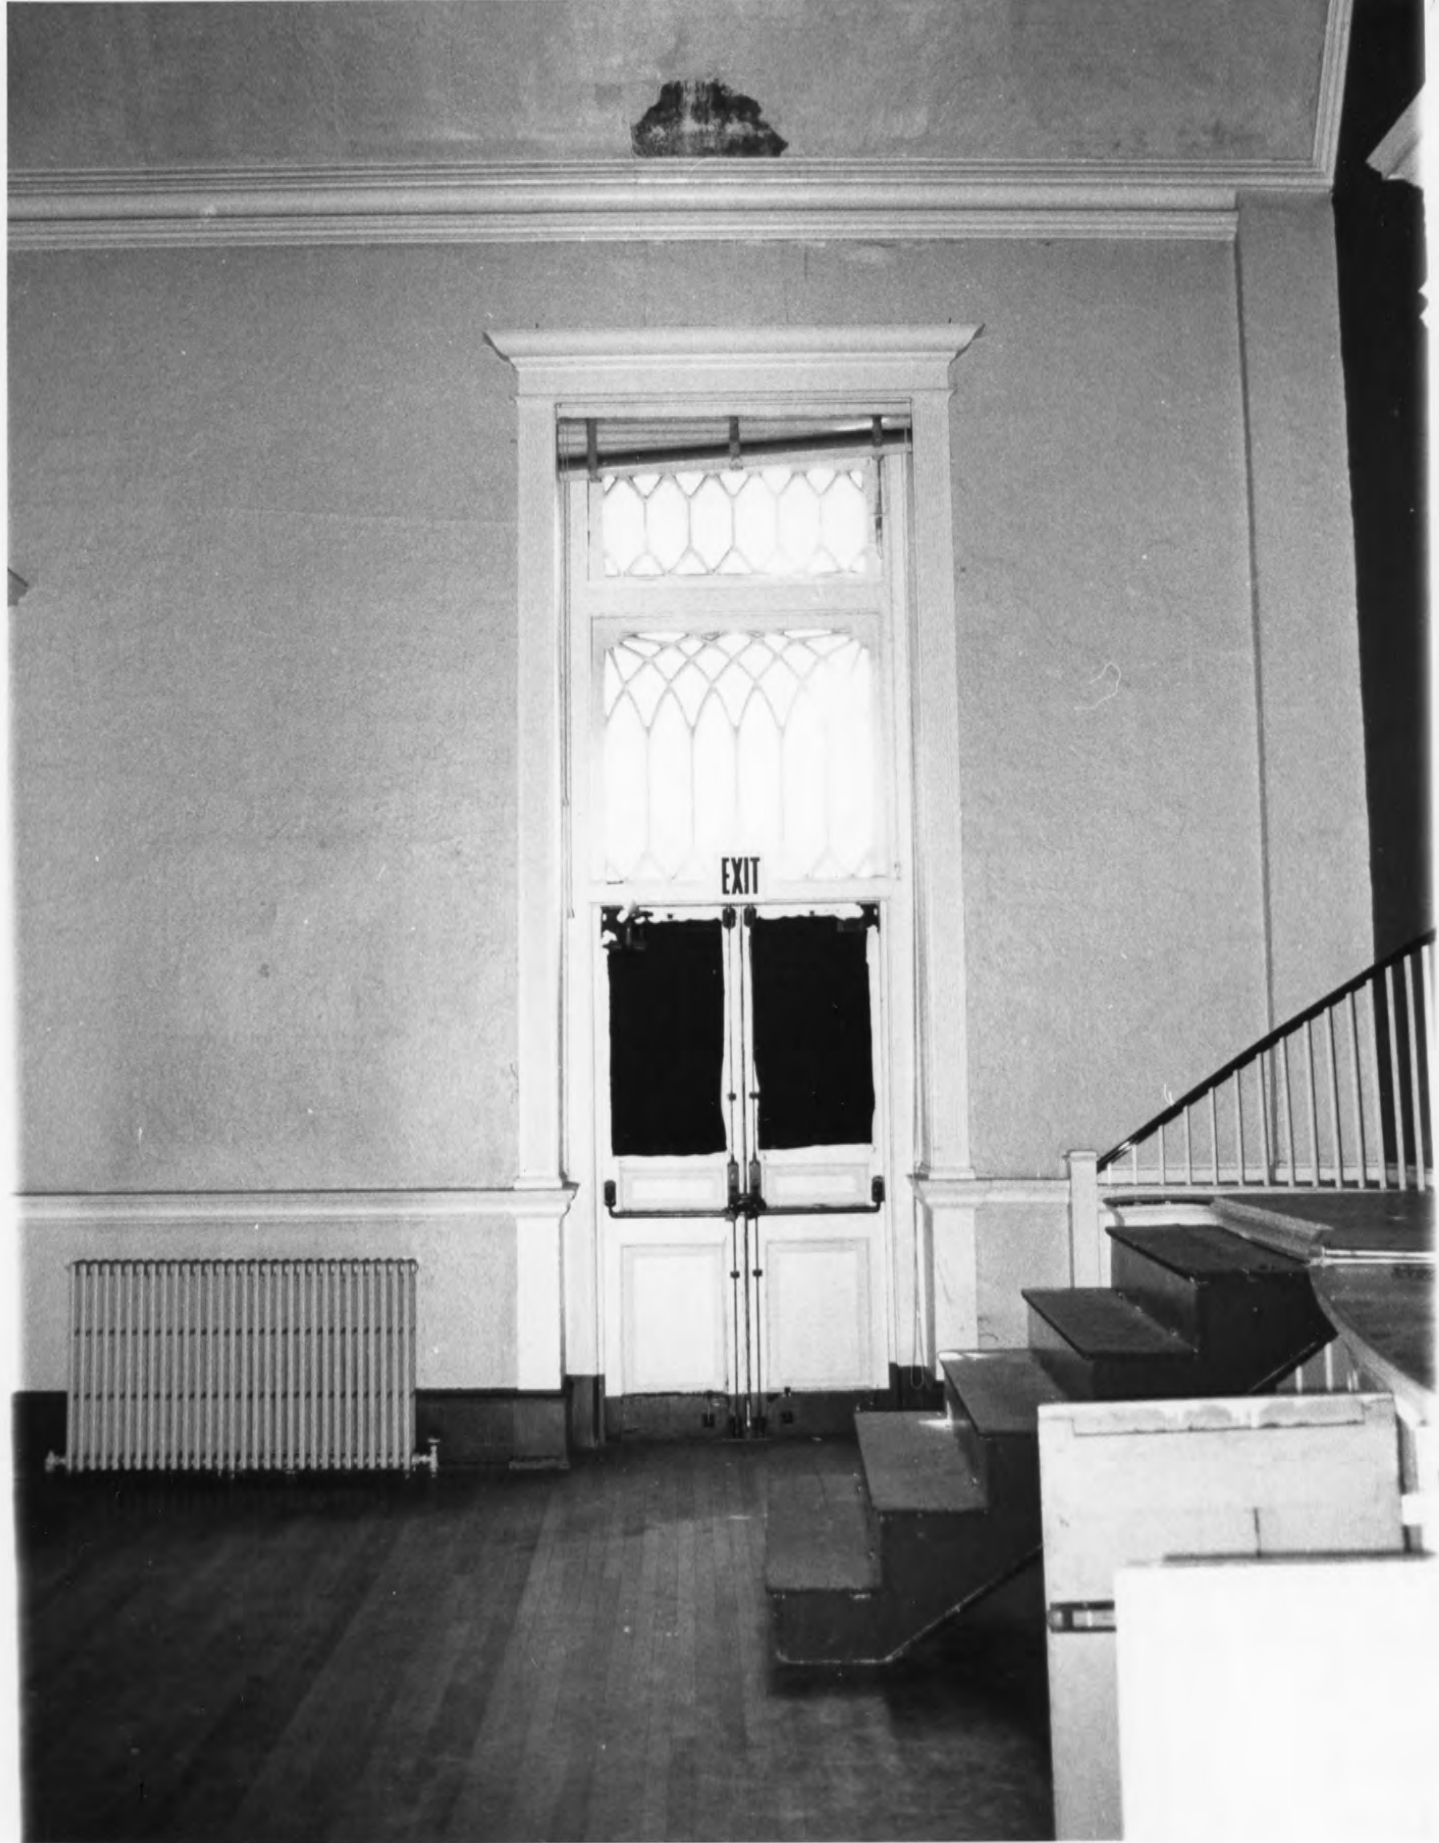
Photograph Number: 10

Description: SIDE DOOR IN EAST WALL, off auditorium
also shows chair rail.

Directly ahead (looking south from the main hall) is the large assembly area and stage. The main room's flooring is oak stripping with 12 inch molded wood baseboard. A three foot high chair rail encircles the room on three walls to meet the stage at floor level (photo #10, interior). The walls are textured plaster. Entry ways have the molding and pilasters found in the front hallway. Windows retain either the palladian shape or tracery (photo #11, interior).

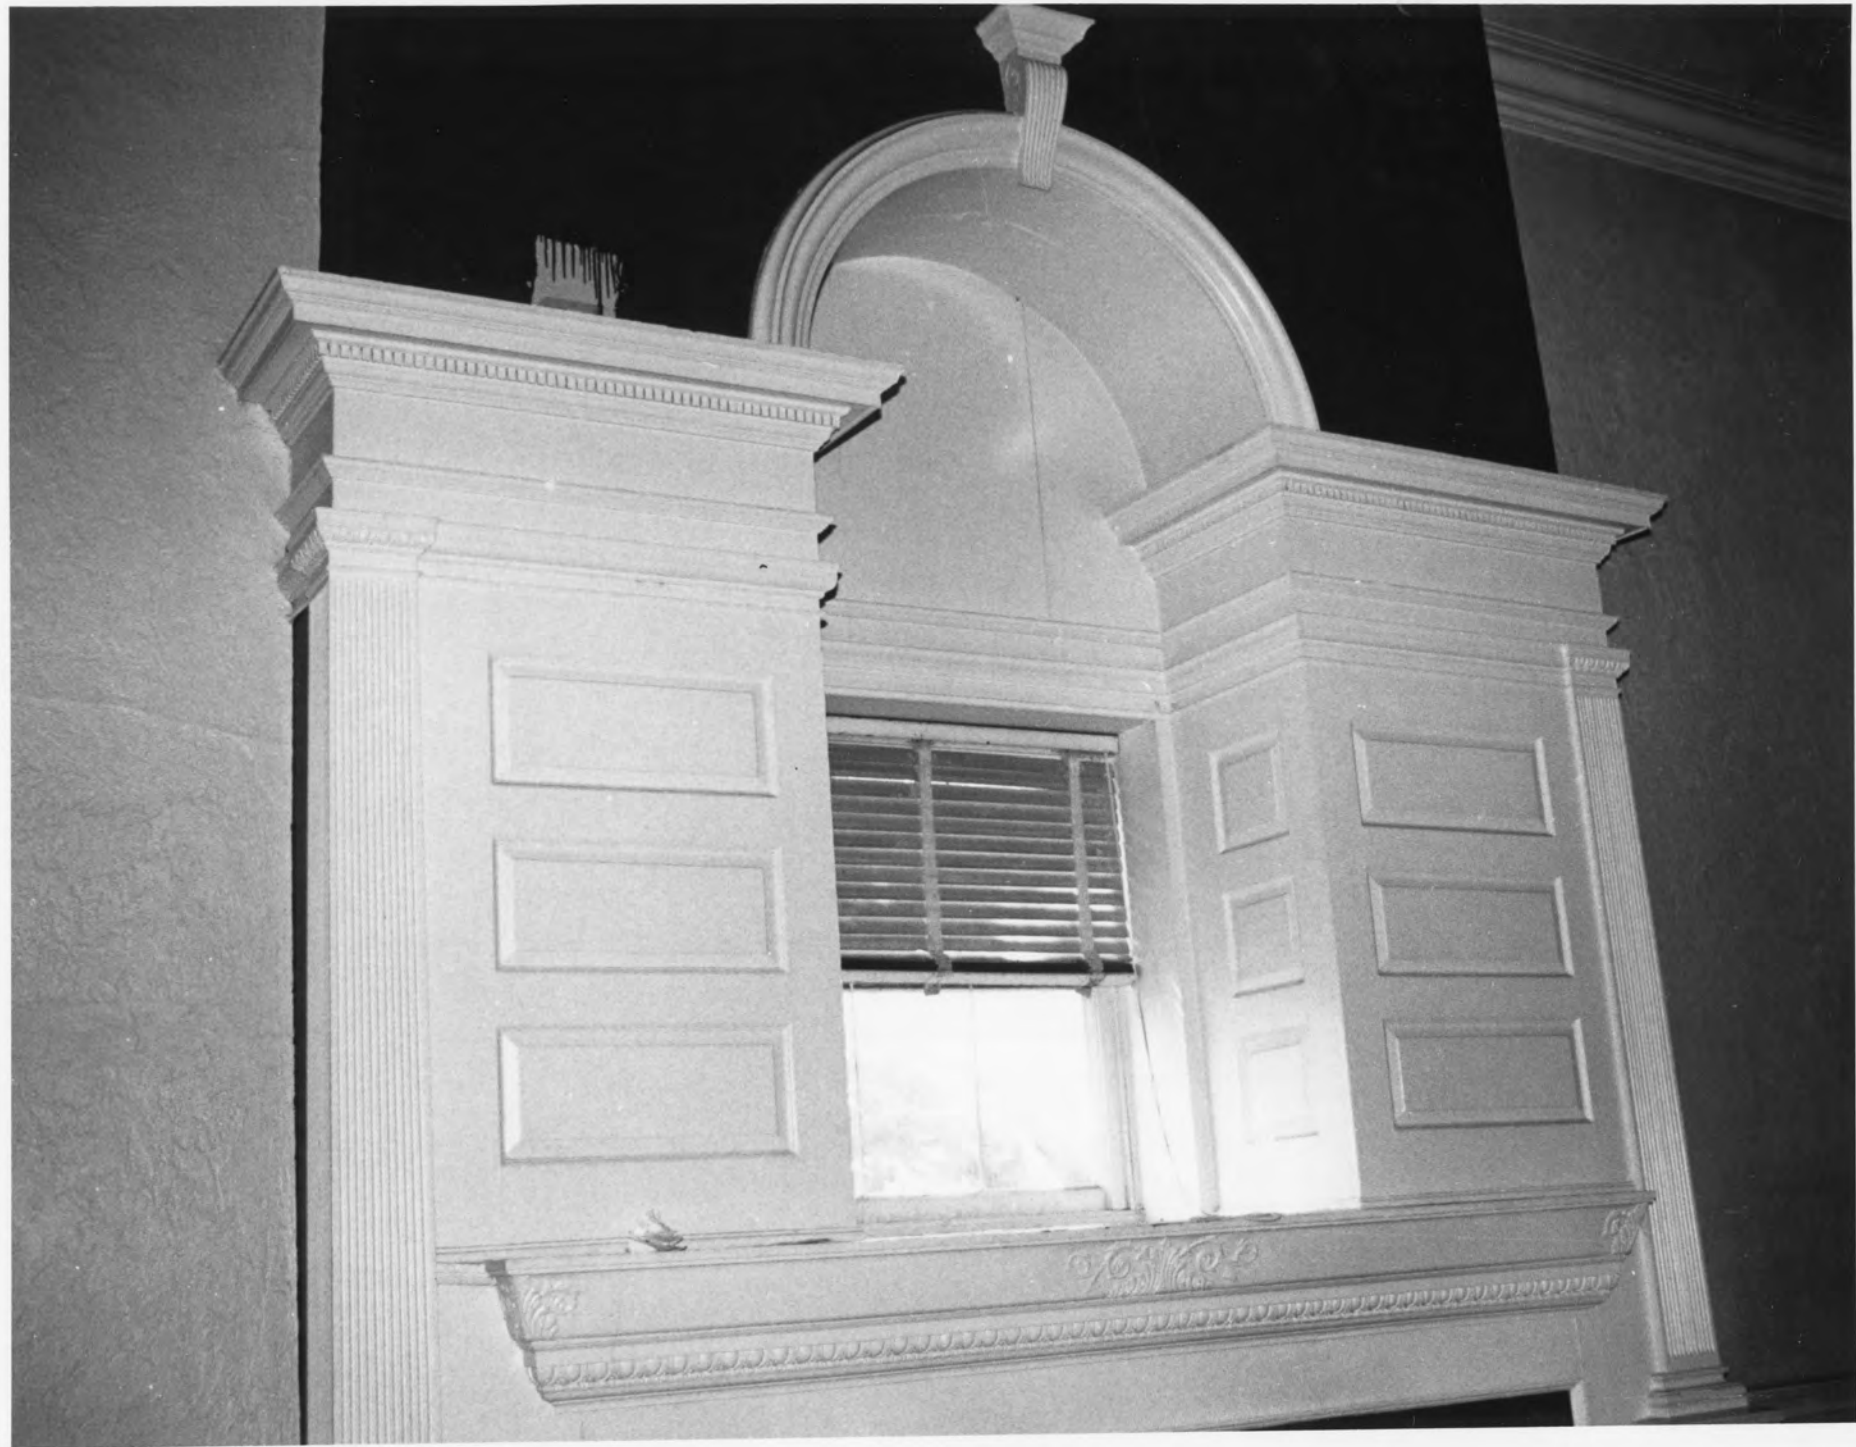
Name: NEW CENTURY CLUB
Location: 1014 DELAWARE AVE. , WILMINGTON, DE.
Photographer: PATRICIA MALEY
Date: SUMMER 1982
Location of Negative:
WILMINGTON PLANNING OFFICE
WILMINGTON, DE.
Description: WINDOW, above fireplace, east wall of
auditorium
Photograph Number: 11

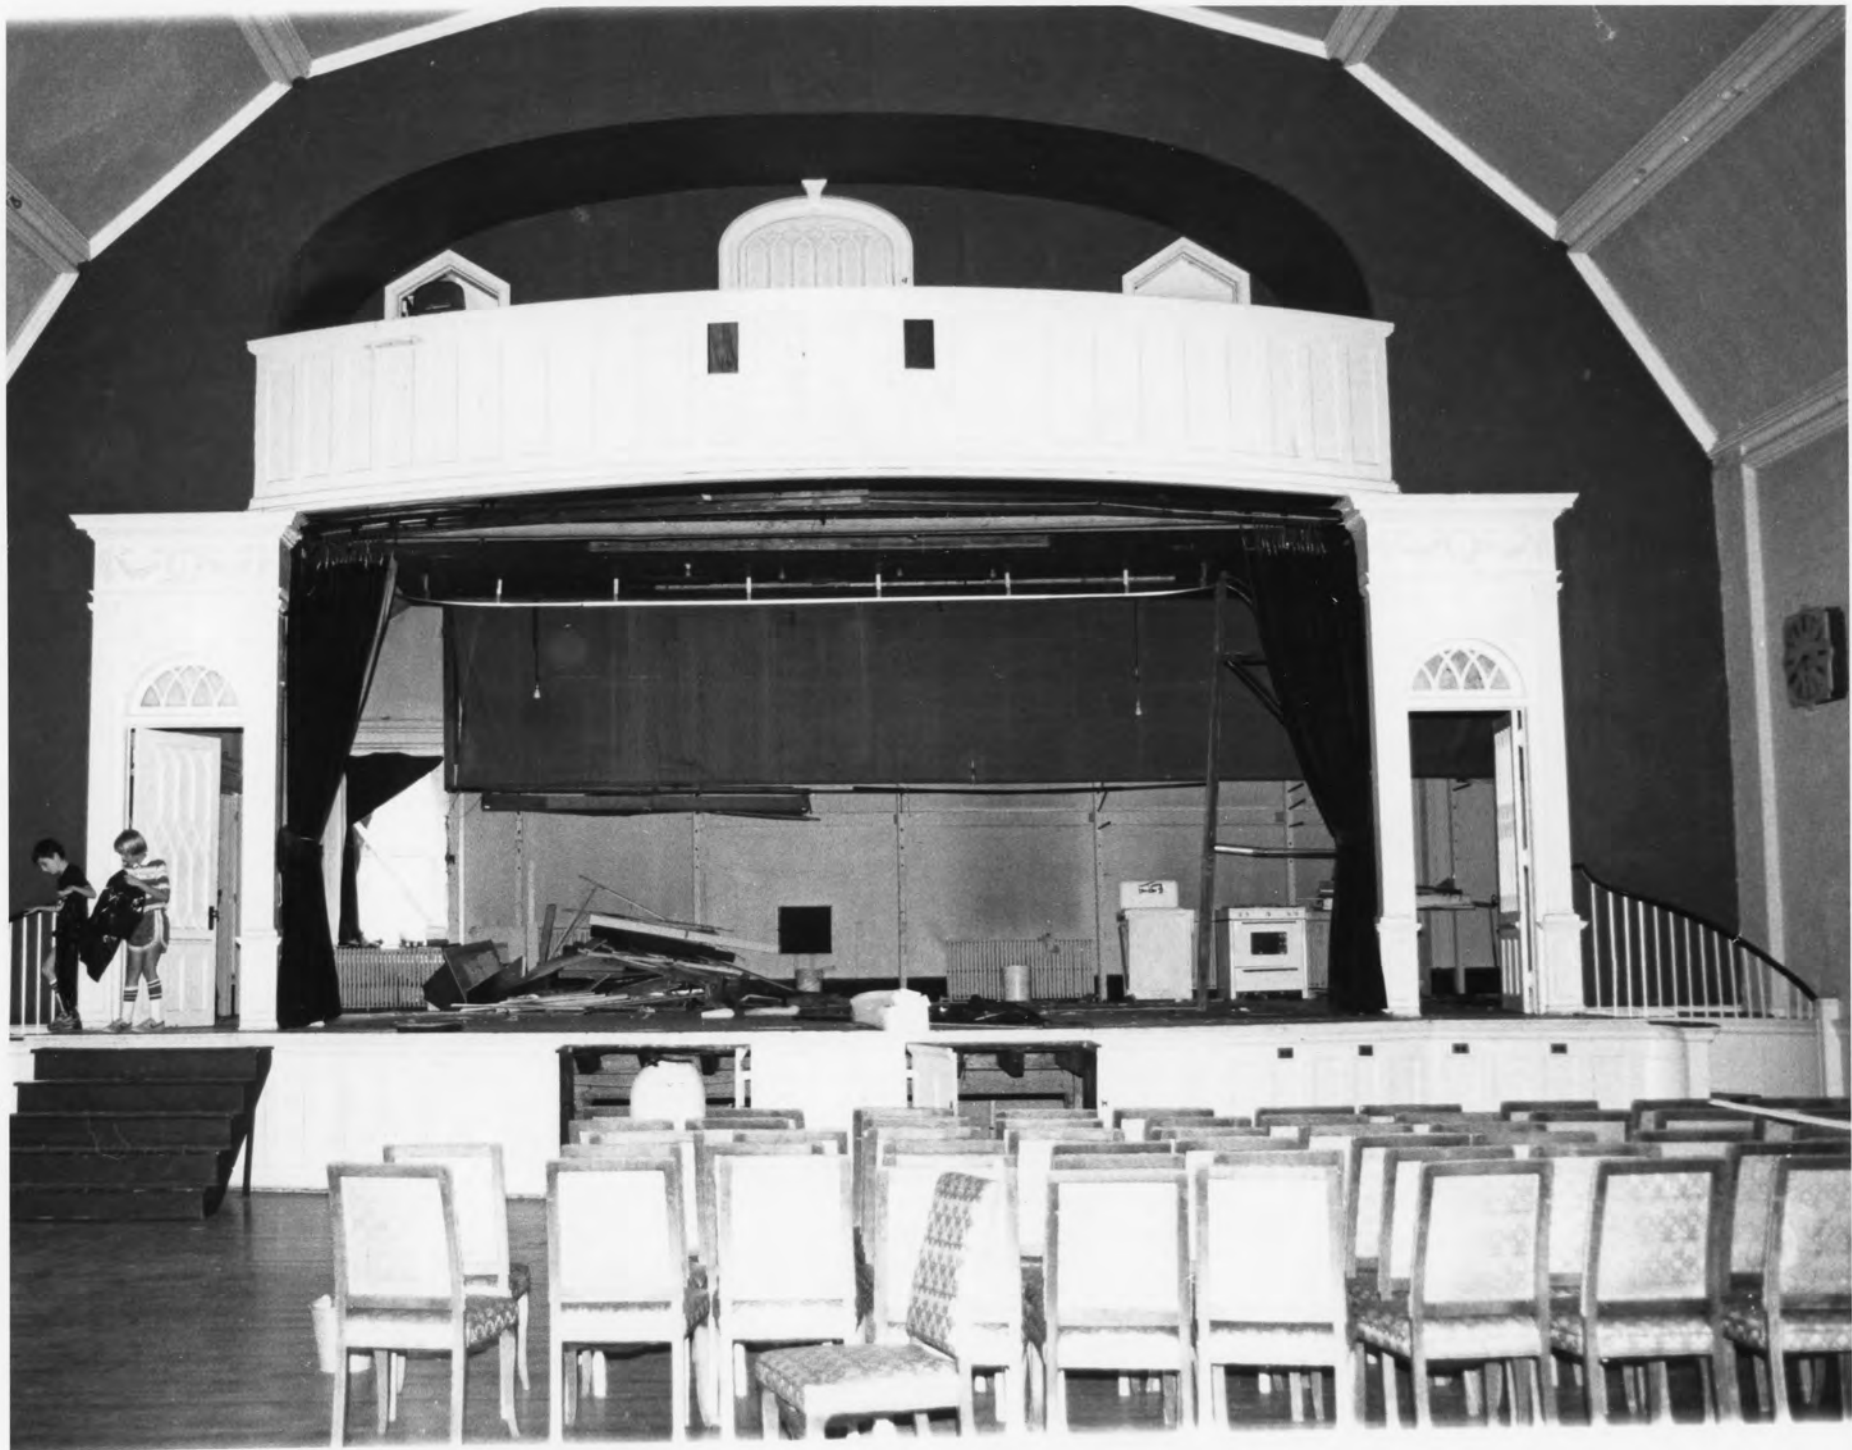
Photograph Number: 12

Description: STAGE, looking south

The stage has symmetrically placed doorways and stair approaches with curved handrails (photo #12, interior). On the east side, back stage, a non-decorative staircase rises to dressing rooms above the stage. The dressing rooms open to the musicians' balcony above the stage through pointed arch doors (photo #13, interior). The auditorium ceiling is of plaster with molding at the wall intersections along two sides of the room. The interior plaster ceiling mirrors the exterior gambrel roof shape. In the center of the ceiling is a round cast iron grill with a scroll and lattice design (photo #14, interior). On the western side of the main room is the annex added in the early 20th century for kitchen and buffet. Entry into the annex may be obtained through large double doors set in a Palladian enclosure with fluted pilasters topped with Ionic detailing (photo #15, interior). Entry into the kitchen section is obtained through either of two five-sunken panel doors. The annex shares the features of the main assembly room in floor, walls, and ornamentation. The western wall of the annex has five windows separated by fluted palasters with plain moldings surrounding the rest of the window. The windows are single hung with the bottom sash being a single light; the upper sash having the tracery found elsewhere in the building. These may be the windows from the original western wall of the building simply moved to the annex wall.

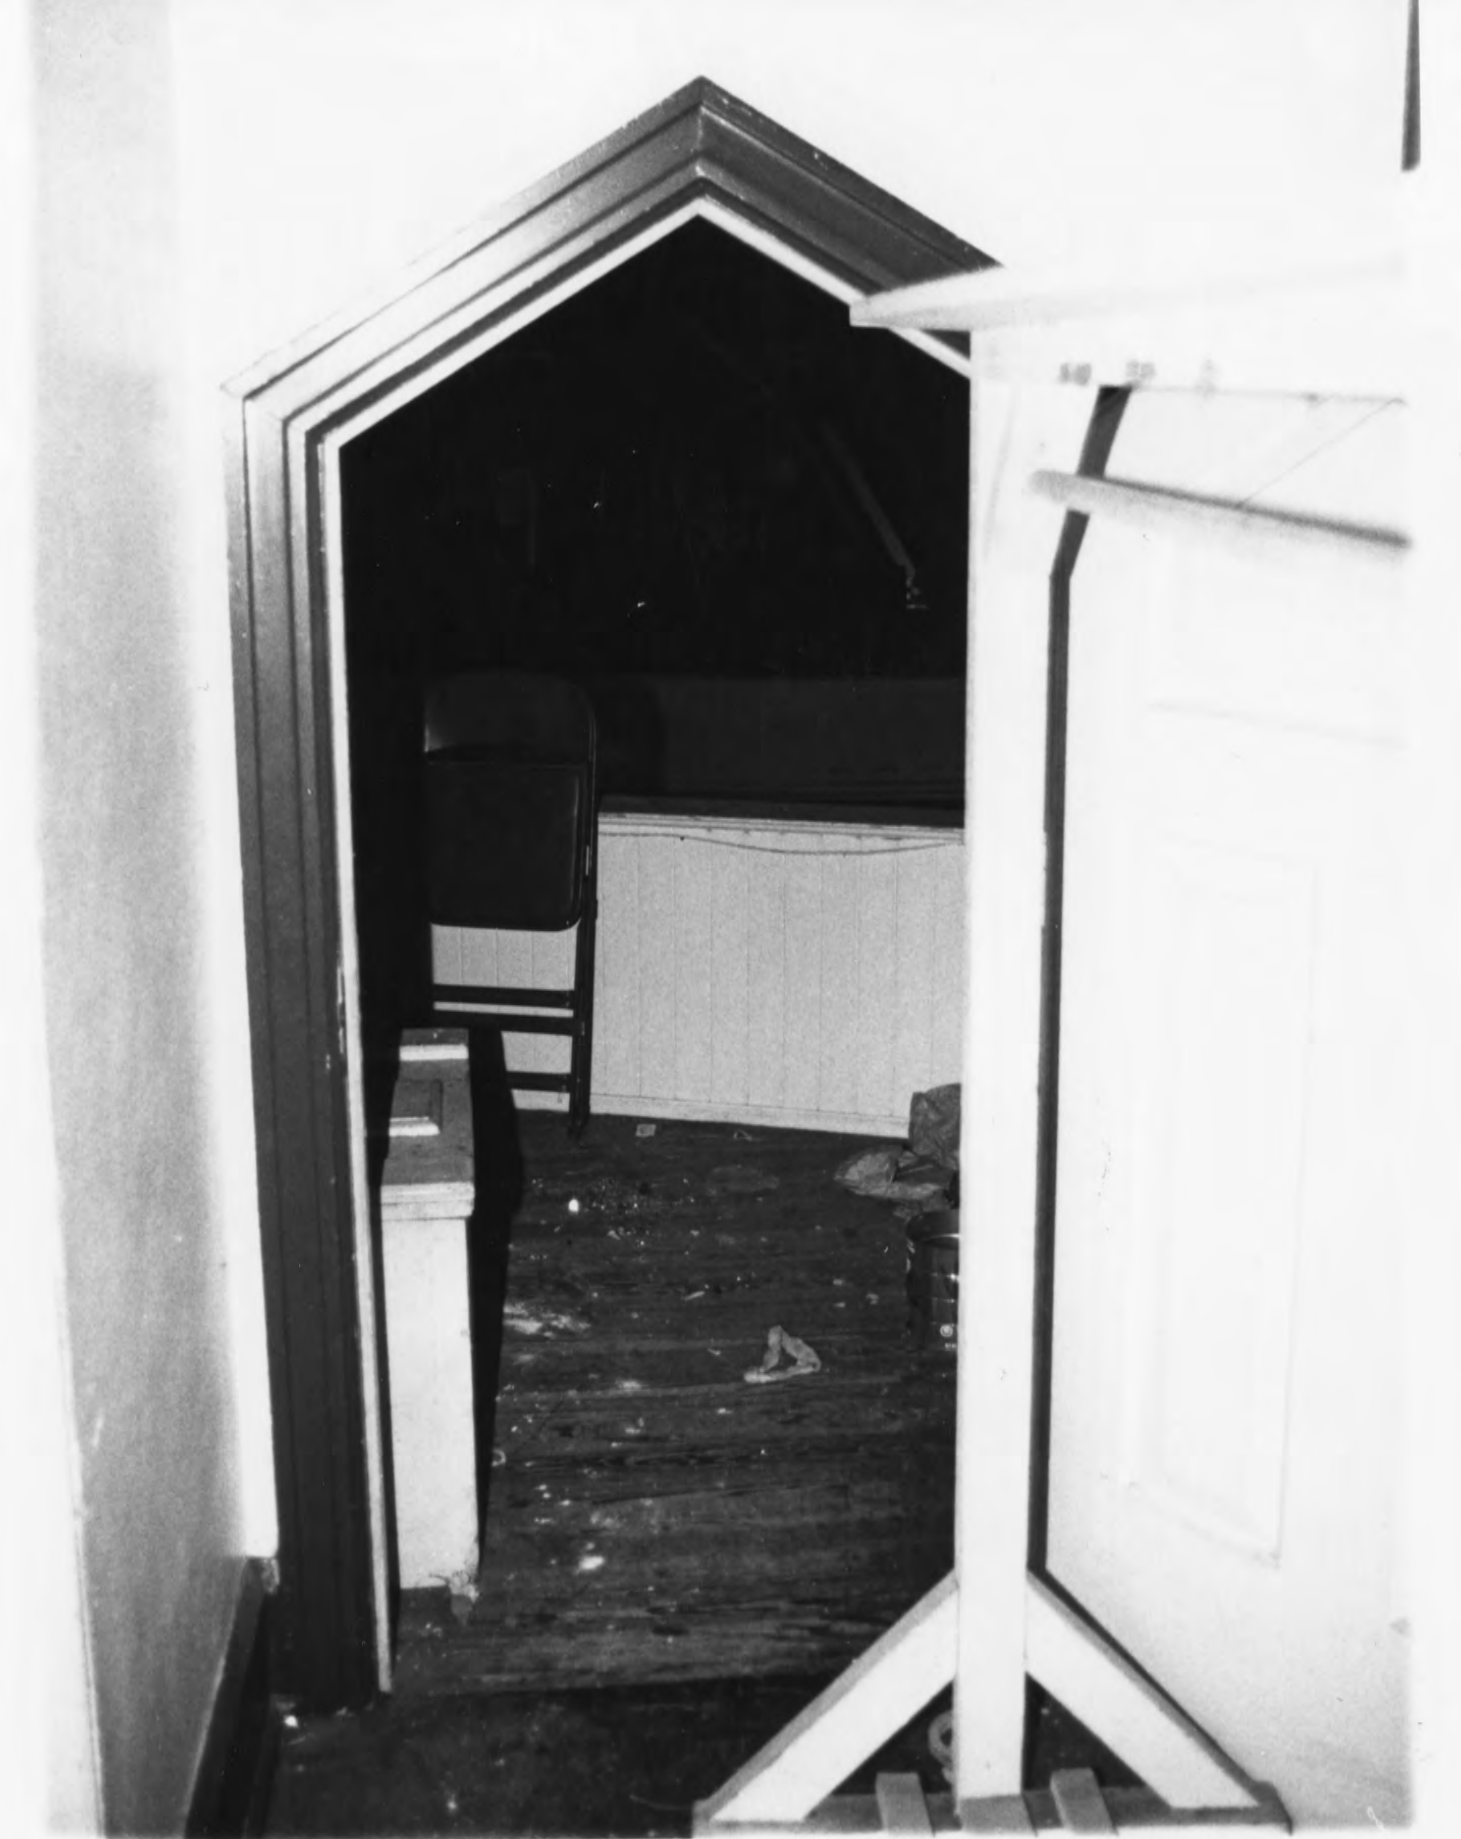
Photograph Number: 13

Description: Doorway from second floor dressing rooms
to balcony above stage (south end of
building)

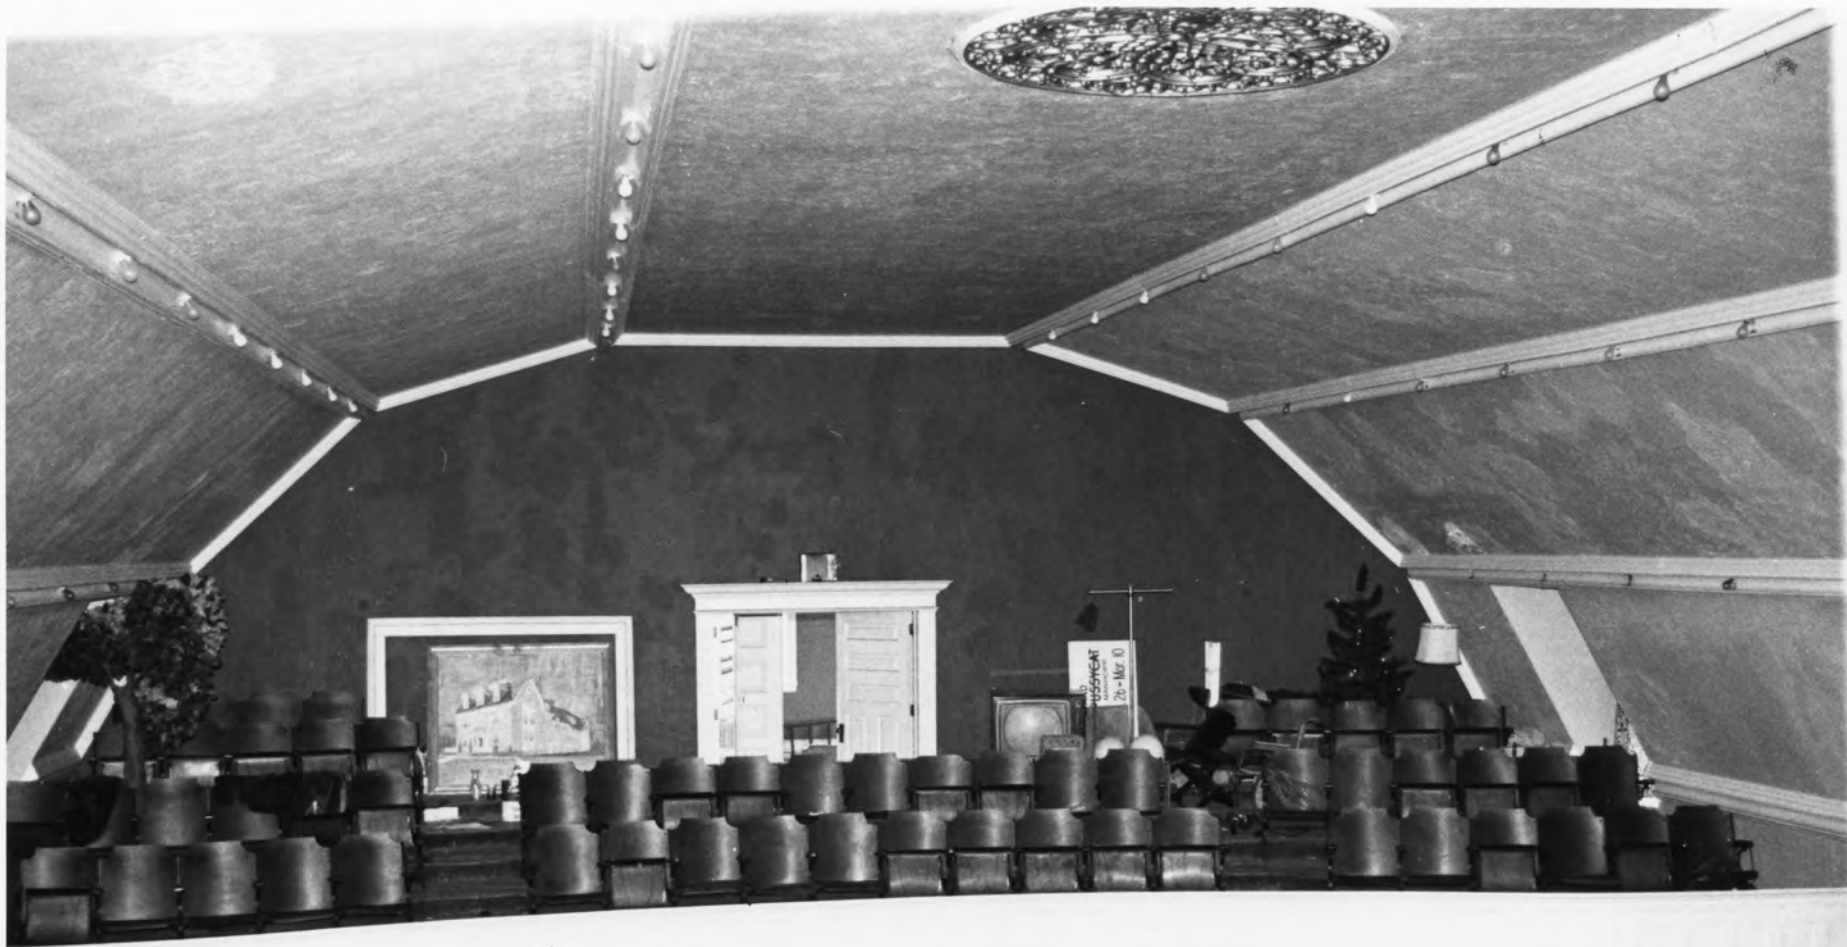
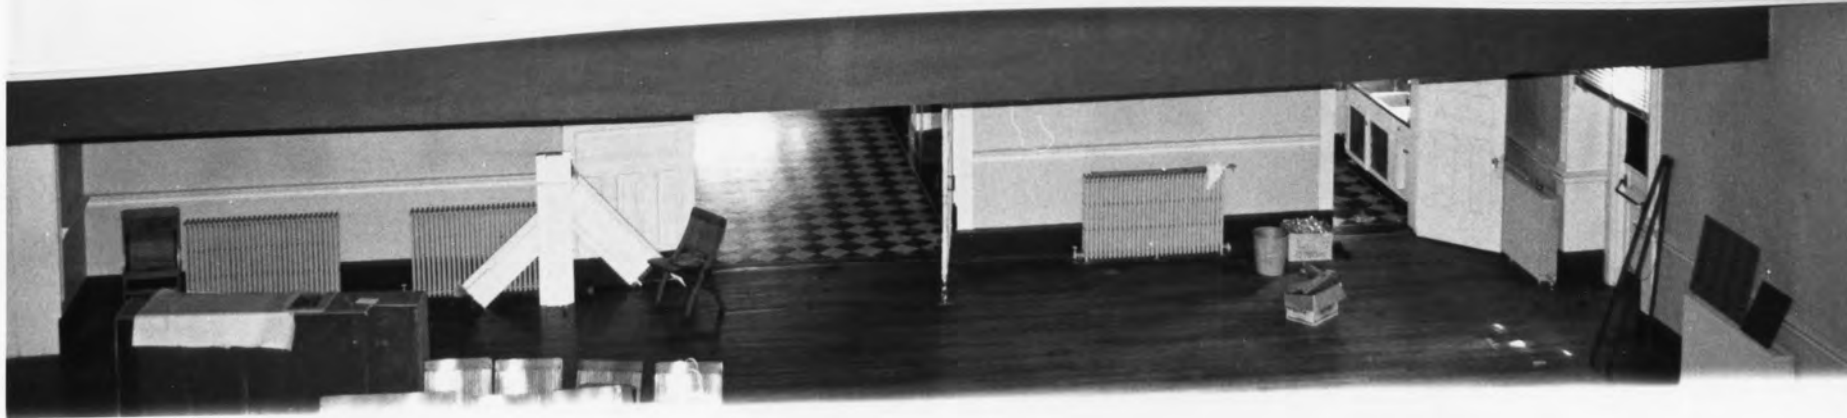
Photograph Number: 14

Description: AUDIENCE balcony at north end of auditorium;
shot, looking north, from balcony above stage

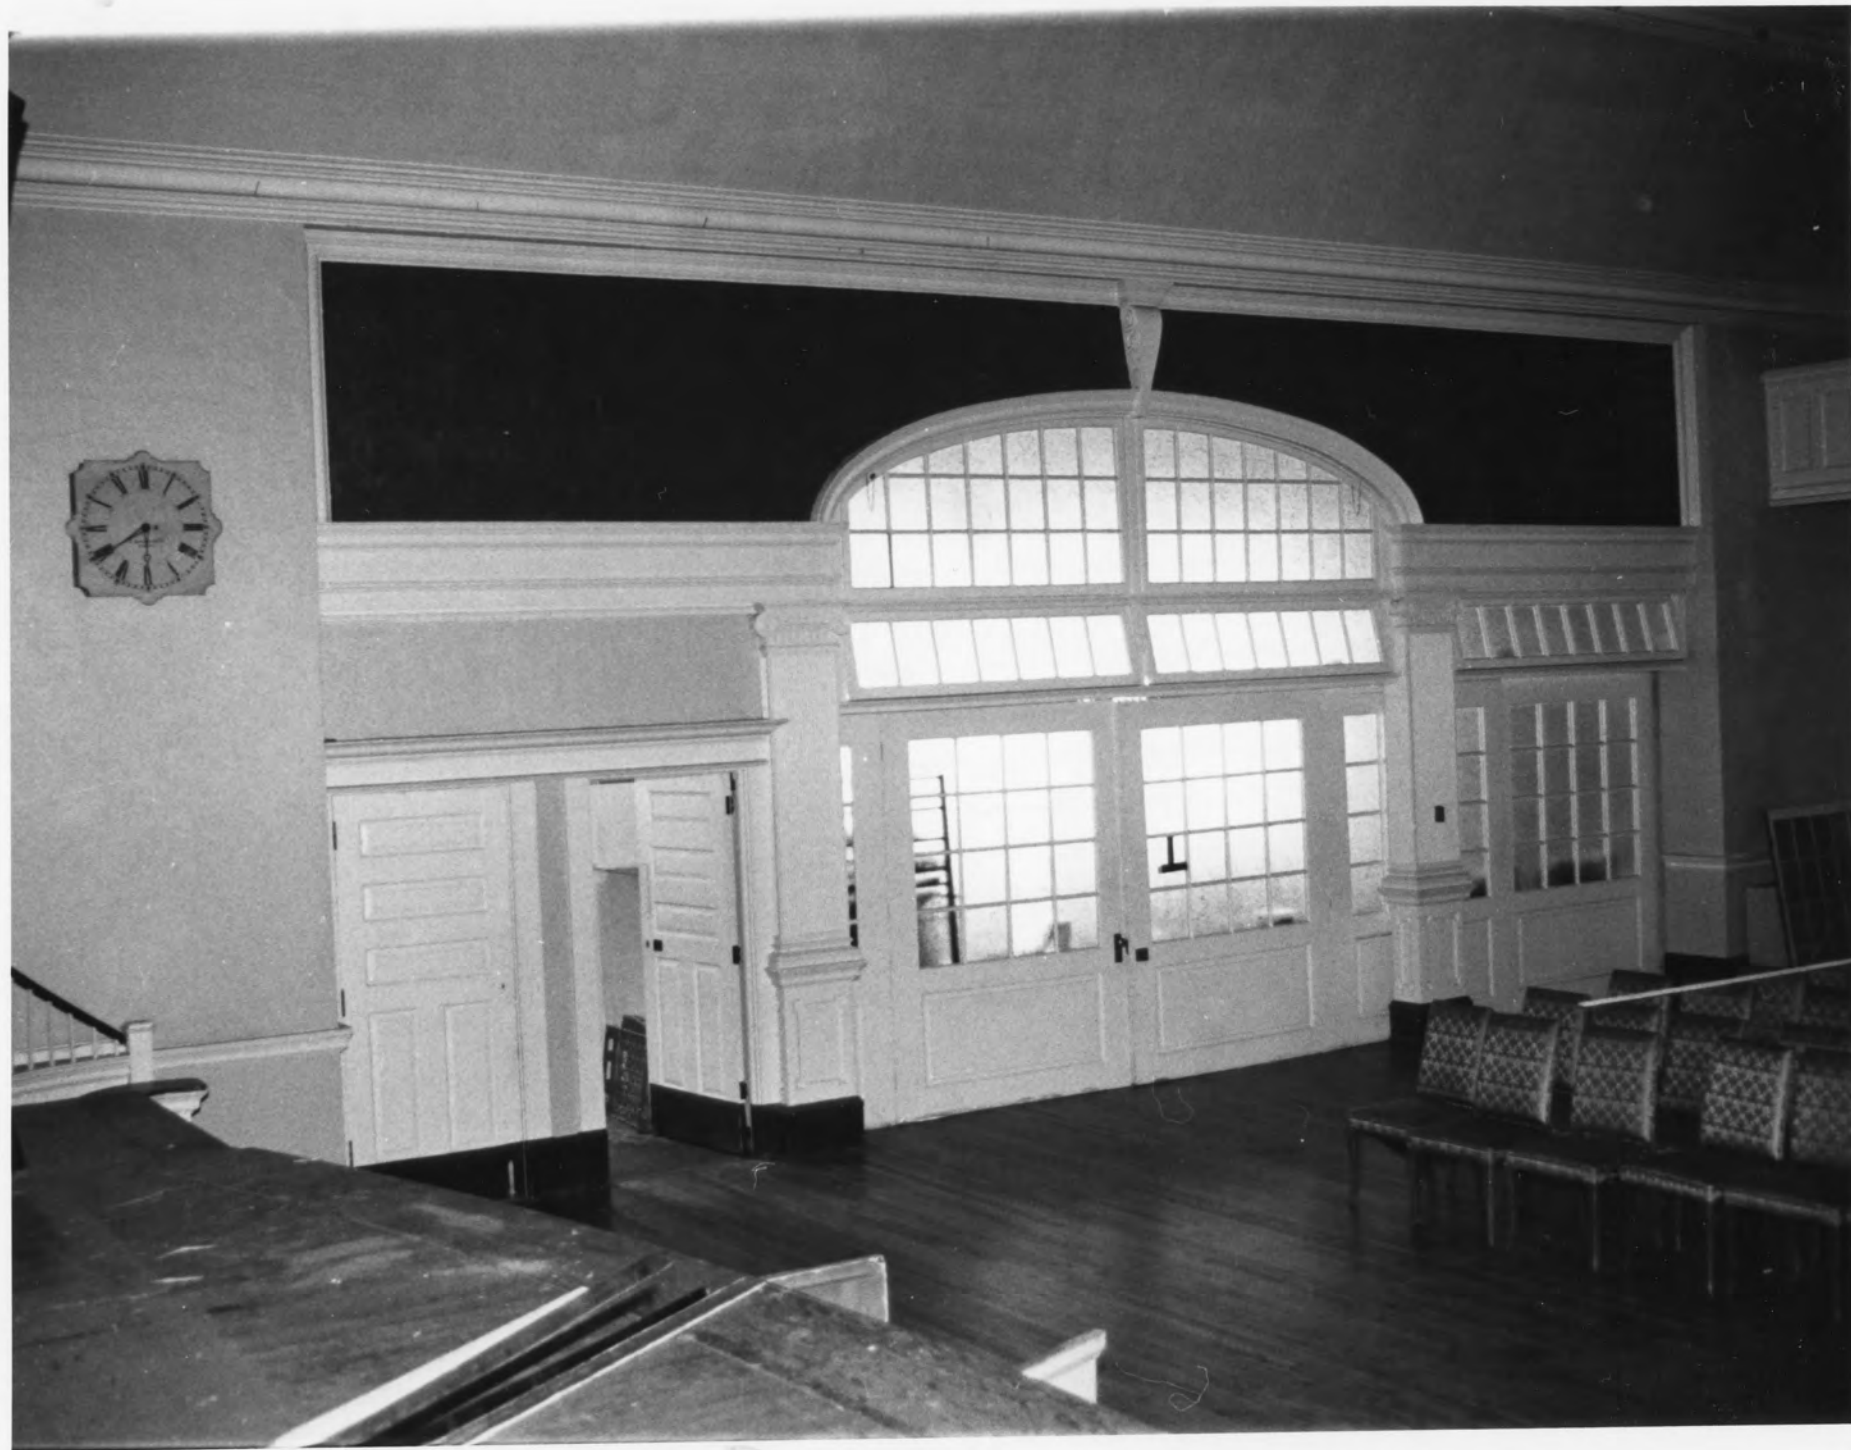
Photograph Number: 15

Description: west wall of auditorium showing doors leading
to annex ; shot from stage looking northwest

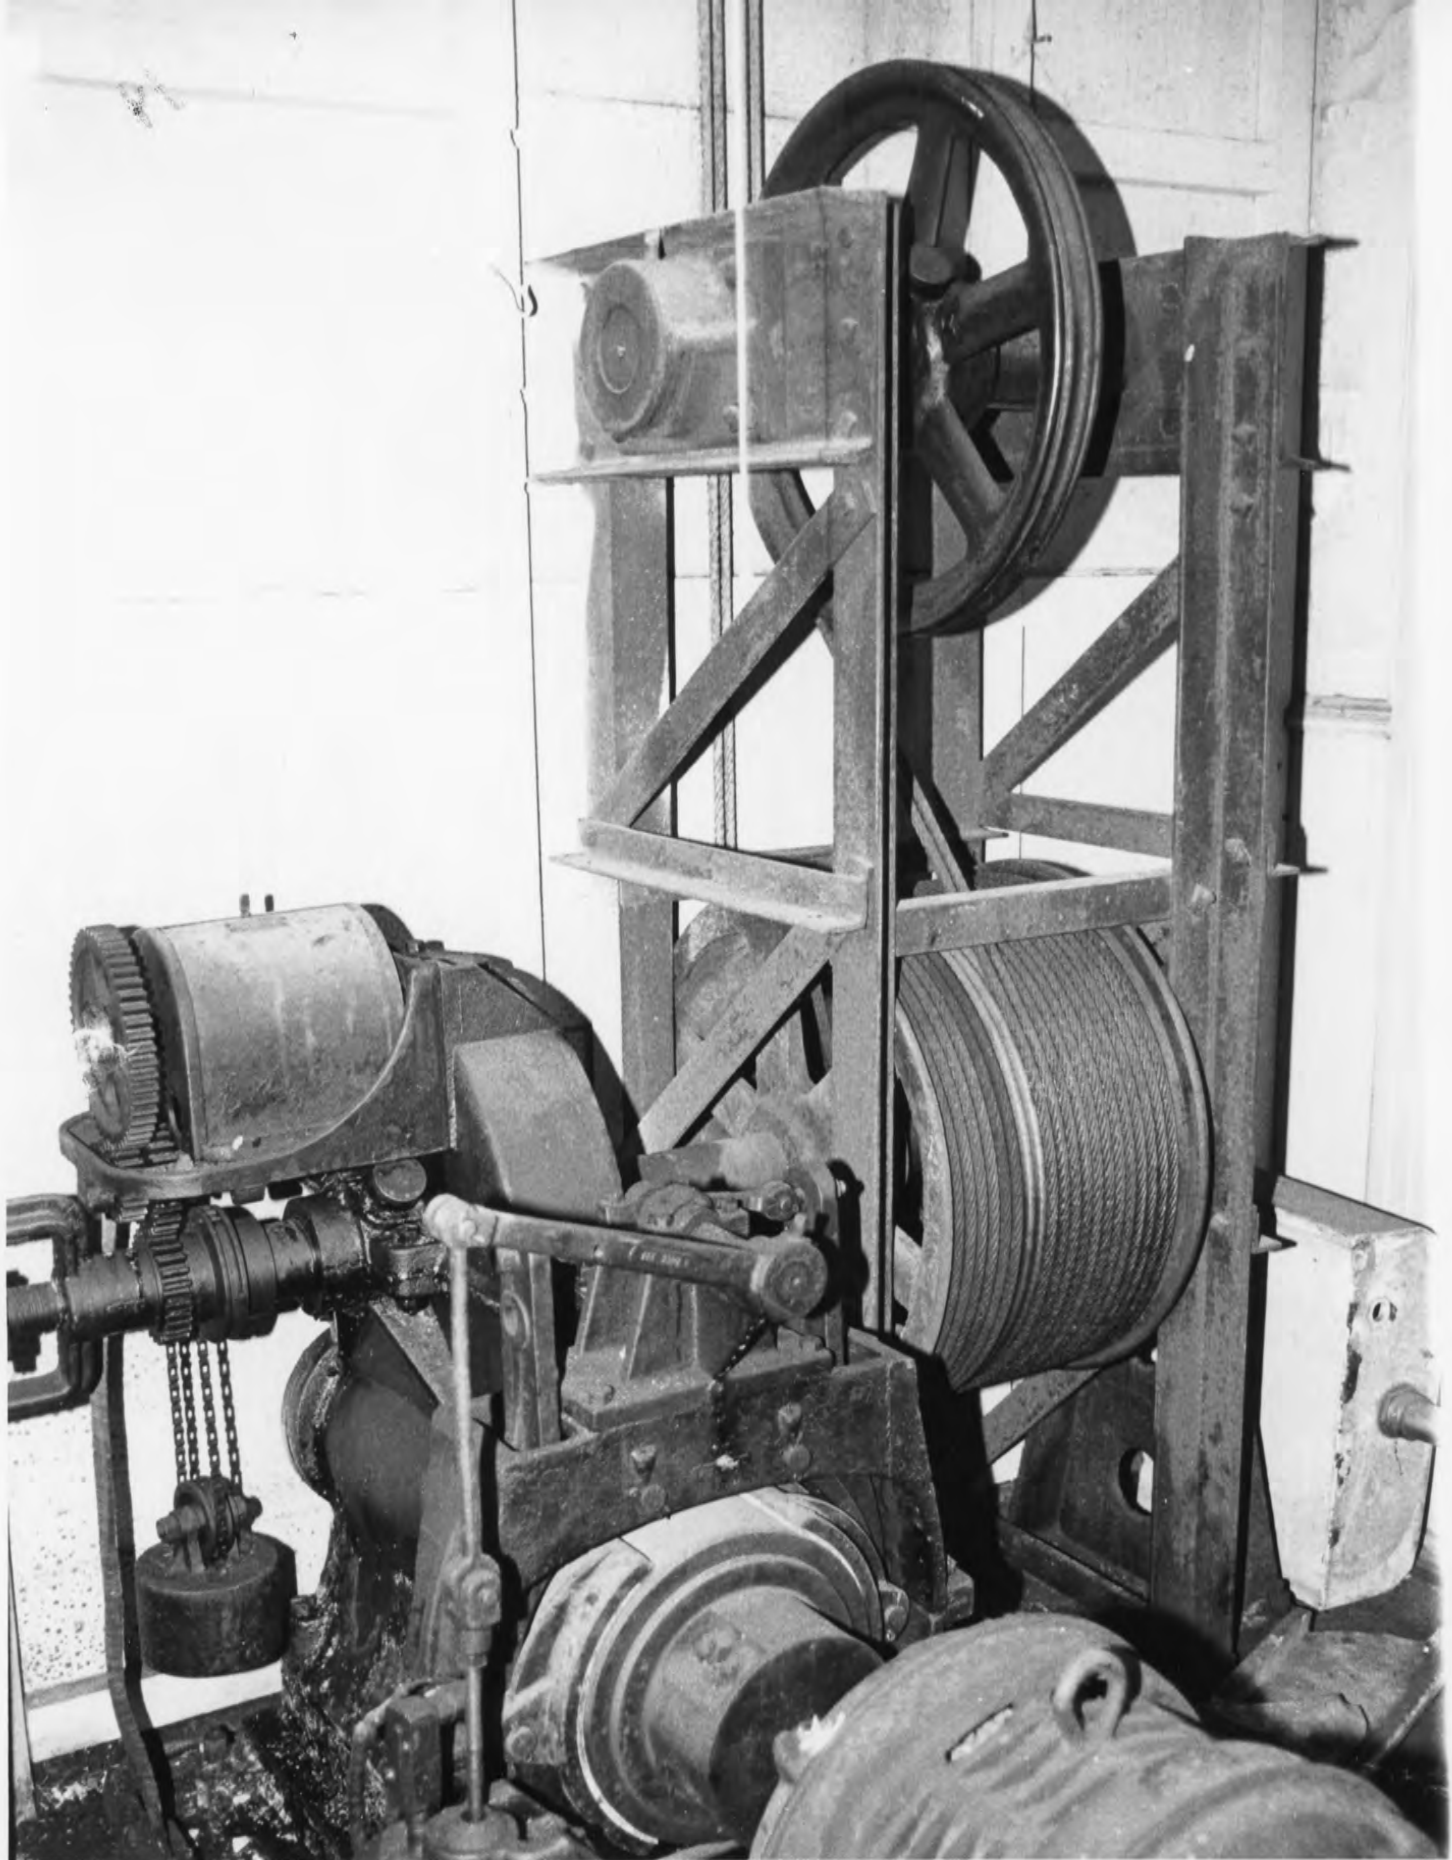
Photograph Number: 20

Description: ELEVATOR MOTOR , BASEMENT

The structure's basement contains the original elevator mechanism (photo #20, interior), as well as furnace. The area below the stage has access either through a basement walkway or a trap door from the stage level for removal of chairs or scenery.

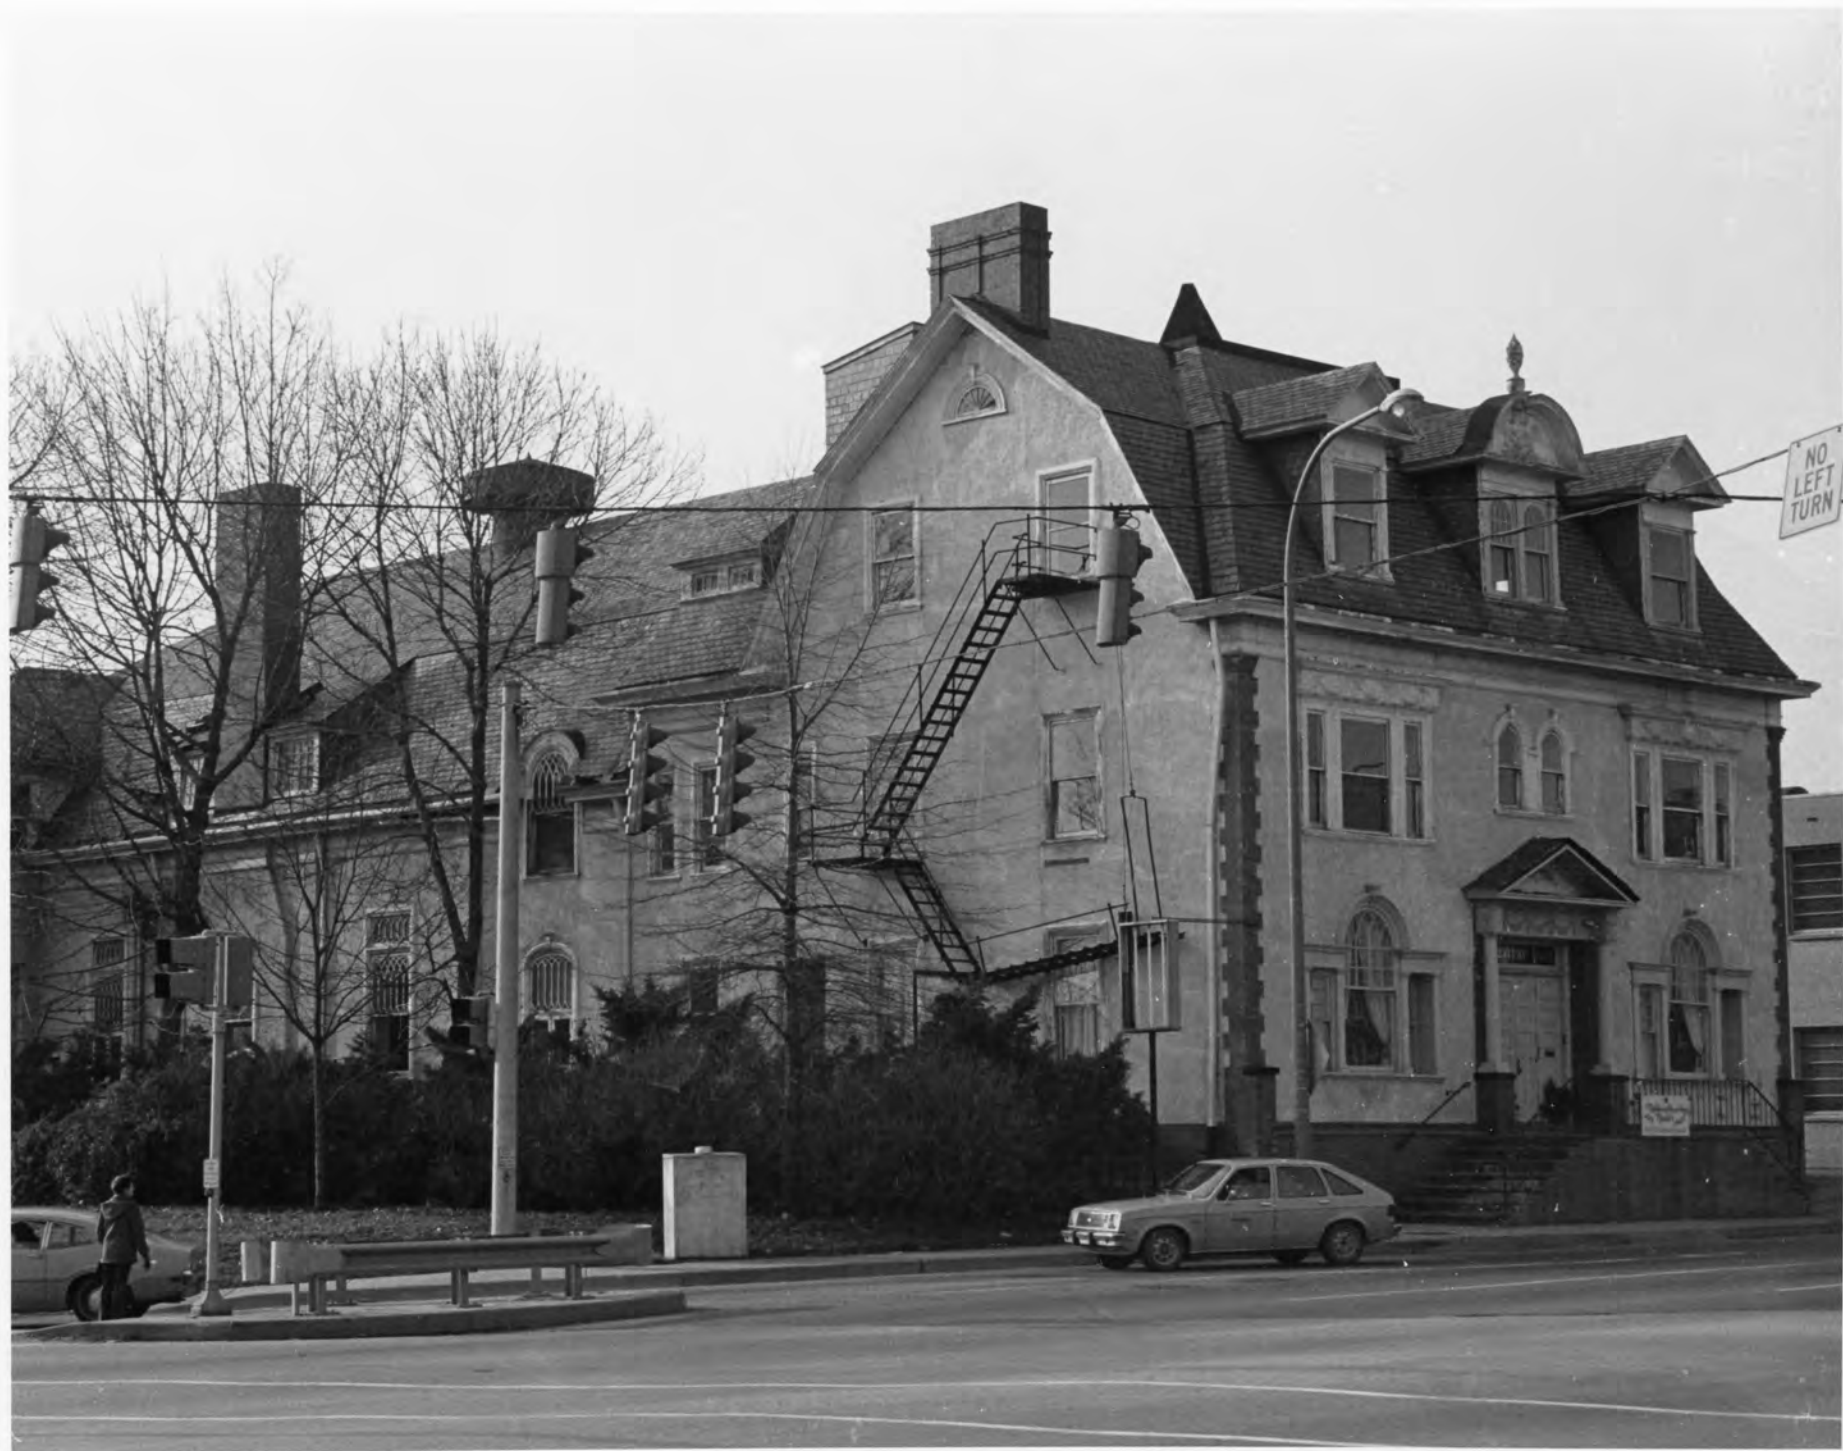
Photograph Number: 22

Description: NORTH AND EAST FACADES
(looking southwest)
