National Register of Historic Places Inventory—Nomination Form

historic New Century Club

street & number 1014 Delaware Avenue not for publication

NEW CENTURY CLUB DESCRIPTION

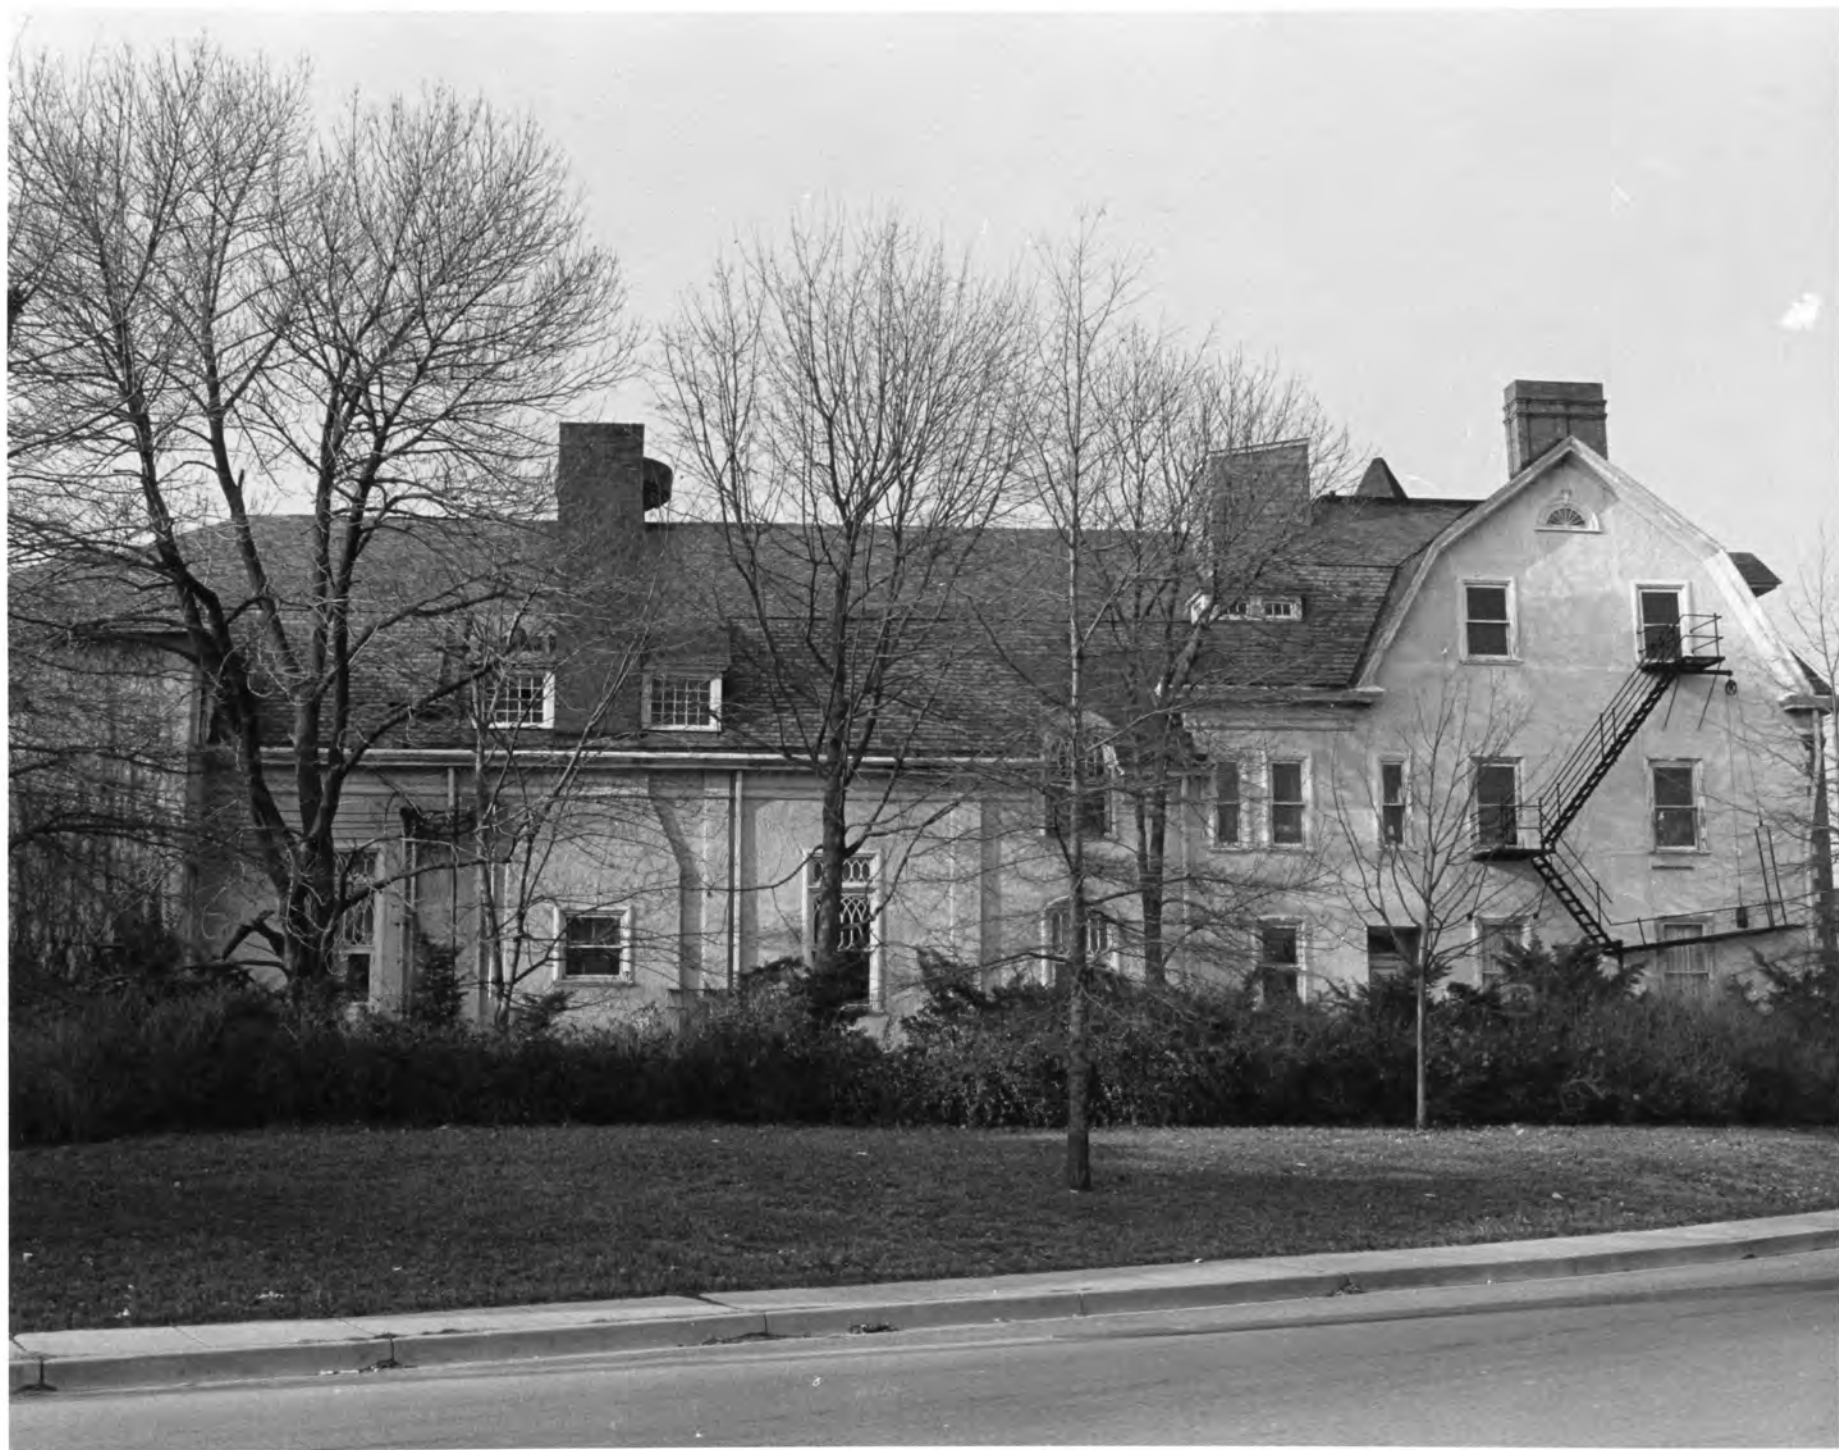
Photograph Number: 23

Description: EAST FACADE

The east wall has a variety of window types along its entire length; single, double, some with upper sash tracery. The two and one half story rear wing has two shed dormers, one on either side of a chimney. There is also a door in the rear of the wing.
