**NATIONAL REGISTER OF HISTORIC PLACES
INVENTORY - NOMINATION FORM**

COMMON:
Augustine Beach Hotel

National Register of Historic Places Registration Form

Historic name: Augustine Beach Hotel AMENDED - Additional Documentation

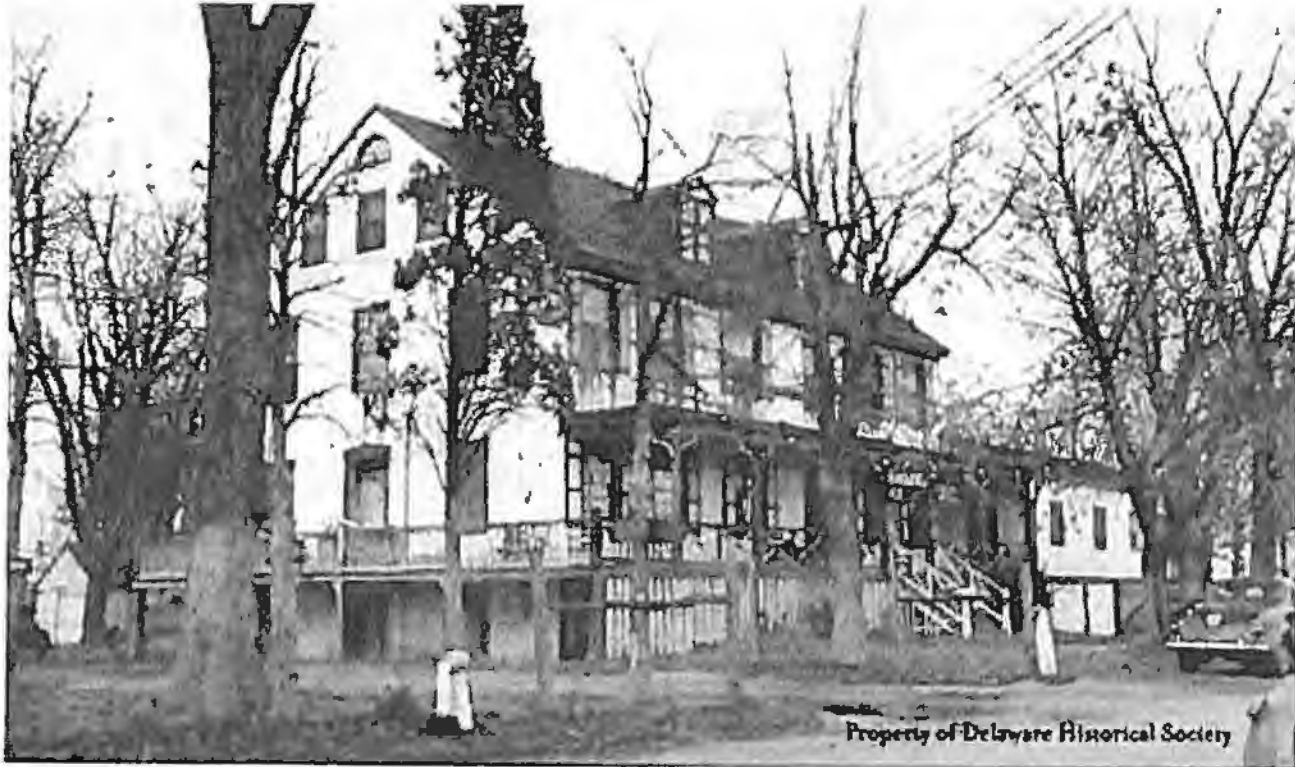
Historic Photo of the Augustine Beach Hotel circa 1940 (Courtesy of Delaware Historical Society)
